Annual Inspection

Admiralty Quay Play Area

Off Ordnance Way, Admiralty Quay, SO40 4AR

Inspection Ref: 122028

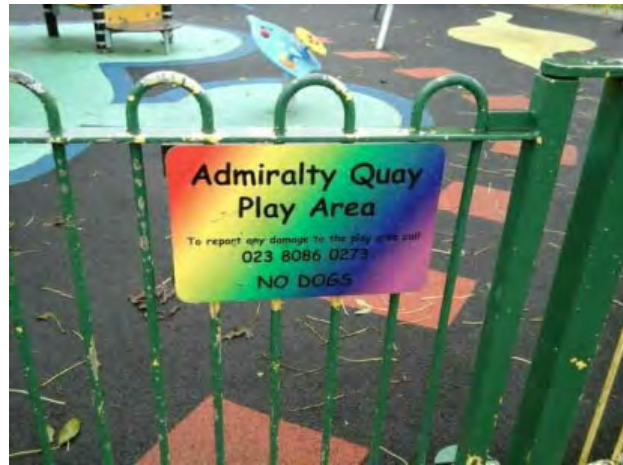
Item: Ancillary Items - Sign
Manufacturer: Owner/Operator
Surface Type: N/A
Equipment Compliance: N/A
Surface Area Compliance: N/A
Ref/Part Number:
Total Findings: 1

It is recommended that information signs with emergency contact details are installed at each entrance/exit point to the playground - Provide in accordance with the recommendations set out in BS EN 1176

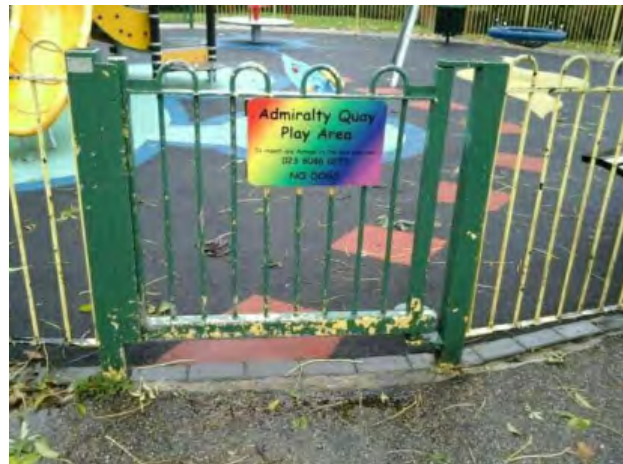
Item: Ancillary Items - Gate
Manufacturer: Owner/Operator
Surface Type: N/A
Equipment Compliance: N/A
Surface Area Compliance: N/A
Ref/Part Number:
Total Findings: 1

This item is satisfactory - no work required

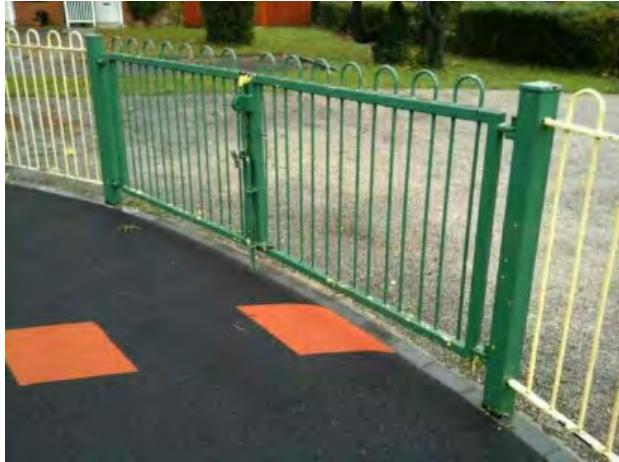
Item: Ancillary Items - Gate - Maintenance
Manufacturer: Owner/Operator
Surface Type: N/A
Equipment Compliance: N/A
Surface Area Compliance: N/A
Ref/Part Number:
Total Findings: 1

This item is satisfactory - no work required

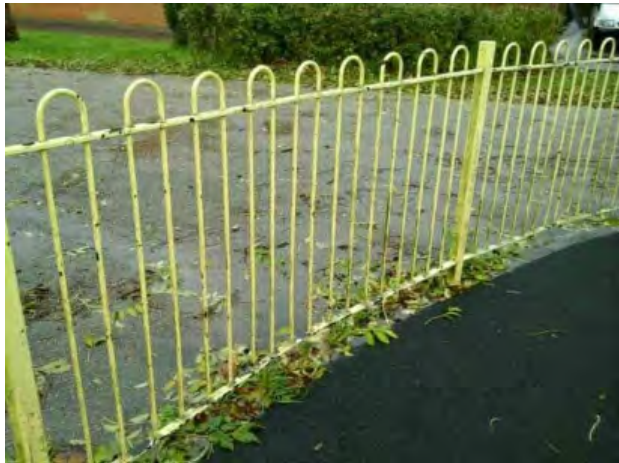
Item: Ancillary Items - Fence - Bow Top
Manufacturer: Owner/Operator
Surface Type: N/A
Equipment Compliance: N/A
Surface Area Compliance: N/A
Ref/Part Number:
Total Findings: 1

There are gaps in excess of 100mm under the fence/gate that may allow the passage of small animals into the area - Monitor playground for animal faeces and adjust height of the gates/fence if necessary

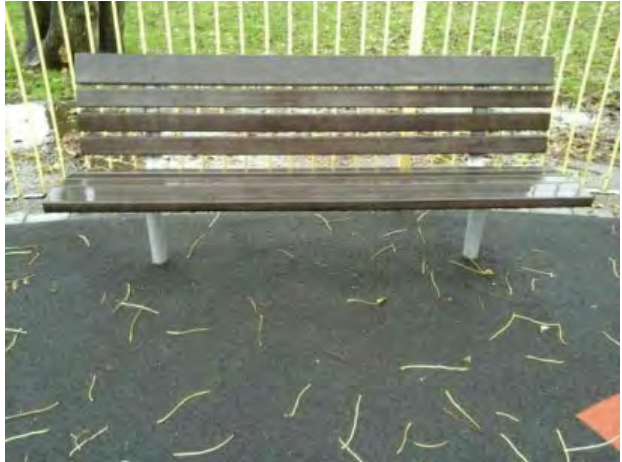
Item: Ancillary Items - Bench
Manufacturer: Owner/Operator
Surface Type: N/A
Equipment Compliance: N/A
Surface Area Compliance: N/A
Ref/Part Number:
Total Findings: 1

This item is satisfactory - no work required

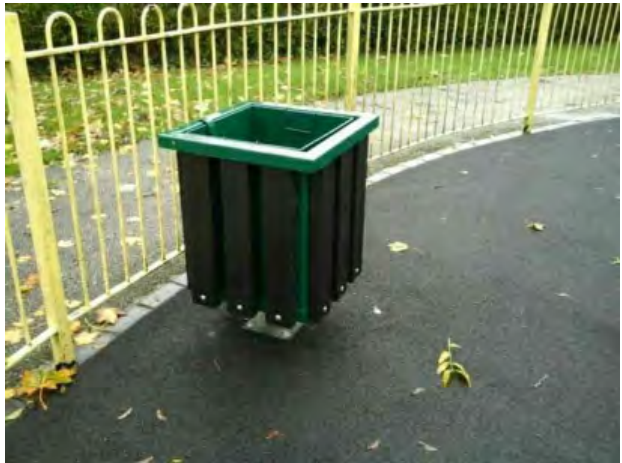
Item: Ancillary Items - Litter Bin
Manufacturer: Owner/Operator
Surface Type: N/A
Equipment Compliance: N/A
Surface Area Compliance: N/A
Ref/Part Number:
Total Findings: 1

This item is satisfactory - no work required

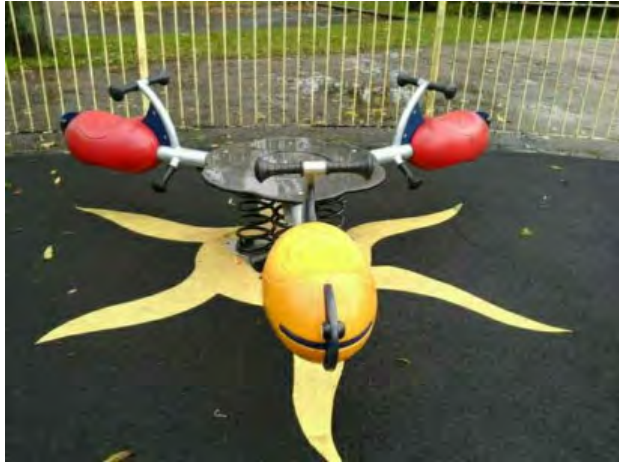
Item: Rocking Equipment - Three Way Springer
Manufacturer: Kompan Ltd
Surface Type: Wet Pour
Equipment Compliance: Yes
Surface Area Compliance: Yes
Ref/Part Number:
Total Findings: 1
Life Expectancy: 5 -10 Years

This item is satisfactory - no work required

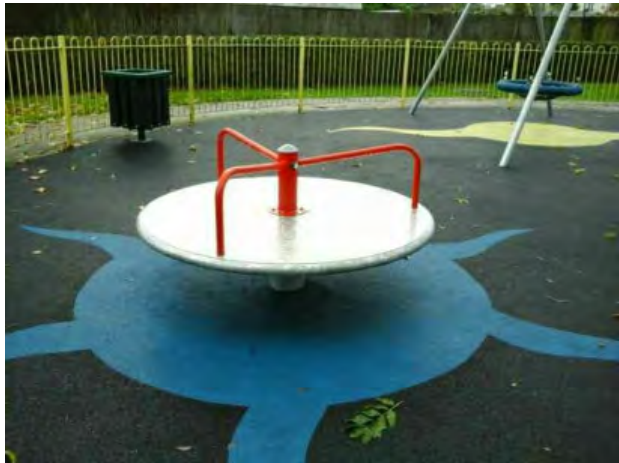
Item: Rotor Play - Roundabout
Manufacturer: Kompan Ltd
Surface Type: Wet Pour
Equipment Compliance: No
Surface Area Compliance: Yes
Ref/Part Number:
Total Findings: 1
Life Expectancy: 5 -10 Years

The height of the roundabout platform is less than 400mm and fails the requirements of BS EN 1176 Part 5 - Monitor use

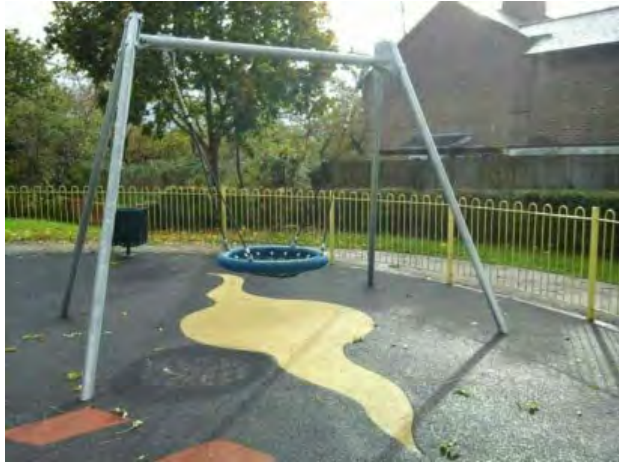
Item: Swings - Basket Swing - Type 1
Manufacturer: Kompan Ltd
Surface Type: Wet Pour
Equipment Compliance: No
Surface Area Compliance: Yes
Ref/Part Number:
Total Findings: 1
Life Expectancy: 5 -10 Years

The connecting links are in excess of 8.6mm and less than 12mm and fail the requirements of BS EN 1176:2008 Part 1; clause 4.2.13, Chains - Monitor use and replace with compliant links at the next maintenance cycle

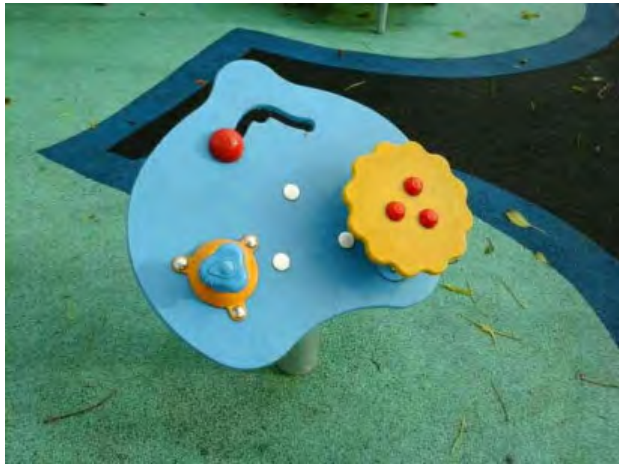
Item: Other - Play Panel
Manufacturer: Kompan Ltd
Surface Type: Wet Pour
Equipment Compliance: Yes
Surface Area Compliance: Yes
Ref/Part Number:
Total Findings: 1
Life Expectancy: 5 -10 Years

This item is satisfactory - no work required

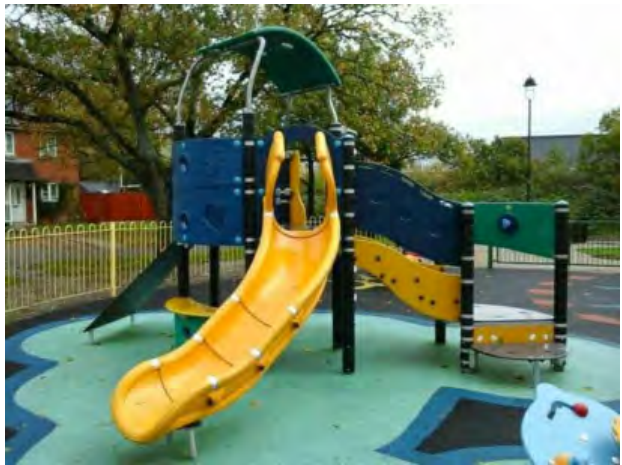
Item: Activity Equipment - Multi Play (Junior)
Manufacturer: Kompan Ltd
Surface Type: Wet Pour
Equipment Compliance: No
Surface Area Compliance: Yes
Ref/Part Number:
Total Findings: 1
Life Expectancy: 5 -10 Years

There is/are finger entrapment/s at the top of the slide - Monitor use

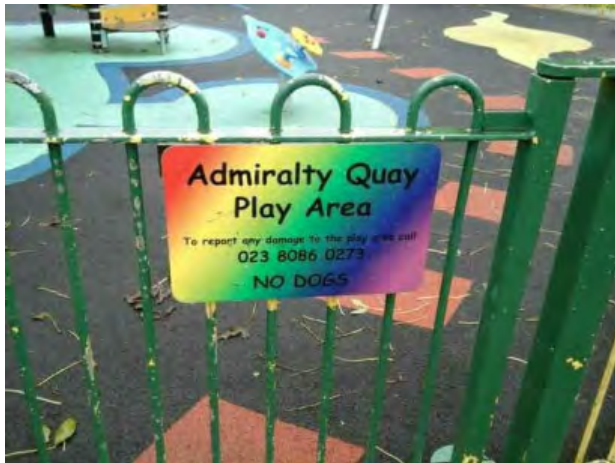
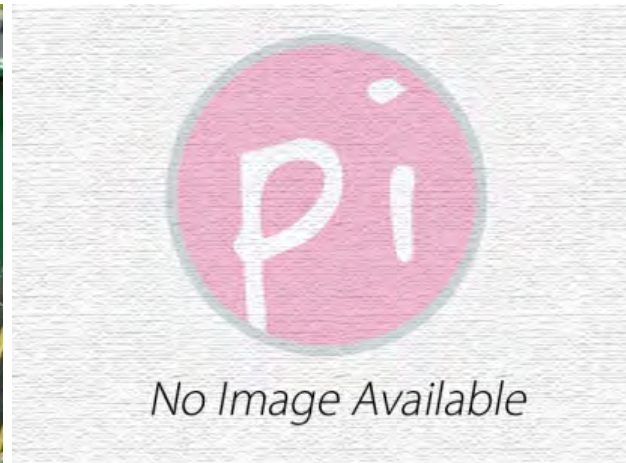
Item: Ancillary Items - Sign
Manufacturer: Owner/Operator

Risk Level: V - Very Low Risk
Surface: N/A

Finding: It is recommended that information signs with emergency contact details are installed at each entrance/exit point to the playground

Action: Provide in accordance with the recommendations set out in BS EN 1176

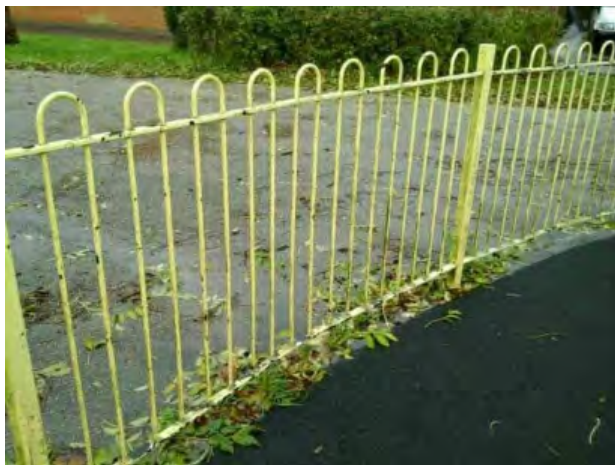
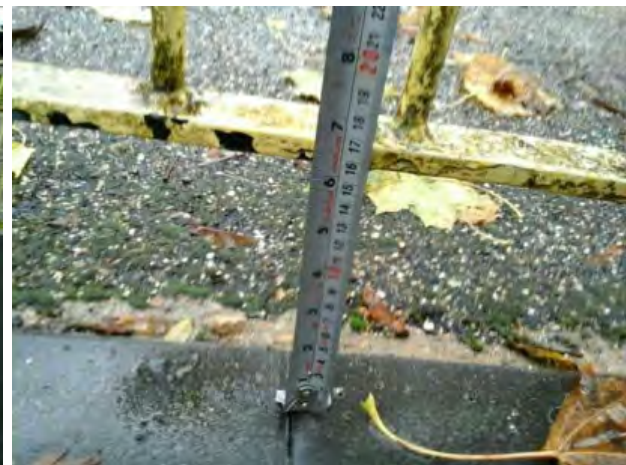
Item: Ancillary Items - Fence - Bow Top
Manufacturer: Owner/Operator

Risk Level: L - Low Risk
Surface: N/A

Finding: There are gaps in excess of 100mm under the fence/gate that may allow the passage of small animals into the area

Action: Monitor playground for animal faeces and adjust height of the gates/fence if necessary

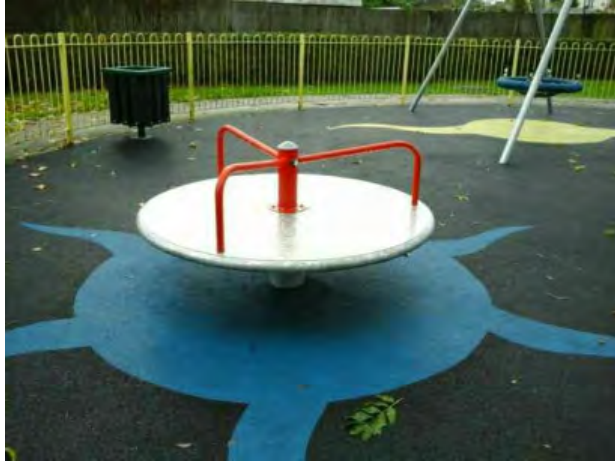
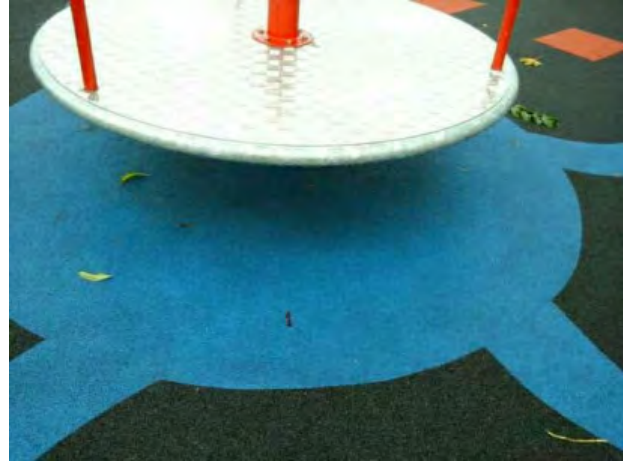
Item: Rotor Play - Roundabout
Manufacturer: Kompan Ltd

Risk Level: L - Low Risk
Surface: Wet Pour

Finding: The height of the roundabout platform is less than 400mm and fails the requirements of BS EN 1176 Part 5

Action: Monitor use

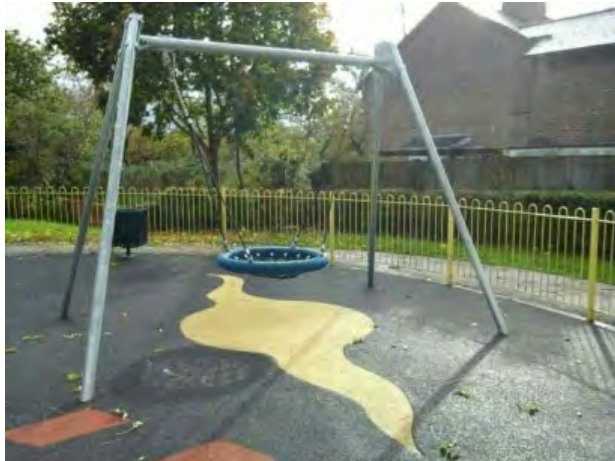
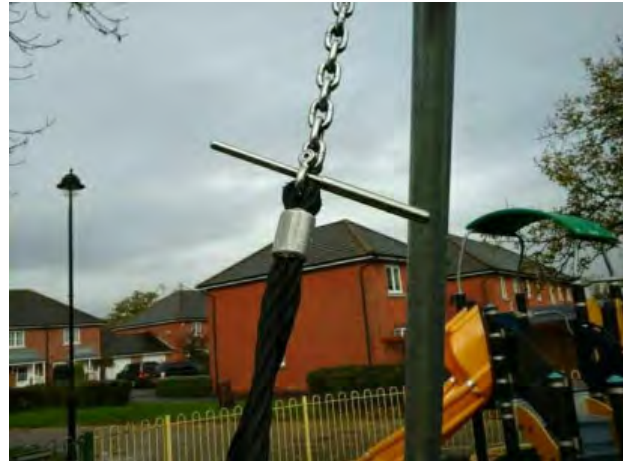
Item: Swings - Basket Swing - Type 1
Manufacturer: Kompan Ltd

Risk Level: V - Very Low Risk
Surface: Wet Pour

Finding: The connecting links are in excess of 8.6mm and less than 12mm and fail the requirements of BS EN 1176:2008 Part 1; clause 4.2.13, Chains

Action: Monitor use and replace with compliant links at the next maintenance cycle

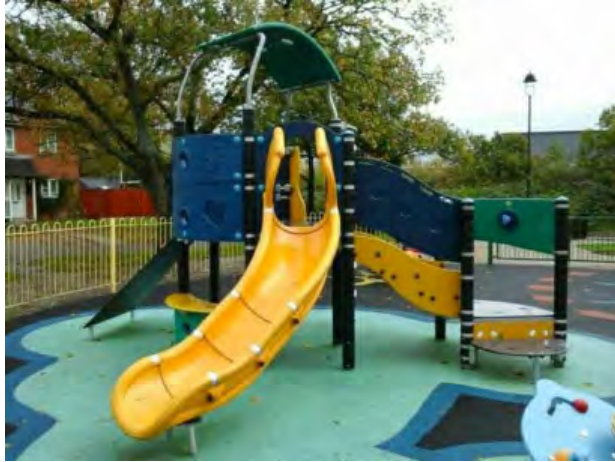
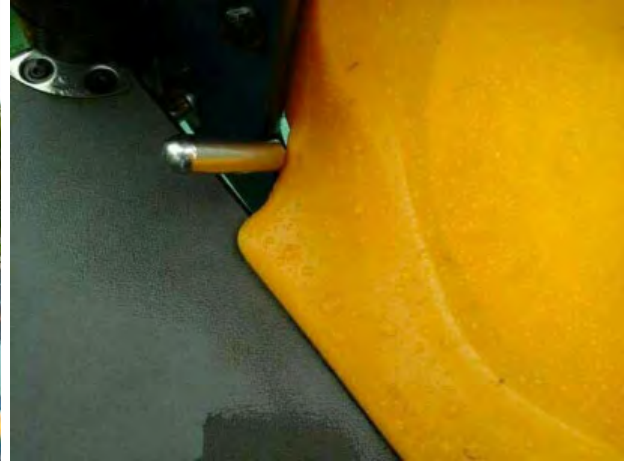
Item: Activity Equipment - Multi Play (Junior)

Risk Level: V - Very Low Risk

Finding: There is/are finger entrapment/s at the top of the slide

Action: Monitor use
