Annual Inspection

Cork Field Skate Park

Normandy Way, Marchwood

Inspection Ref: 122029

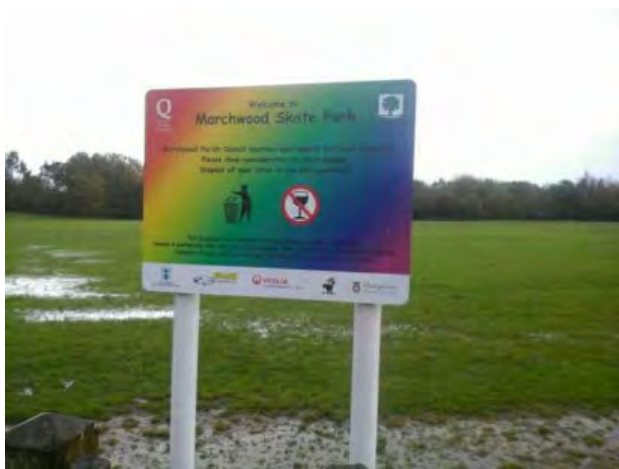
Item: Ancillary Items - Sign
Manufacturer: Owner/Operator
Surface Type: N/A
Equipment Compliance: N/A
Surface Area Compliance: N/A
Ref/Part Number:
Total Findings: 1

4 - Very Low Risk

Signage should be provided as recommended in BS EN 14974; this will include, but not exclusively, the use of the area, a recommendation to wear protective equipment, emergency contact details etc. - Provide signage as recommended by BS EN 14974

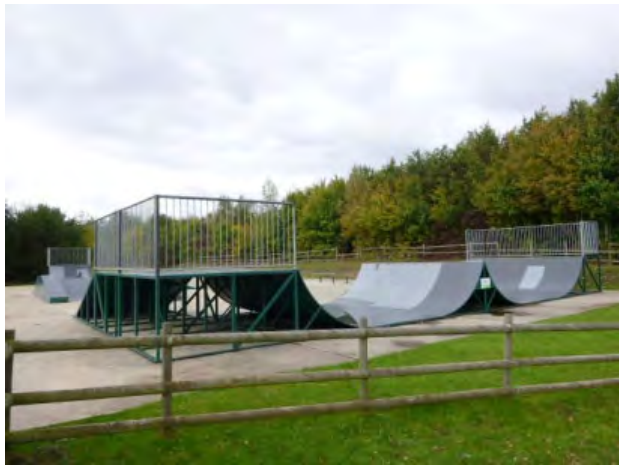
Item: Ancillary Items - Site General
Manufacturer: Owner/Operator
Surface Type: N/A
Equipment Compliance: N/A
Surface Area Compliance: N/A
Ref/Part Number:
Total Findings: 1

6 - Low Risk

The concrete surface around the site is showing signs of wear/damage - Monitor for any further deterioration and repair as required

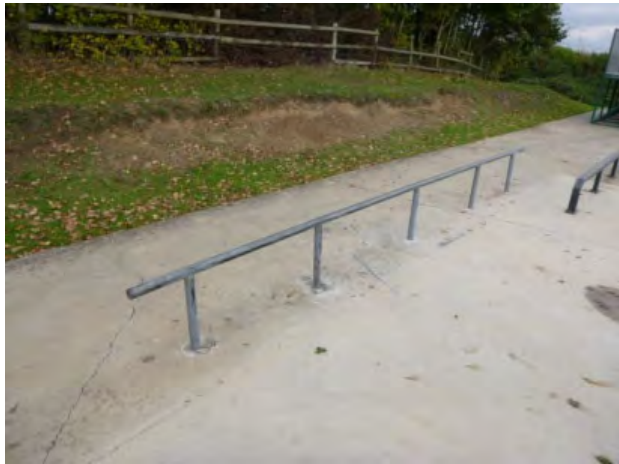
Item: Wheeled Sports - Grind Rail
Manufacturer: Not Identified
Surface Type: Concrete
Equipment Compliance: No
Surface Area Compliance: No
Ref/Part Number:
Total Findings: 2
Life Expectancy: 5 -10 Years

8 - Low Risk

The end of the grind rail should reach the ground to meet the requirements of BS EN 14974 - Monitor use

The item has insufficient safety zone allowed as required by BS EN 14974. This should equal at least 2.0 metres on most items and 5.0 metres behind a Jump Ramp - Monitor use

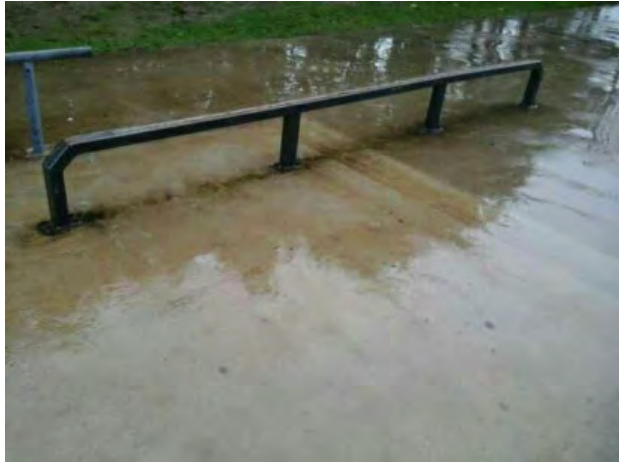
Item: Wheeled Sports - Grind Rail
Manufacturer: Not Identified
Surface Type: Concrete
Equipment Compliance: Yes
Surface Area Compliance: No
Ref/Part Number:
Total Findings: 1
Life Expectancy: 5 -10 Years

8 - Low Risk

The item has insufficient safety zone allowed as required by BS EN 14974. This should equal at least 2.0 metres on most items and 5.0 metres behind a Jump Ramp - Monitor use

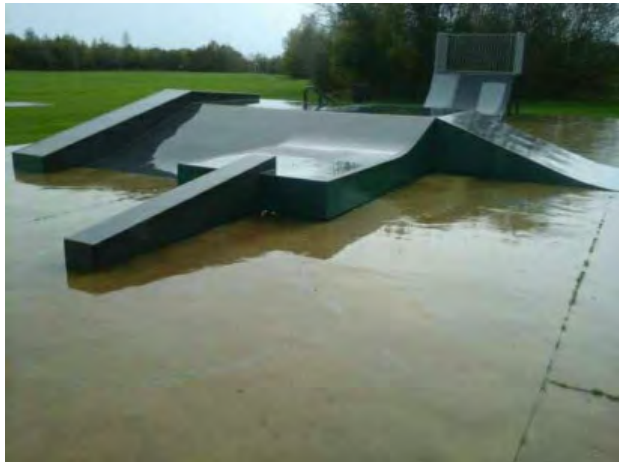
Item: Wheeled Sports - Fun Box
Manufacturer: Not Identified
Surface Type: Concrete
Equipment Compliance: Yes
Surface Area Compliance: Yes
Ref/Part Number:
Total Findings: 1
Life Expectancy: 5 -10 Years

6 - Low Risk

The paintwork on this item has been damaged or worn exposing the metal underneath which is rusting - Treat any rusting components and repaint

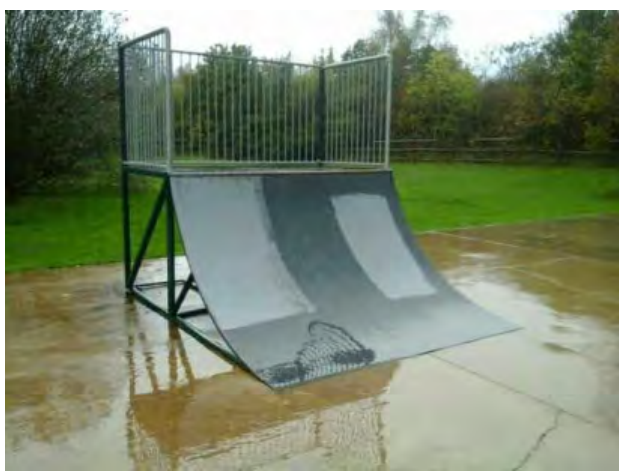
Item: Wheeled Sports - Platform Transition
Manufacturer: Not Identified
Surface Type: Concrete
Equipment Compliance: No
Surface Area Compliance: Yes
Ref/Part Number:
Total Findings: 3
Life Expectancy: 5 -10 Years

i 8 - Low Risk

The kicker plate protrudes more than 5mm above the surrounding surface level, BS EN 14974 recommends a maximum of 5mm with 3mm preferred - Adjust height to ensure a maximum of 5mm change in level

The height of the barrier is less than 1200mm and fails the requirements of BS EN 14974 - Monitor use

The paintwork on this item has been damaged or worn exposing the metal underneath which is rusting - Treat any rusting components and repaint

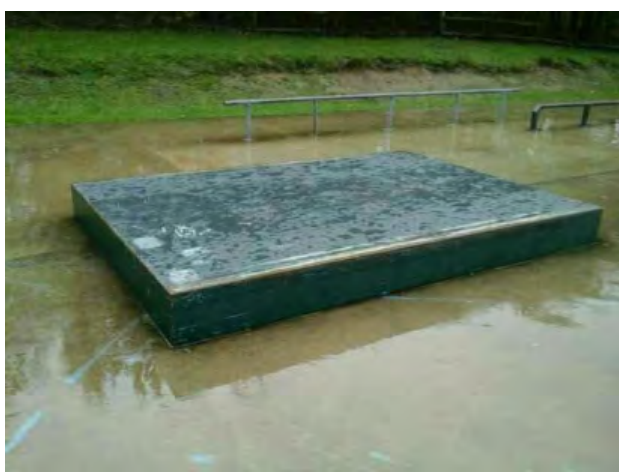
Item: Wheeled Sports - Ledge
Manufacturer: Not Identified
Surface Type: Concrete
Equipment Compliance: Yes
Surface Area Compliance: Yes
Ref/Part Number:
Total Findings: 2
Life Expectancy: 5 -10 Years

i 6 - Low Risk

The paintwork on this item has been damaged or worn exposing the metal underneath which is rusting - Treat any rusting components and repaint

There is offensive graffiti present on site - Remove as soon as practicable

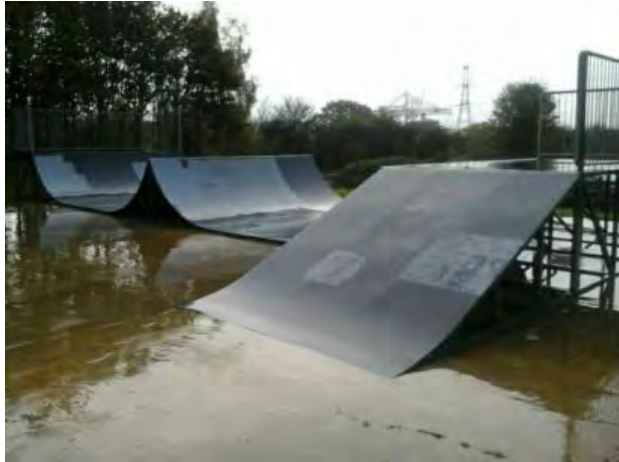
Item: Wheeled Sports - Half Pipe
Manufacturer: Not Identified
Surface Type: Concrete
Equipment Compliance: No
Surface Area Compliance: Yes
Ref/Part Number:
Total Findings: 5
Life Expectancy: 5 -10 Years

8 - Low Risk

The gap between the underside of the barrier and the platform is in excess of 60mm and fails the requirements of BS EN 14974 - Monitor use

The height of the barrier is less than 1200mm and fails the requirements of BS EN 14974 - Monitor use

The horizontal opening in the barrier is in excess of 89mm and fails the requirements of BS EN 14974 - Monitor use

The barrier has some minor damage - Monitor for any further deterioration and repair as required

The paintwork on this item has been damaged or worn exposing the metal underneath which is rusting - Treat any rusting components and repaint

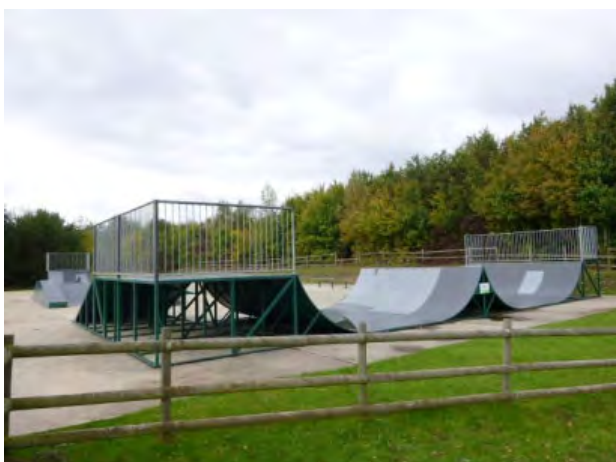
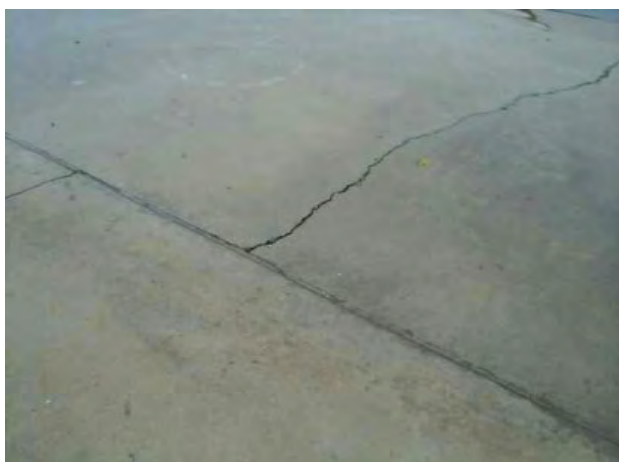
6 - Low Risk			
Item:	Ancillary Items - Site General	Risk Level:	L - Low Risk
Manufacturer:	Owner/Operator	Surface:	N/A

Finding:	The concrete surface around the site is showing signs of wear/damage		Action: Monitor for any further deterioration and repair as required

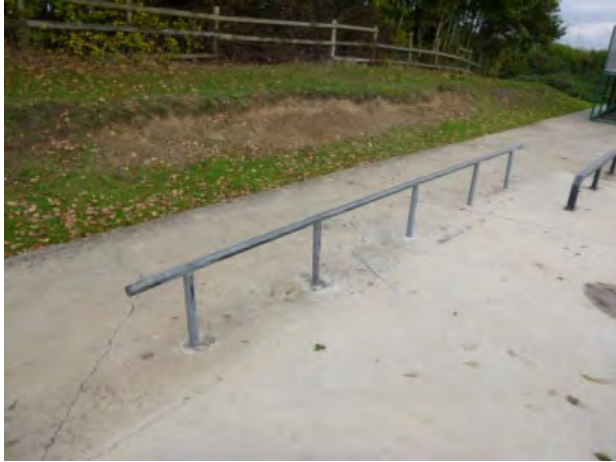
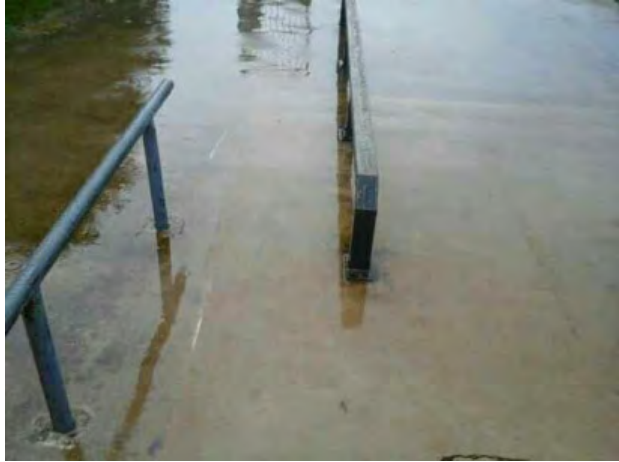
8 - Low Risk			
Item:	Wheeled Sports - Grind Rail	Risk Level:	L - Low Risk
Manufacturer:	Not Identified	Surface:	Concrete

Finding:	The item has insufficient safety zone allowed as required by BS EN 14974. This should equal at least 2.0 metres on most items and 5.0 metres behind a Jump Ramp		Action: Monitor use

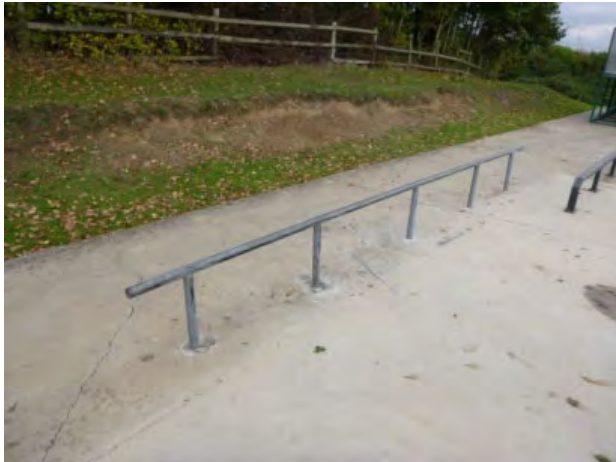
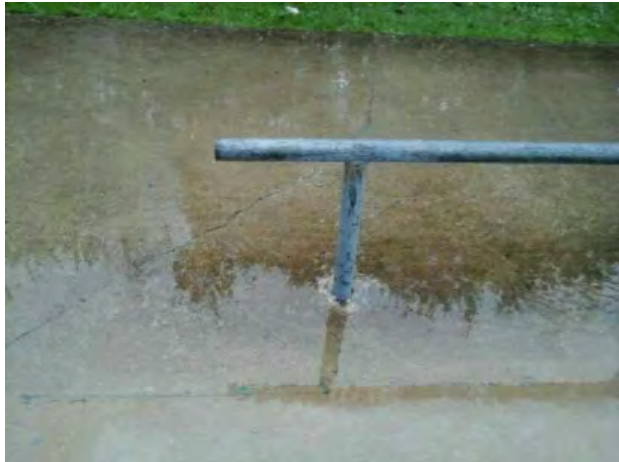
8 - Low Risk			
Item:	Wheeled Sports - Grind Rail	Risk Level:	L - Low Risk
Manufacturer:	Not Identified	Surface:	Concrete

Finding:	The end of the grind rail should reach the ground to meet the requirements of BS EN 14974		Action: Monitor use

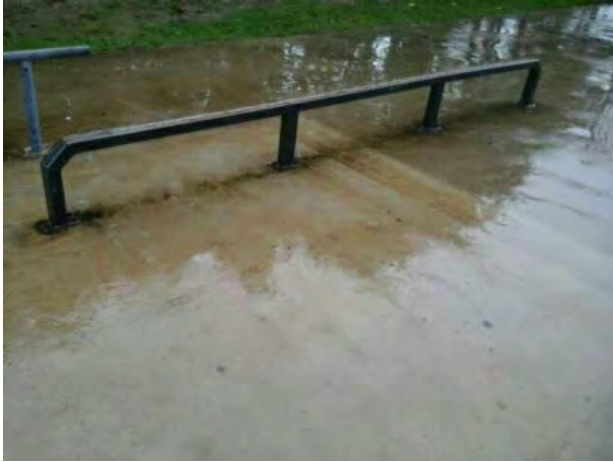
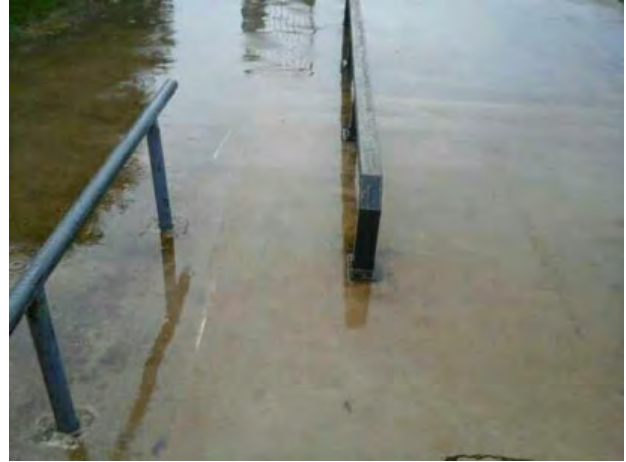
Item: Wheeled Sports - Grind Rail
Manufacturer: Not Identified

Risk Level: L - Low Risk
Surface: Concrete

Finding: The item has insufficient safety zone allowed as required by BS EN 14974. This should equal at least 2.0 metres on most items and 5.0 metres behind a Jump Ramp

Action: Monitor use

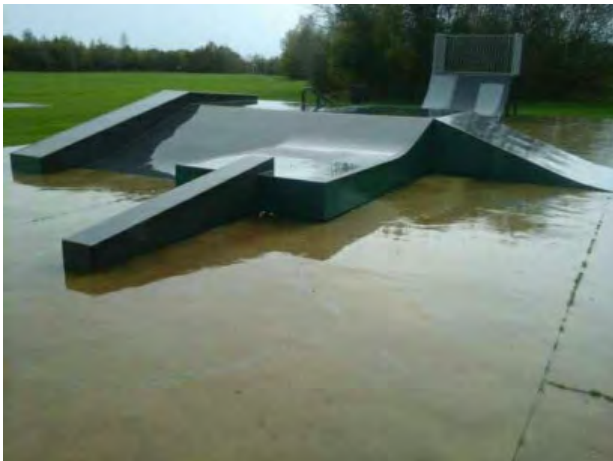
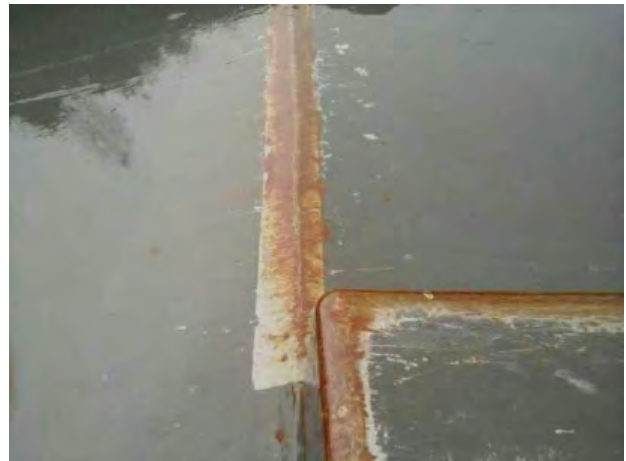
Item: Wheeled Sports - Fun Box
Manufacturer: Not Identified

Risk Level: L - Low Risk
Surface: Concrete

Finding: The paintwork on this item has been damaged or worn exposing the metal underneath which is rusting

Action: Treat any rusting components and repaint

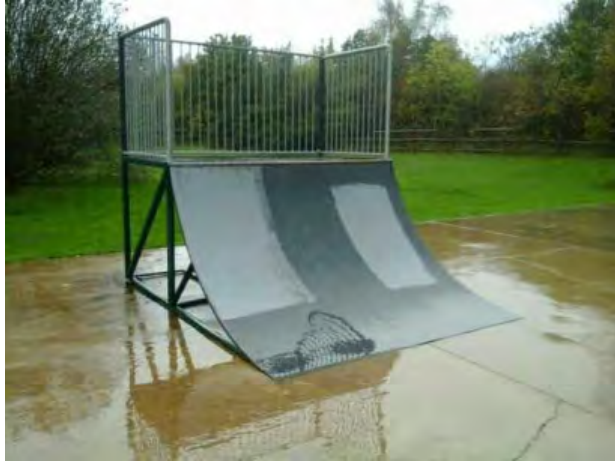
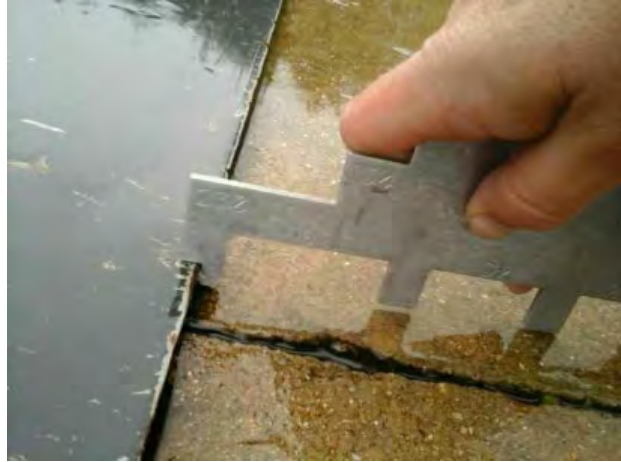
Item: Wheeled Sports - Platform Transition
Manufacturer: Not Identified

Risk Level: L - Low Risk
Surface: Concrete

Finding: The kicker plate protrudes more than 5mm above the surrounding surface level, BS EN 14974 recommends a maximum of 5mm with 3mm preferred

Action: Adjust height to ensure a maximum of 5mm change in level

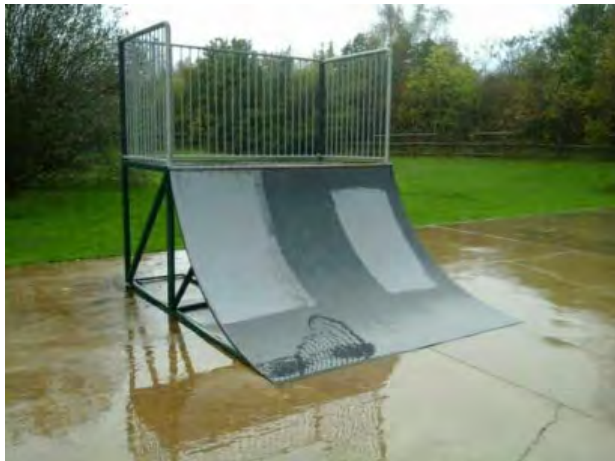
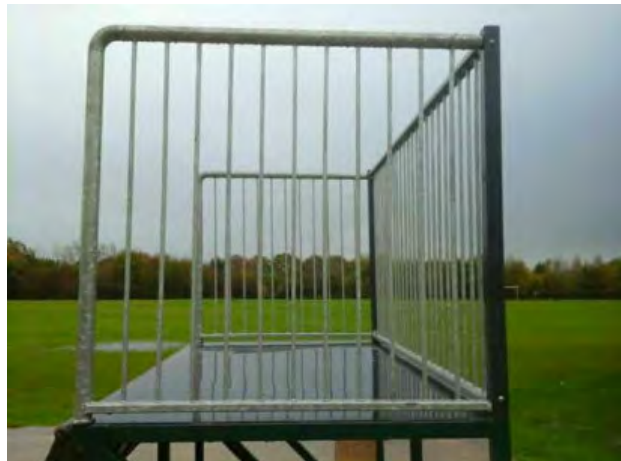
Item: Wheeled Sports - Platform Transition
Manufacturer: Not Identified

Risk Level: L - Low Risk
Surface: Concrete

Finding: The height of the barrier is less than 1200mm and fails the requirements of BS EN 14974

Action: Monitor use

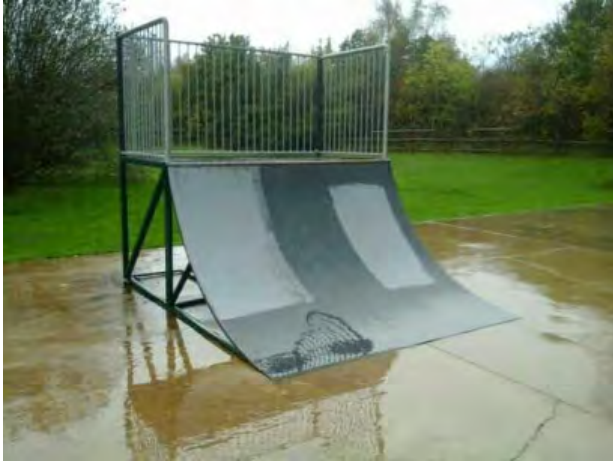
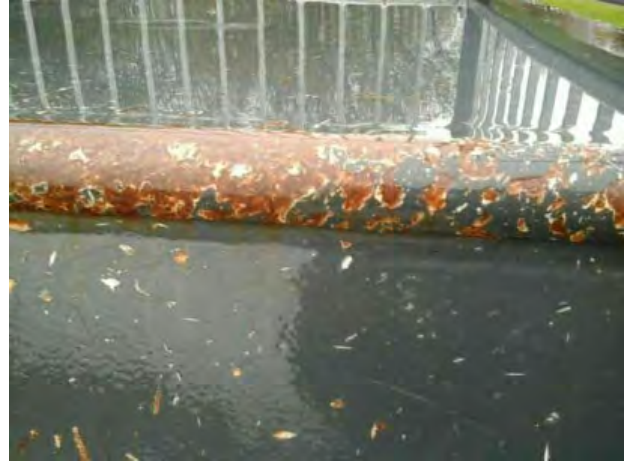
Item: Wheeled Sports - Platform Transition
Manufacturer: Not Identified

Risk Level: L - Low Risk
Surface: Concrete

Finding: The paintwork on this item has been damaged or worn exposing the metal underneath which is rusting

Action: Treat any rusting components and repaint

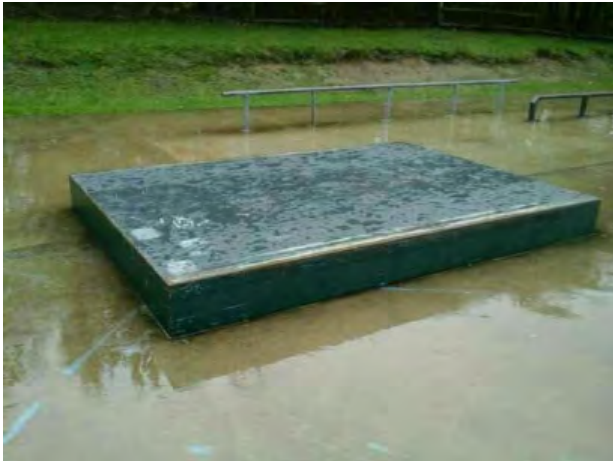
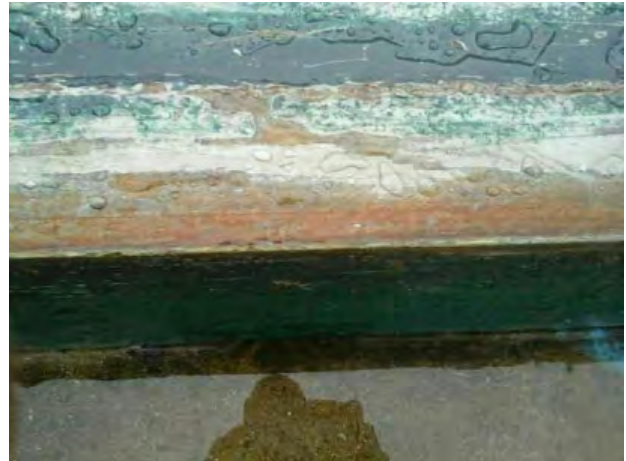
Item: Wheeled Sports - Ledge
Manufacturer: Not Identified

Risk Level: L - Low Risk
Surface: Concrete

Finding: The paintwork on this item has been damaged or worn exposing the metal underneath which is rusting

Action: Treat any rusting components and repaint

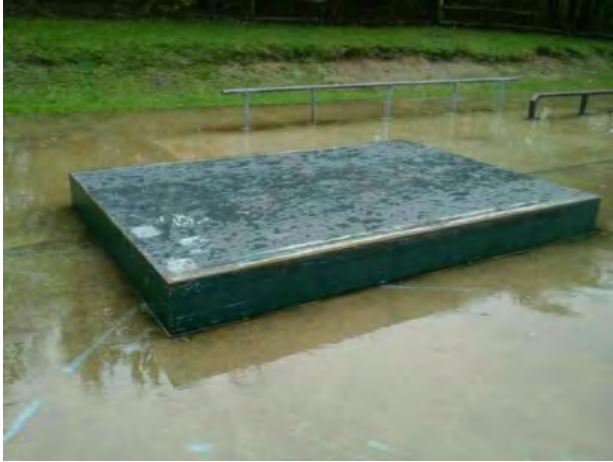
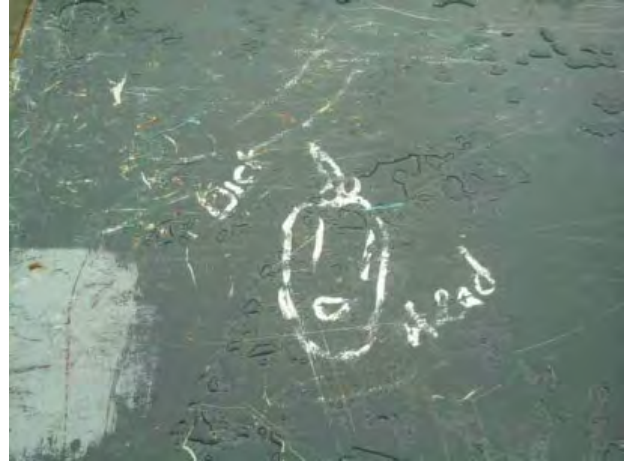
Item: Wheeled Sports - Ledge
Manufacturer: Not Identified

Risk Level: V - Very Low Risk
Surface: Concrete

Finding: There is offensive graffiti present on site

Action: Remove as soon as practicable

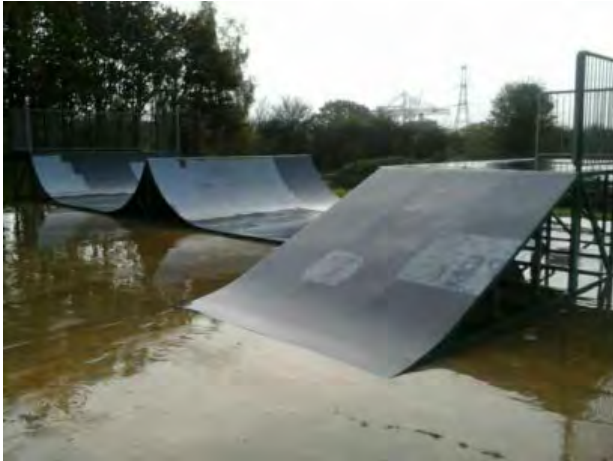
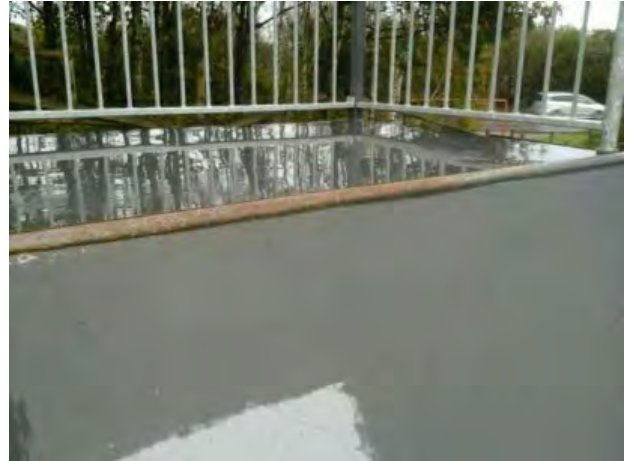
Item: Wheeled Sports - Half Pipe
Manufacturer: Not Identified

Risk Level: L - Low Risk
Surface: Concrete

Finding: The paintwork on this item has been damaged or worn exposing the metal underneath which is rusting

Action: Treat any rusting components and repaint

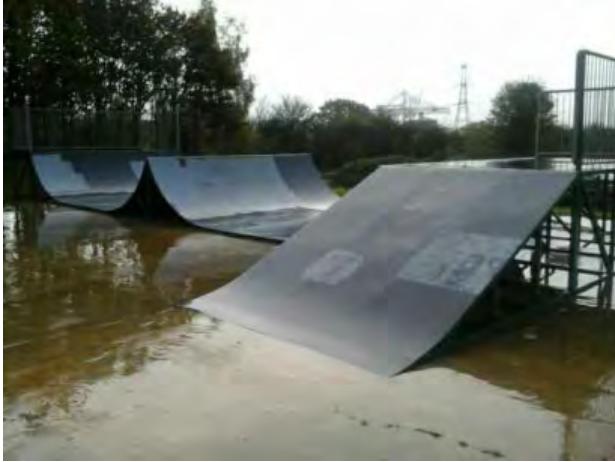
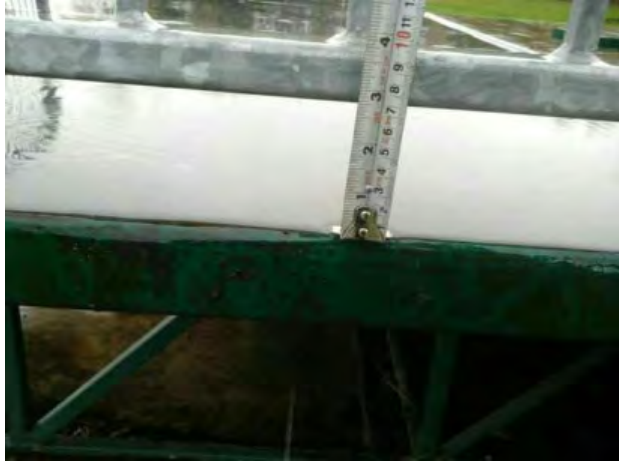
Item: Wheeled Sports - Half Pipe
Manufacturer: Not Identified

Risk Level: L - Low Risk
Surface: Concrete

Finding: The gap between the underside of the barrier and the platform is in excess of 60mm and fails the requirements of BS EN 14974

Action: Monitor use

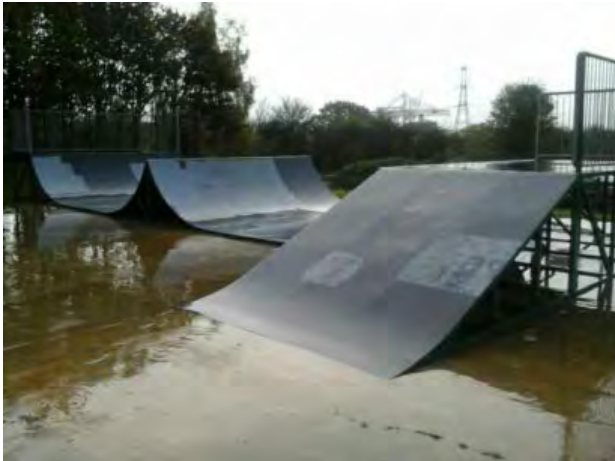
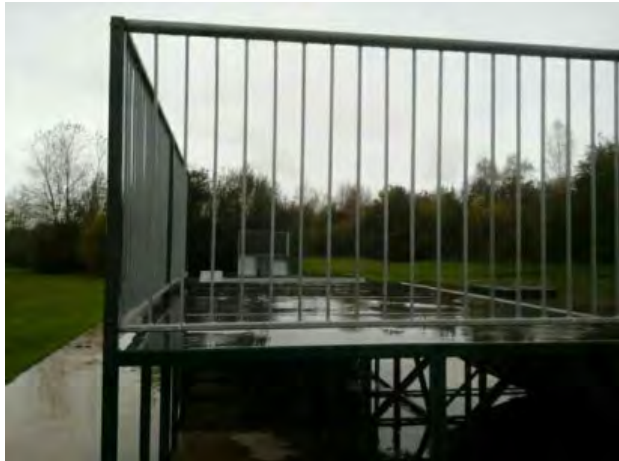
Item: Wheeled Sports - Half Pipe
Manufacturer: Not Identified

Risk Level: L - Low Risk
Surface: Concrete

Finding: The height of the barrier is less than 1200mm and fails the requirements of BS EN 14974

Action: Monitor use

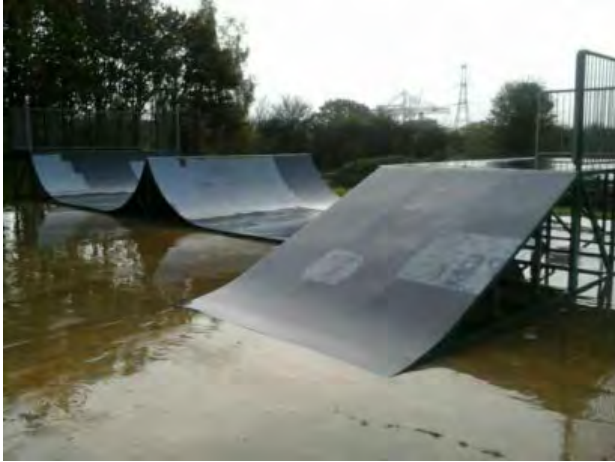
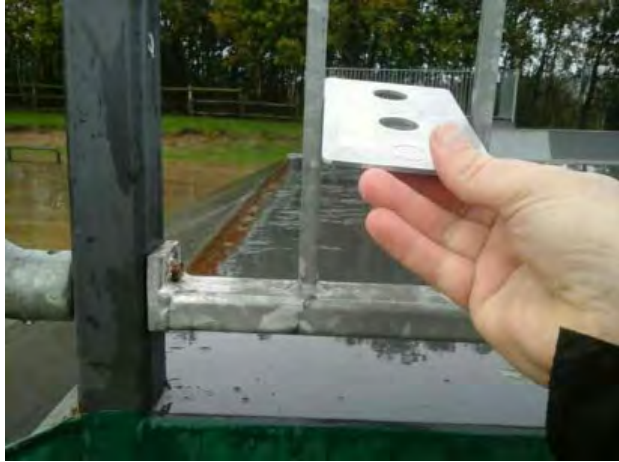
Item: Wheeled Sports - Half Pipe
Manufacturer: Not Identified

Risk Level: V - Very Low Risk
Surface: Concrete

Finding: The horizontal opening in the barrier is in excess of 89mm and fails the requirements of BS EN 14974

Action: Monitor use

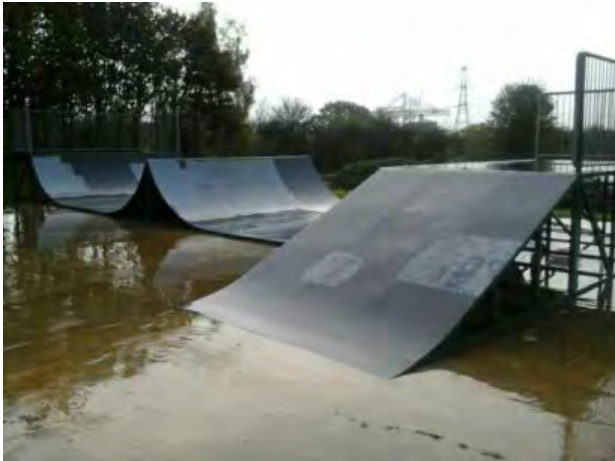
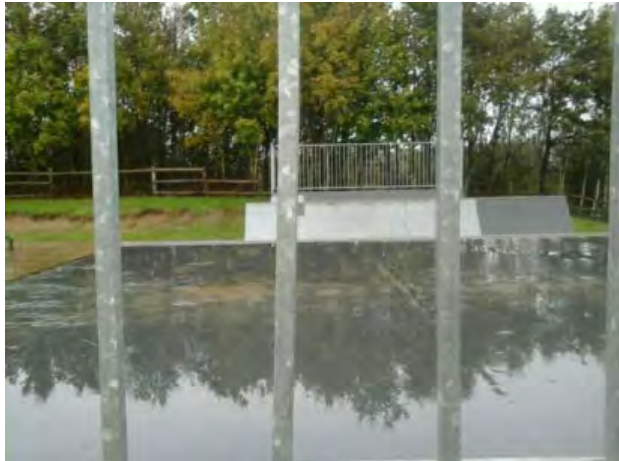
Item: Wheeled Sports - Half Pipe
Manufacturer: Not Identified

Risk Level: L - Low Risk
Surface: Concrete

Finding: The barrier has some minor damage

Action: Monitor for any further deterioration and repair as required
