Annual Inspection Came & Company @ Cork Field Skate Park

Inspection Ref: 79847

Inspected: 14 October 2013 at 1346 Inspector: Didrik Wold RPII Annual Inspector

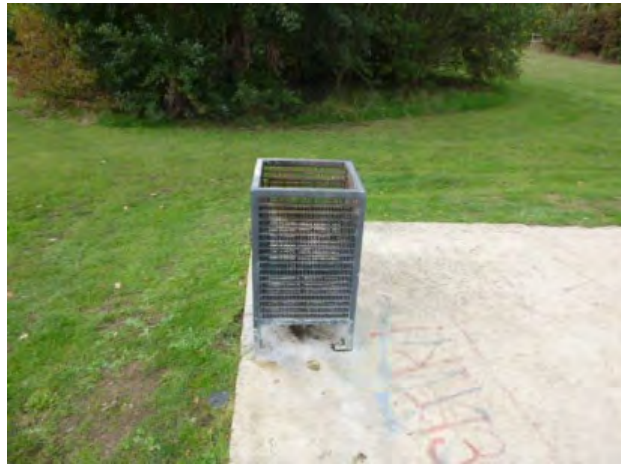
Item: Ancillary Items - Bin - Ground Based
Manufacturer: Owner/Operator
Surface Type: N/A
Equipment Compliance: N/A
Surface Area Compliance: N/A
Ref/Part Number:
Total Findings: 1

This item is satisfactory - no work required

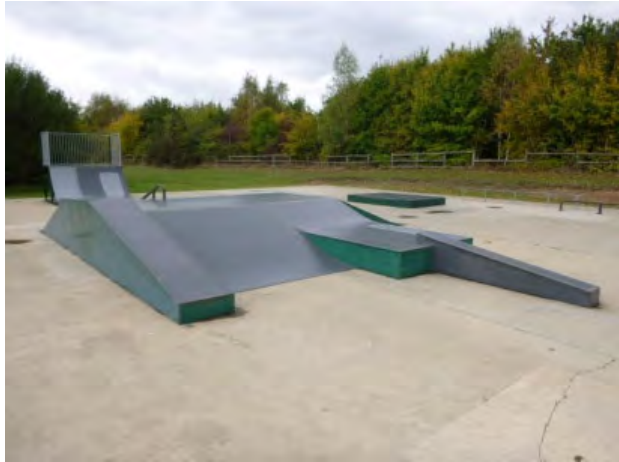
Item: Skateboard Equipment - Fun Box
Manufacturer: Not Identified
Surface Type: Concrete
Equipment Compliance: Yes
Surface Area Compliance: Yes
Ref/Part Number:
Total Findings: 1
Life Expectancy: 5 -10 Years

This item is satisfactory - no work required

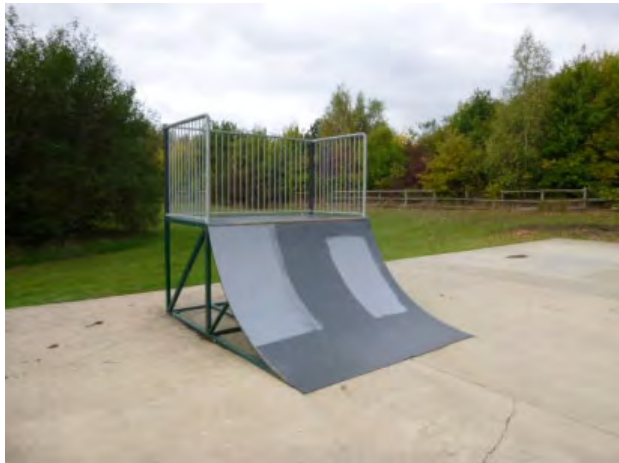
Item: Skateboard Equipment - Platform Transition
Manufacturer: Not Identified
Surface Type: Concrete
Equipment Compliance: No
Surface Area Compliance: Yes
Ref/Part Number:
Total Findings: 1
Life Expectancy: 5 -10 Years

The height of the barrier is less than 1200mm and fails the requirements of BS EN 14974 - Monitor use

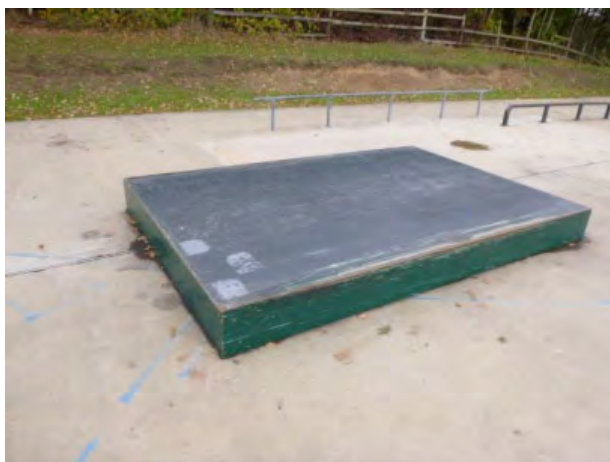
Item: Skateboard Equipment - Ledge
Manufacturer: Not Identified
Surface Type: Concrete
Equipment Compliance: Yes
Surface Area Compliance: Yes
Ref/Part Number:
Total Findings: 1
Life Expectancy: 5 -10 Years

This item is satisfactory - no work required

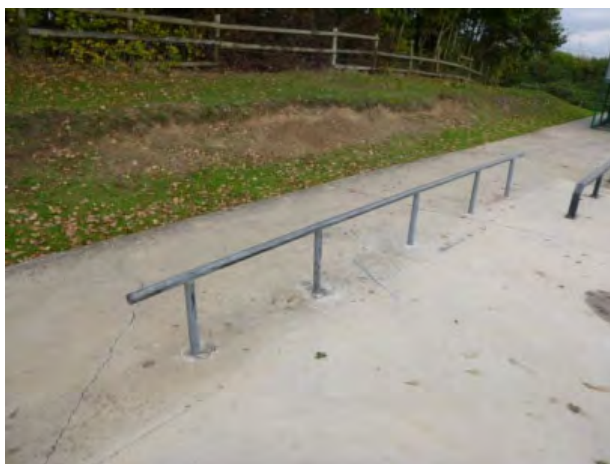
Item: Skateboard Equipment - Grind Rail
Manufacturer: Not Identified
Surface Type: Concrete
Equipment Compliance: No
Surface Area Compliance: No
Ref/Part Number:
Total Findings: 3
Life Expectancy: 5 -10 Years

The end of the grind rail should reach the ground - Monitor use

End caps are missing - Replace missing end caps

The item has insufficient safety zone allowed as required by BS EN 14974 due to the other grind rail and users may fall from one onto the other - Relocate this rail as it fails the requirements

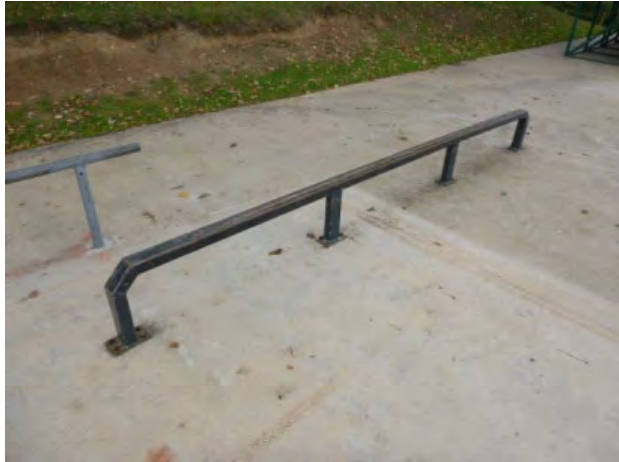
Item: Skateboard Equipment - Grind Rail
Manufacturer: Not Identified
Surface Type: Concrete
Equipment Compliance: Yes
Surface Area Compliance: No
Ref/Part Number:
Total Findings: 1
Life Expectancy: 5 -10 Years

See comments on the other rail

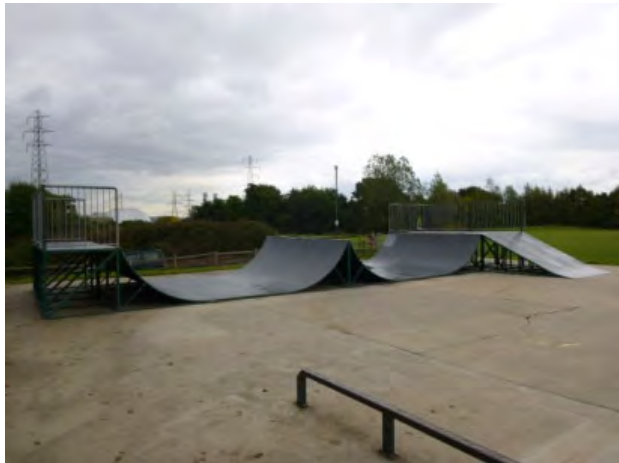
Item: Skateboard Equipment - Double Half Pipe
Manufacturer: Not Identified
Surface Type: Concrete
Equipment Compliance: No
Surface Area Compliance: Yes
Ref/Part Number:
Total Findings: 1
Life Expectancy: 5 -10 Years

The height of the barrier is less than 1200mm and fails the requirements of BS EN 14974 - Monitor use

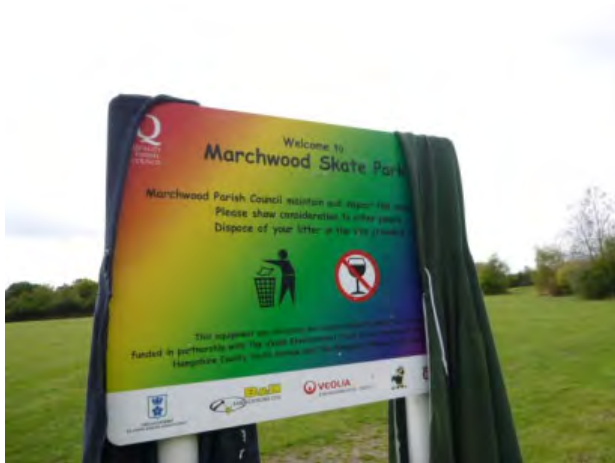
Item: Ancillary Items - Sign
Manufacturer: Owner/Operator

Finding: It is recommended that information signs with emergency contact details are installed at each entrance/exit point to the playground
Action: Provide signage

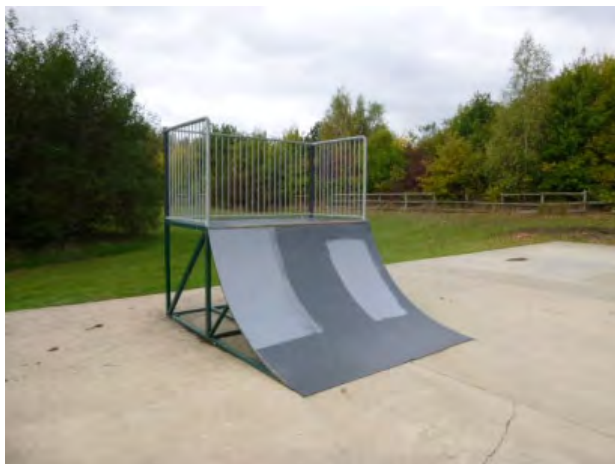
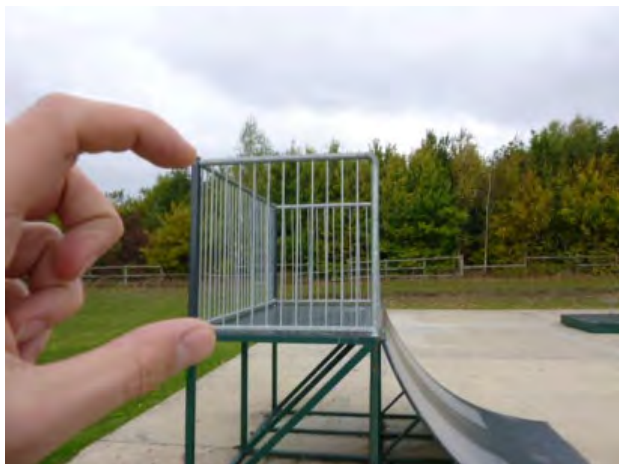
Item: Skateboard Equipment - Platform Transition
Manufacturer: Not Identified

Finding: The height of the barrier is less than 1200mm and fails the requirements of BS EN 14974
Action: Monitor use

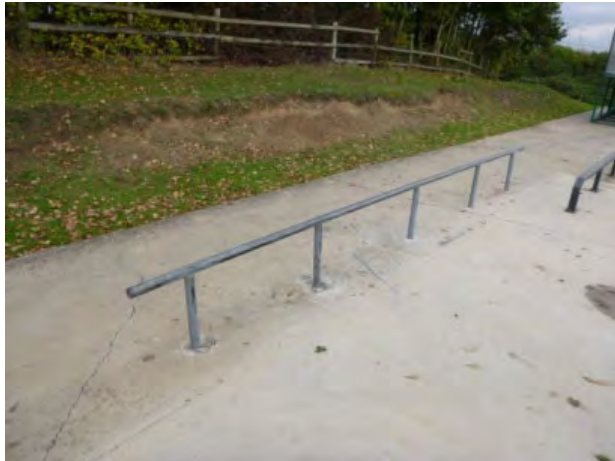
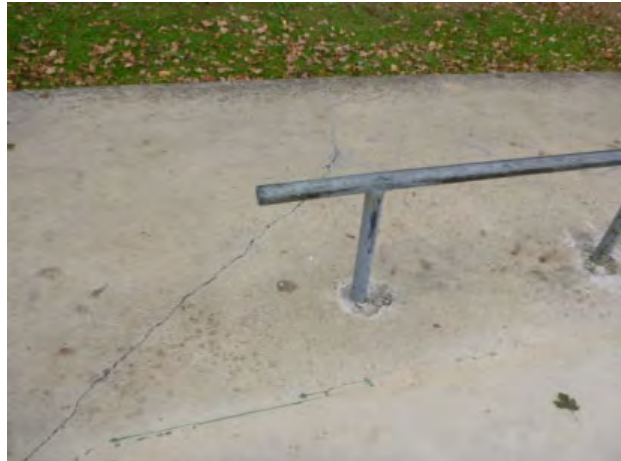
Item: Skateboard Equipment - Grind Rail
Manufacturer: Not Identified

Finding: The end of the grind rail should reach the ground

Action: Monitor use

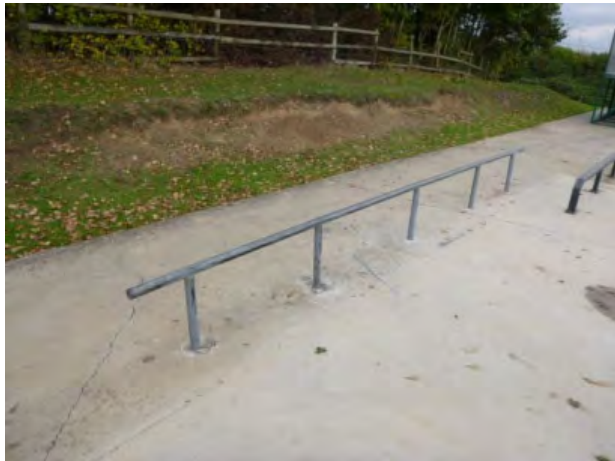
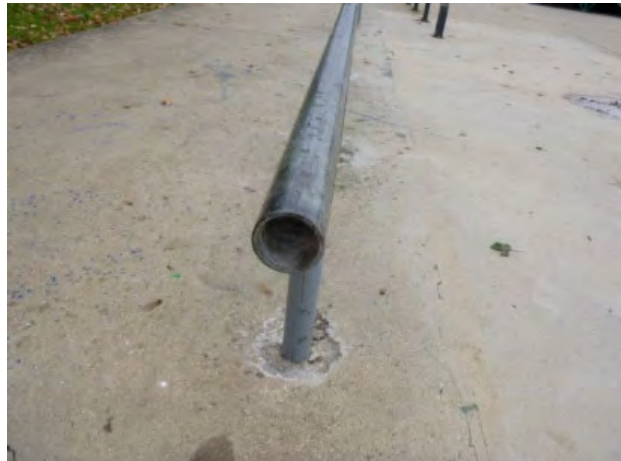
Item: Skateboard Equipment - Grind Rail
Manufacturer: Not Identified

Finding: End caps are missing

Action: Replace missing end caps

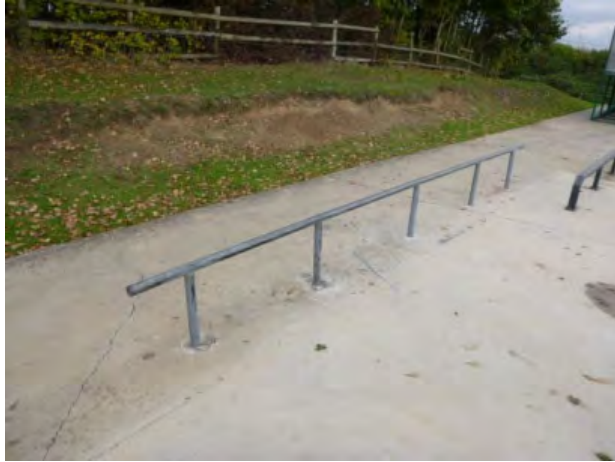
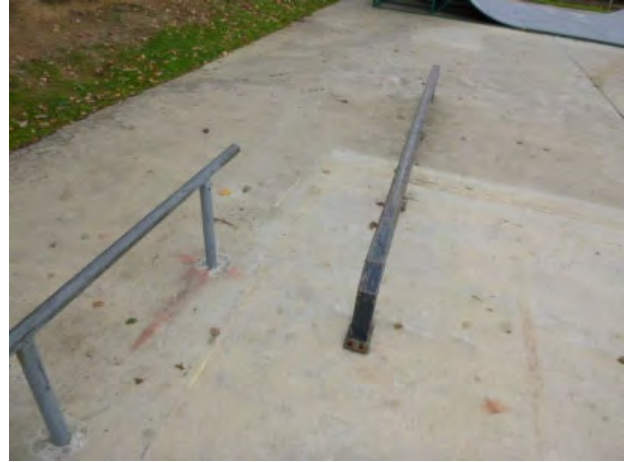
Item: Skateboard Equipment - Grind Rail
Manufacturer: Not Identified

Finding: The item has insufficient safety zone allowed as required by BS EN 14974 due to the other grind rail and users may fall from one onto the other

Action: Relocate this rail as it fails the requirements

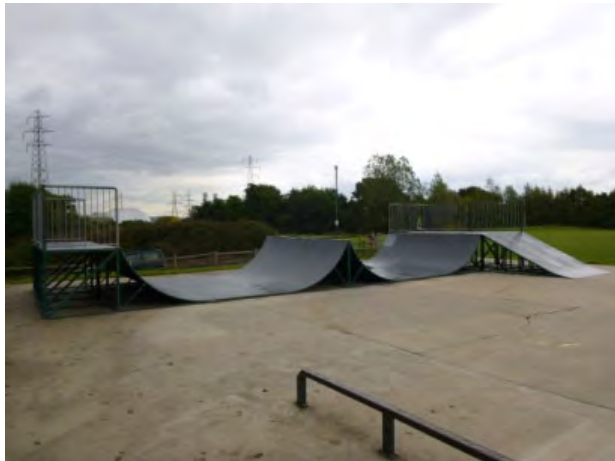
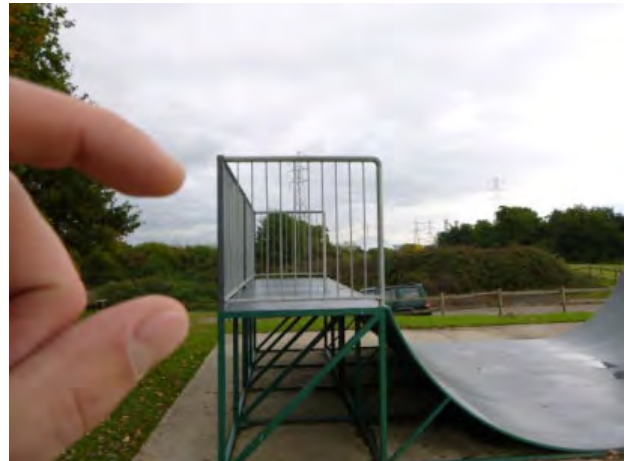
Item: Skateboard Equipment - Double Half Pipe
Manufacturer: Not Identified

Finding: The height of the barrier is less than 1200mm and fails the requirements of BS EN 14974

Action: Monitor use
