## Annual Inspection

Came & Company

Marchwood over 12's Play Area

Annual Inspection - 03 November 2014 at 10:09 Inspector: Leon Pope RPII Annual Inspector

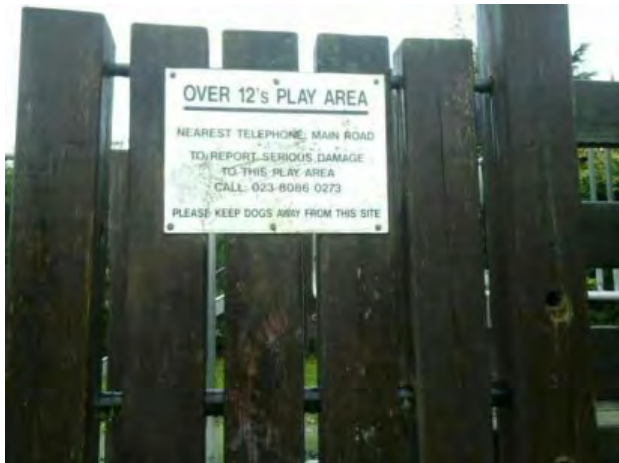
**Item:** Ancillary Items - Sign  
**Manufacturer:** Owner/Operator  
**Surface Type:** N/A  
**Equipment Compliance:** N/A  
**Surface Area Compliance:** N/A  
**Ref/Part Number:**  
**Total Findings:** 1

It is recommended that information signs with emergency contact details are installed at each entrance/exit point to the playground - Provide in accordance with the recommendations set out in BS EN 1176

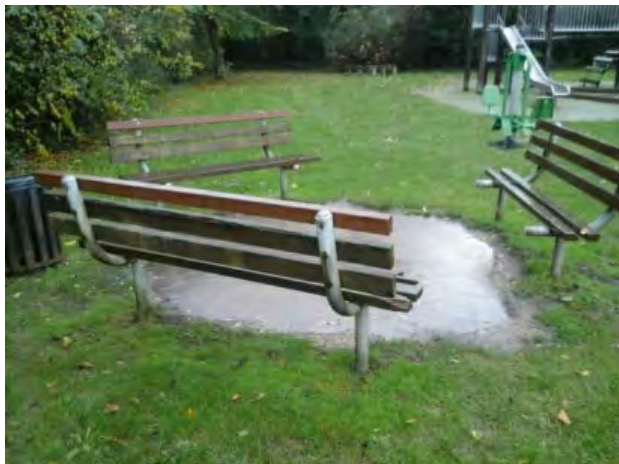
There are areas or parts of the timber on the structure that have rotted - Replace all affected timbers

There are missing slats - Replace slats

The slats are damaged in places - Repair affected areas

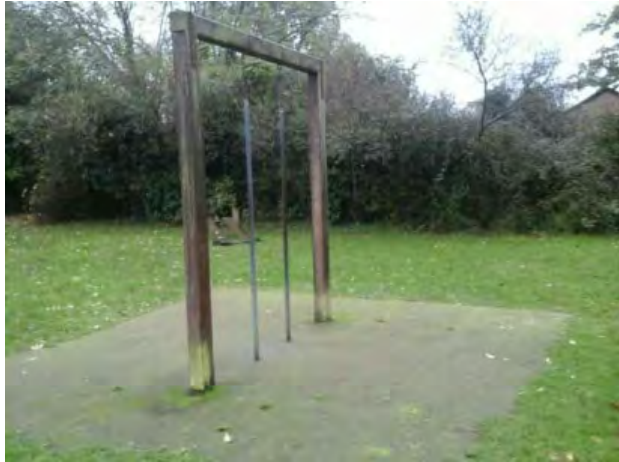
There is algae or moss growth on the surface resulting in slippery conditions - Clean and treat with weed killer

The chain openings are in excess of the 8.6mm as recommended by BS EN 1176 - Monitor use and replace with compliant chains during next maintenance cycle.

There is some chain wear - Monitor for any further deterioration and replace when 40% worn

The item is slightly loose in the ground - Monitor for any further deterioration and reset as required

The paintwork on this item has been damaged or worn exposing the metal underneath which is rusting - Treat any rusting components and repaint

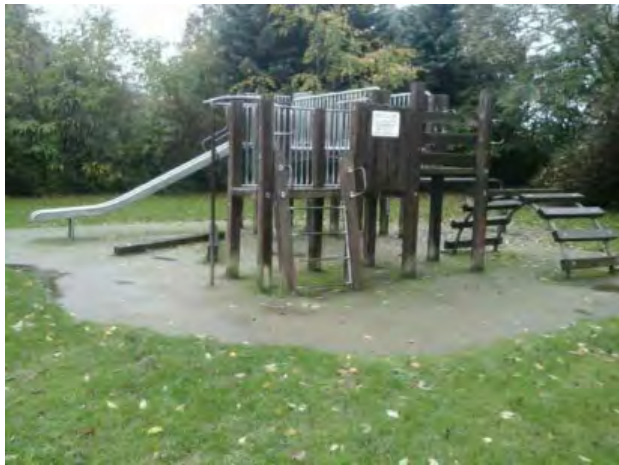
There is algae or moss growth on the surface resulting in slippery conditions - Clean and treat with weed killer

The item fails to meet the requirements of BS EN 1176:2008 for head and neck entrapment in the barriers - Monitor use

The balance beams form a hard object within the falling space of the equipment in contravention of the requirements of BS EN 1176 Part 1 - Monitor use

There is/are finger entrapment/s at the top of the slide - Monitor use

There are a number of dents in the slide surface - Monitor for any further deterioration and repair as required

The paintwork on this item has been damaged or worn exposing the metal underneath which is rusting - Treat any rusting components and repaint

There is algae or moss growth on the item resulting in slippery conditions - Clean and maintain

The plywood has delaminated in some places - Remove all rough or splintered edges.

There is some evidence of rot in the timber - Monitor for any further deterioration and replace as required

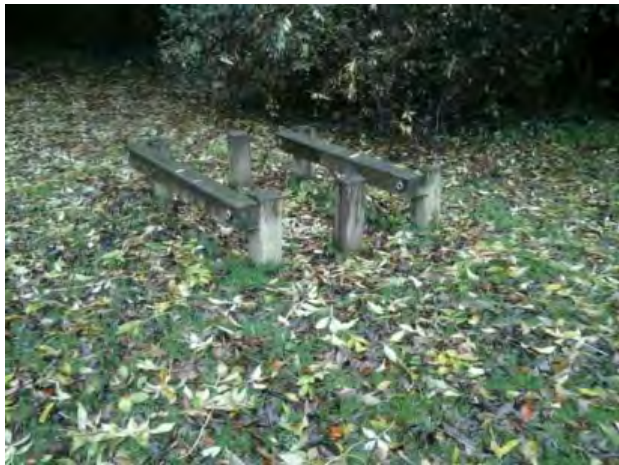
There is algae or moss growth on the item resulting in slippery conditions - Clean and maintain

There are areas or parts of the timber on the structure that have rotted - Replace all affected timbers

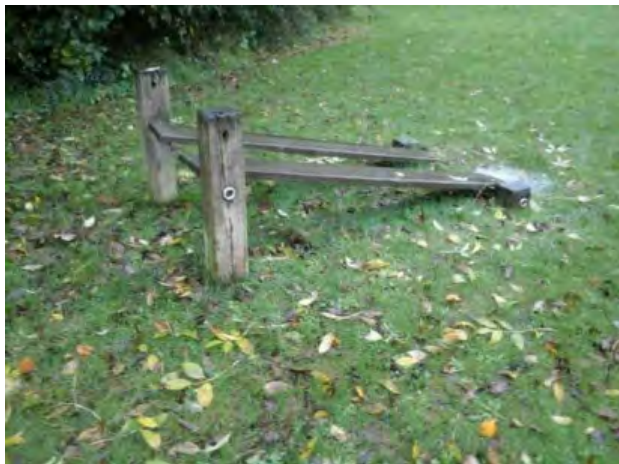
There is algae or moss growth on the item resulting in slippery conditions - Clean and maintain

A number of fixing(s) have worked loose - Secure all loose fixings

There is some evidence of rot in the timber - Monitor for any further deterioration and replace as required

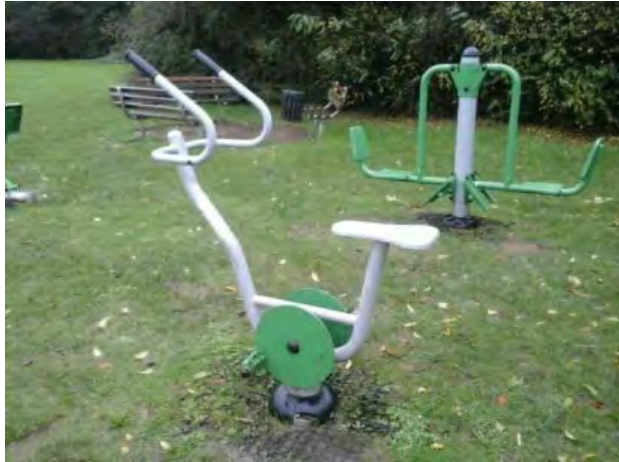
The paintwork on this item has been damaged or worn exposing the metal underneath which is rusting - Treat any rusting components and repaint

There is some graffiti present on site - Remove the graffiti

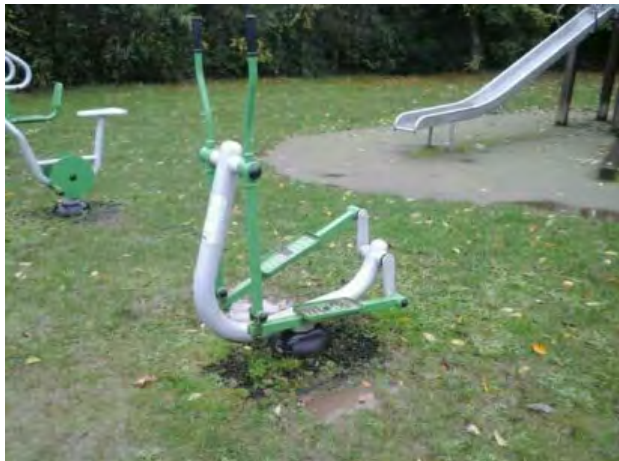
The paintwork on this item has been damaged or worn exposing the metal underneath which is rusting - Treat any rusting components and repaint

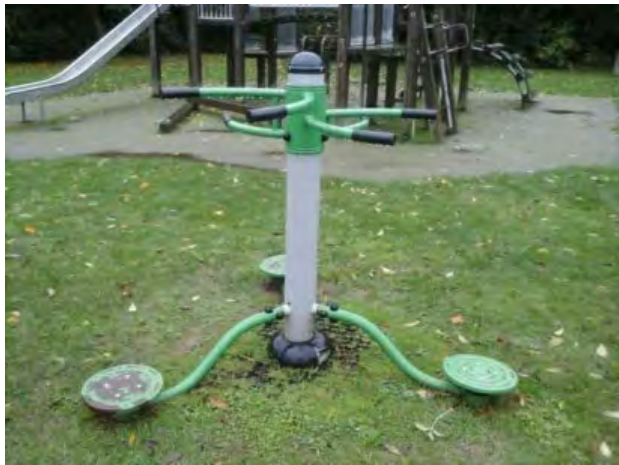
The paintwork on this item has been damaged or worn exposing the metal underneath which is rusting - Treat any rusting components and repaint

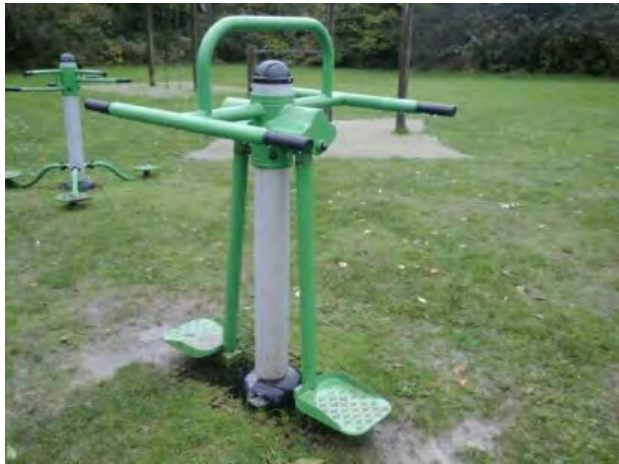
The paintwork on this item has been damaged or worn exposing the metal underneath which is rusting - Treat any rusting components and repaint

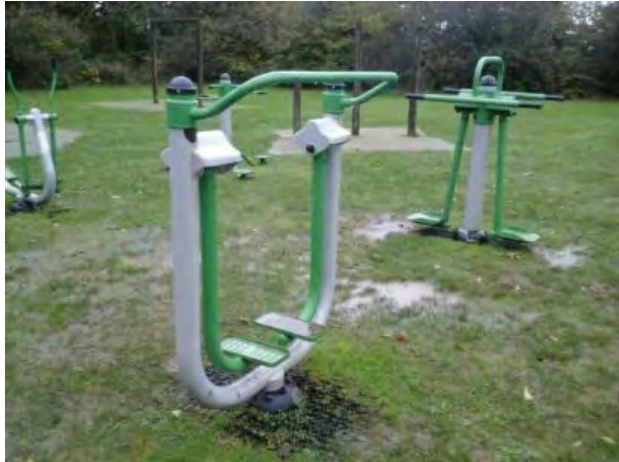
The paintwork on this item has been damaged or worn exposing the metal underneath which is rusting - Treat any rusting components and repaint

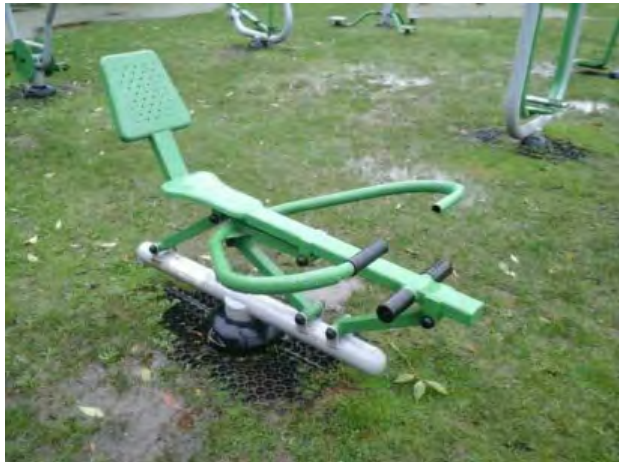
A handgrip(s) is/are missing - Replace missing hand grips

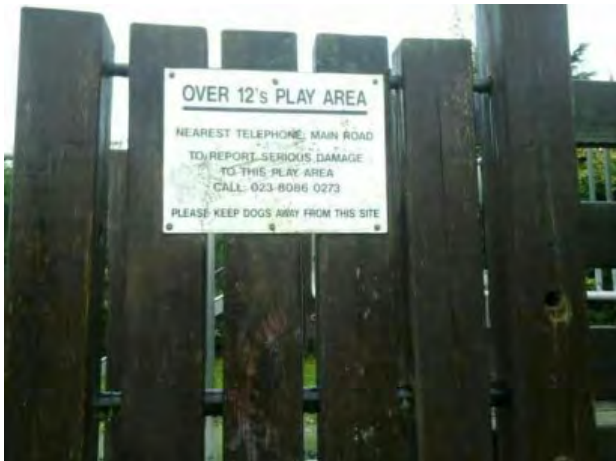
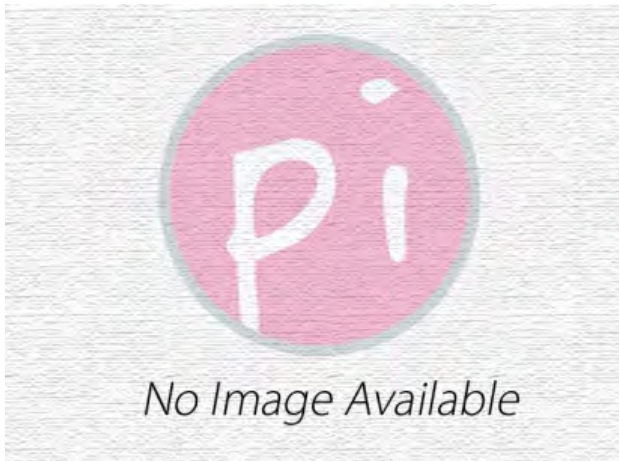
<b>Finding:</b>	It is recommended that information signs with emergency contact details are installed at each entrance/exit point to the playground	<b>Action:</b>	Provide in accordance with the recommendations set out in BS EN 1176

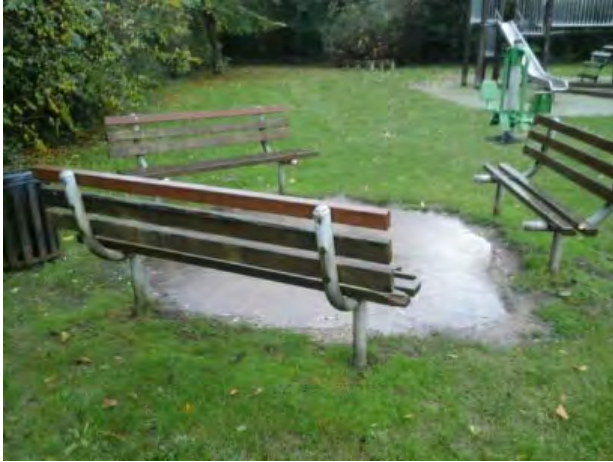
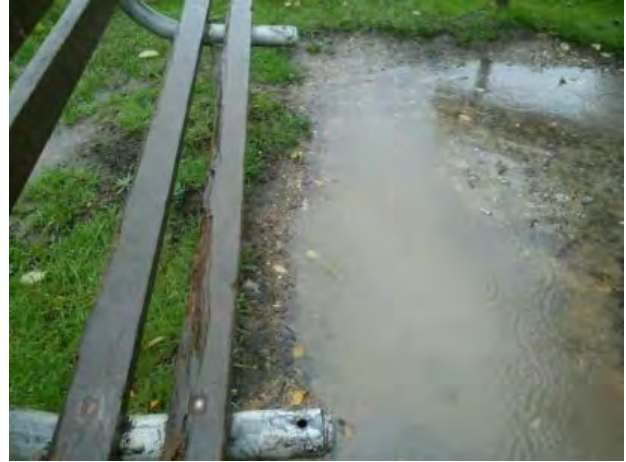
**Finding:** There are missing slats

**Action:** Replace slats

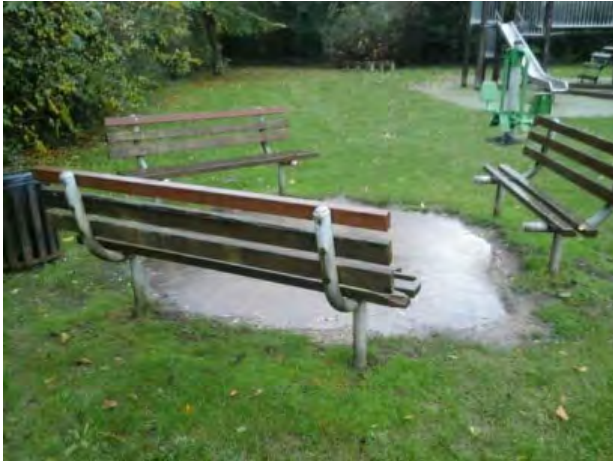
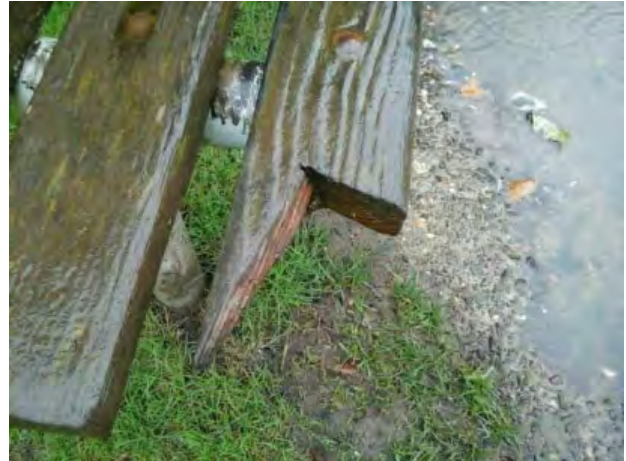
**Finding:** The slats are damaged in places

**Action:** Repair affected areas

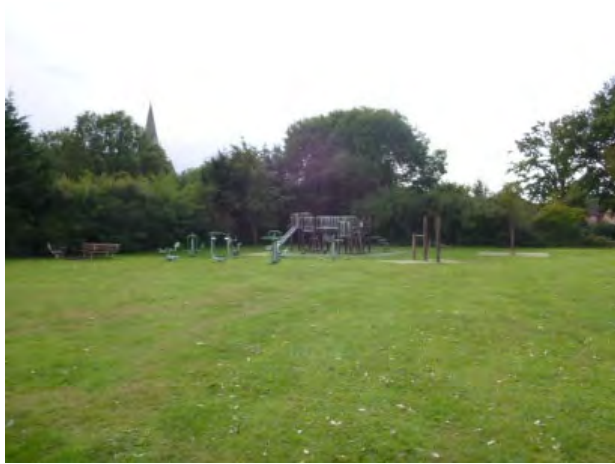
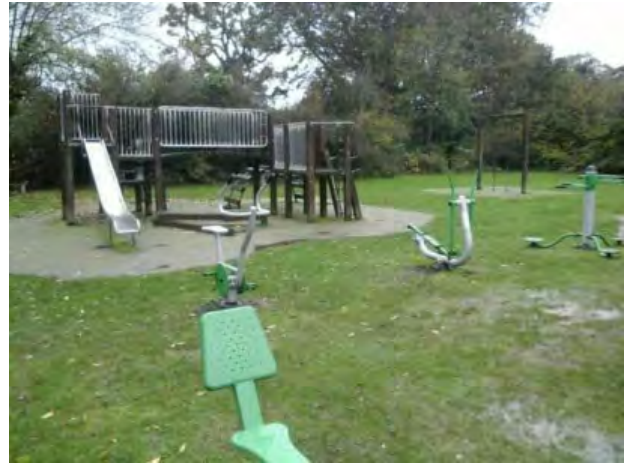
**Finding:** It is recommended that Adult Outdoor Fitness equipment is installed a minimum of 25m away from a children's playground or separated and screened to discourage access by younger children

**Action:** Monitor use and consider relocating the equipment

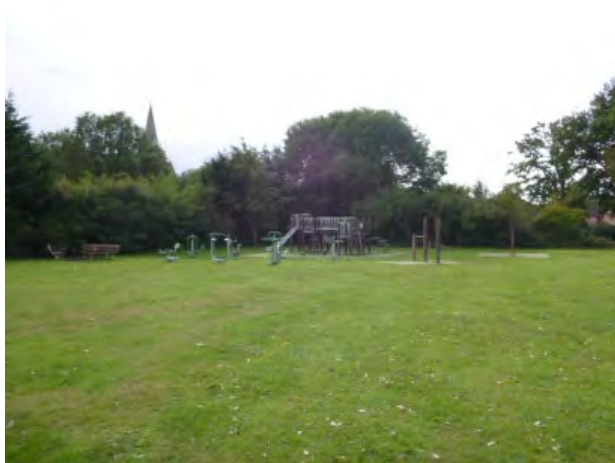
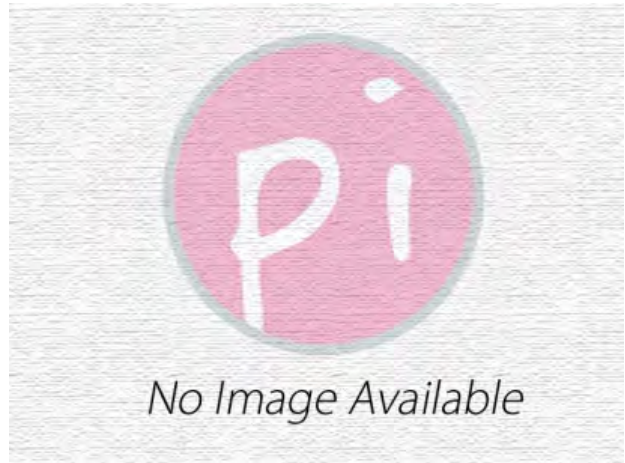
**Finding:** There are currently no European Standards applicable to outdoor adult fitness equipment.

**Action:** We would recommend that the use of this equipment be monitored and adjustments made only if found to be necessary in light of experience

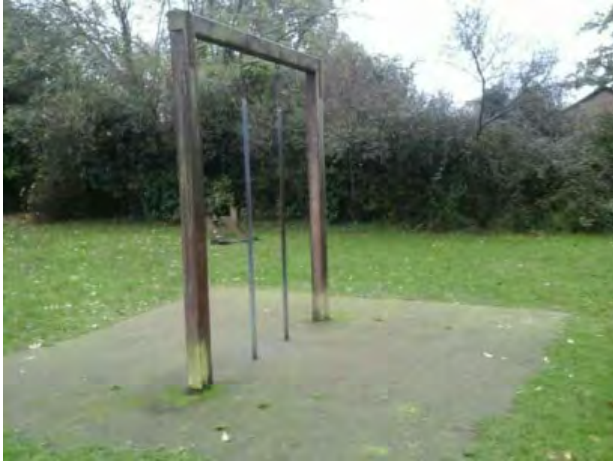
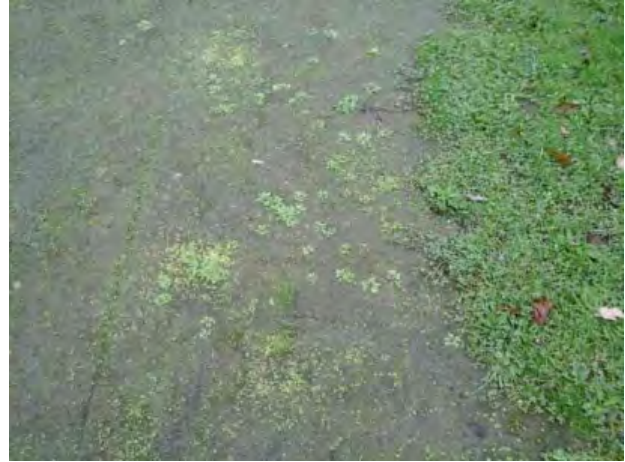
**Finding:** There is algae or moss growth on the surface resulting in slippery conditions

**Action:** Clean and treat with weed killer

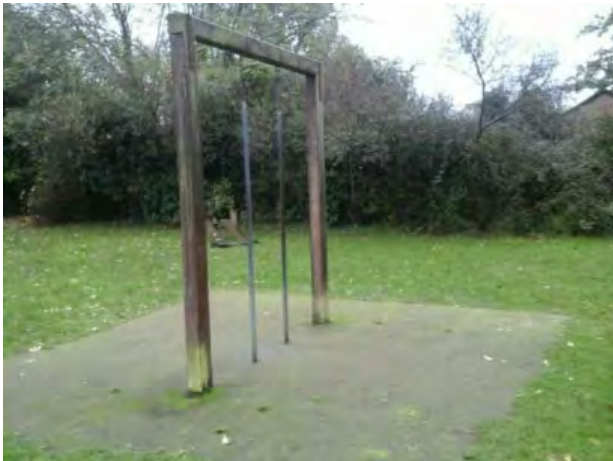
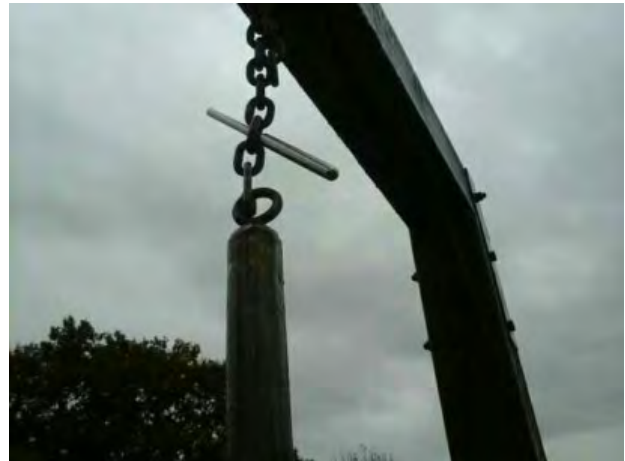
**Finding:** The chain openings are in excess of the 8.6mm as recommended by BS EN 1176

**Action:** Monitor use and replace with compliant chains during next maintenance cycle.

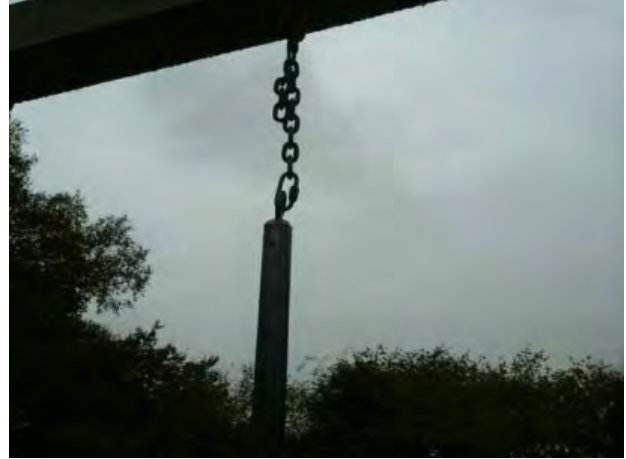
**Finding:** There is some chain wear

**Action:** Monitor for any further deterioration and replace when 40% worn

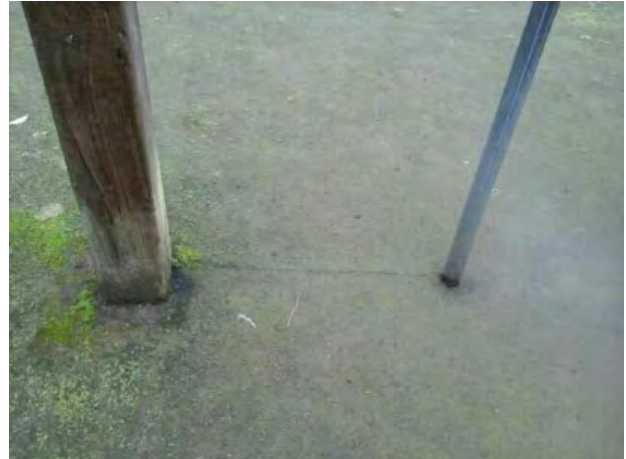
**Finding:** The item is slightly loose in the ground

**Action:** Monitor for any further deterioration and reset as required

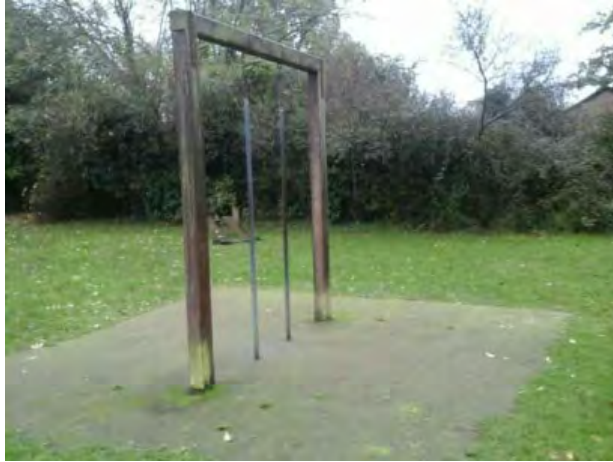
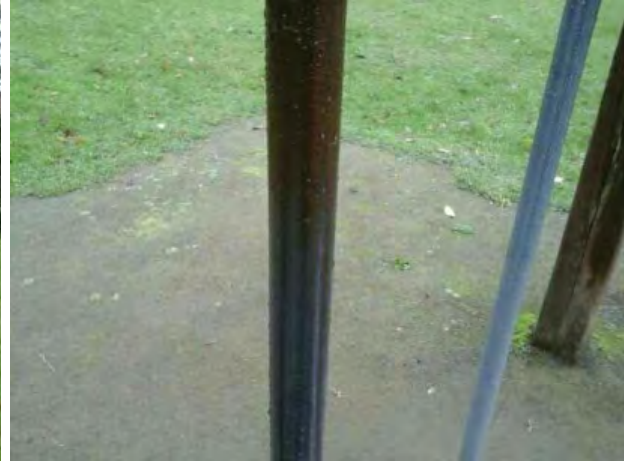
**Finding:** The paintwork on this item has been damaged or worn exposing the metal underneath which is rusting

**Action:** Treat any rusting components and repaint

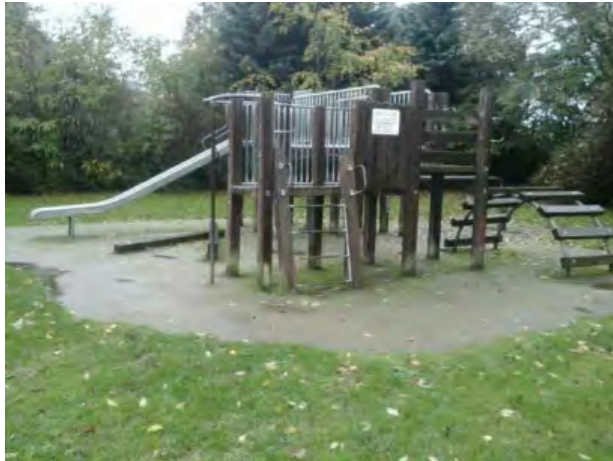
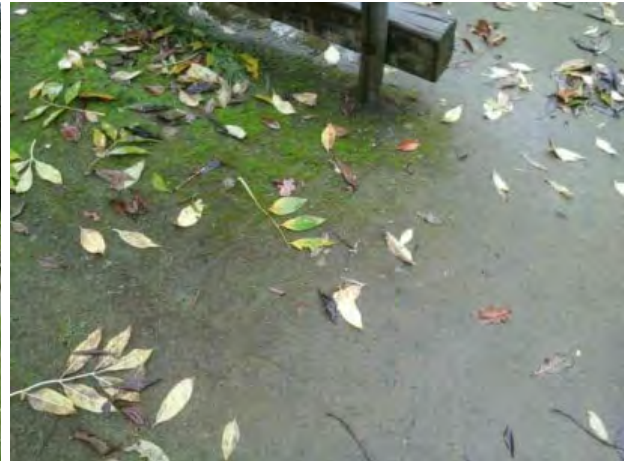
**Finding:** There is algae or moss growth on the surface resulting in slippery conditions

**Action:** Clean and treat with weed killer

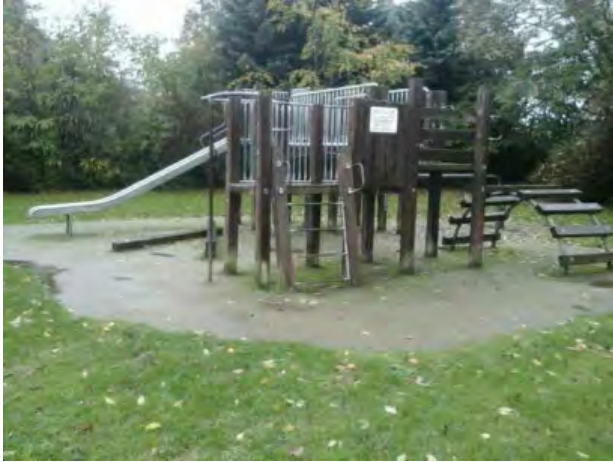
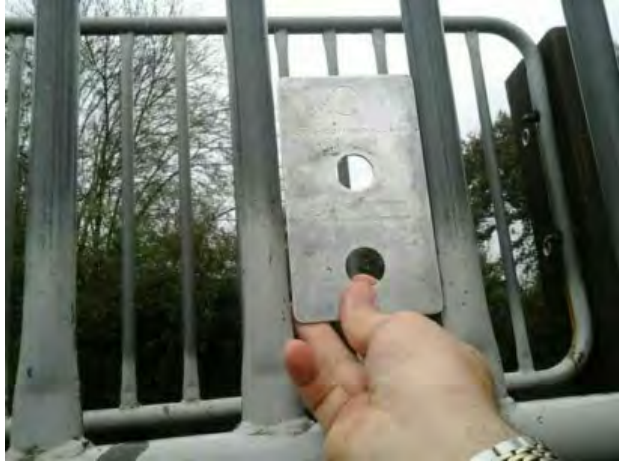
**Finding:** The item fails to meet the requirements of BS EN 1176:2008 for head and neck entrapment in the barriers **Action:** Monitor use

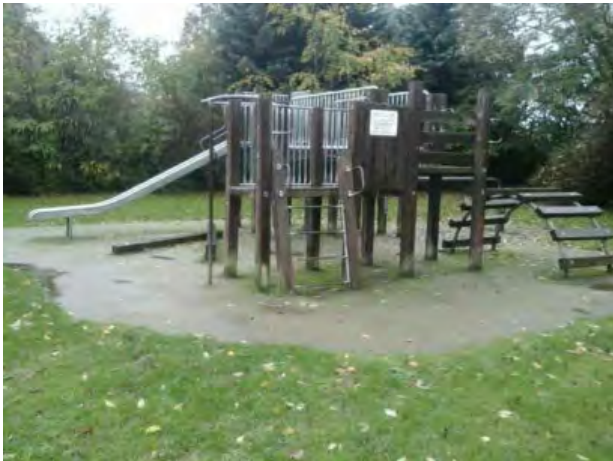
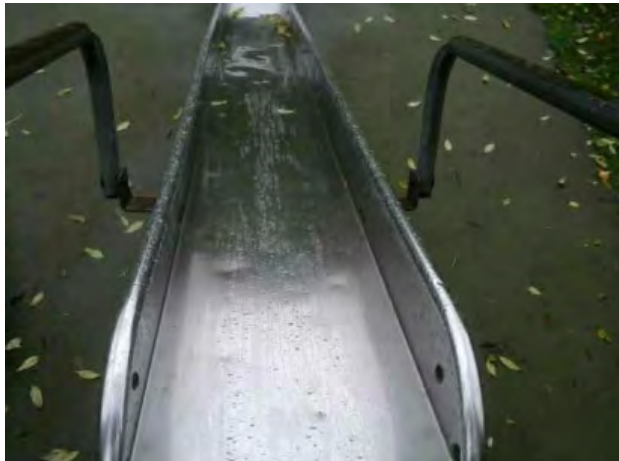
**Finding:** There are a number of dents in the slide surface **Action:** Monitor for any further deterioration and repair as required

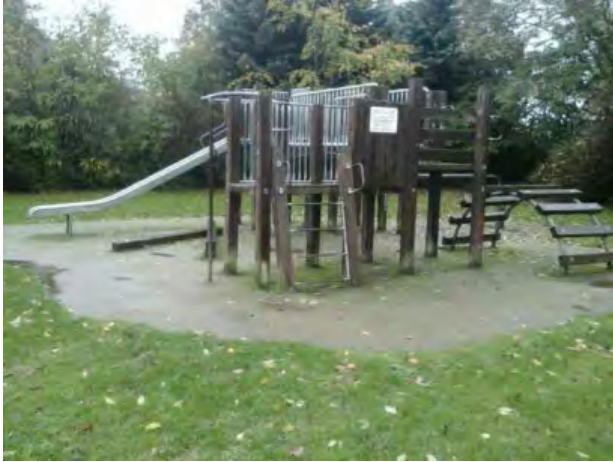
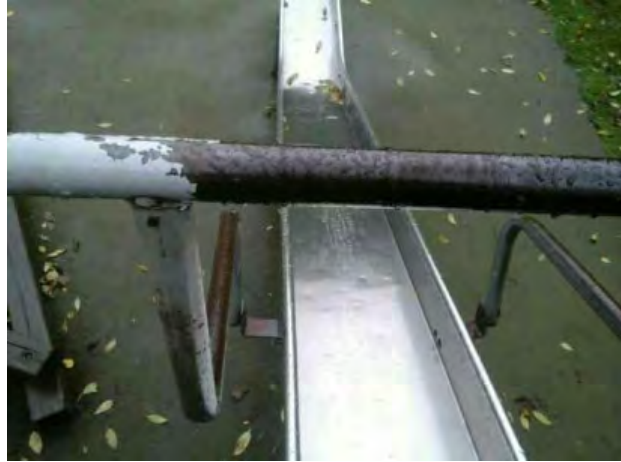
**Finding:** The paintwork on this item has been damaged or worn exposing the metal underneath which is rusting

**Action:** Treat any rusting components and repaint

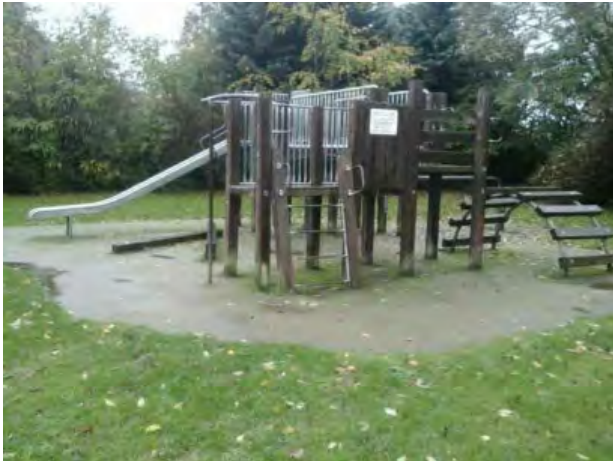
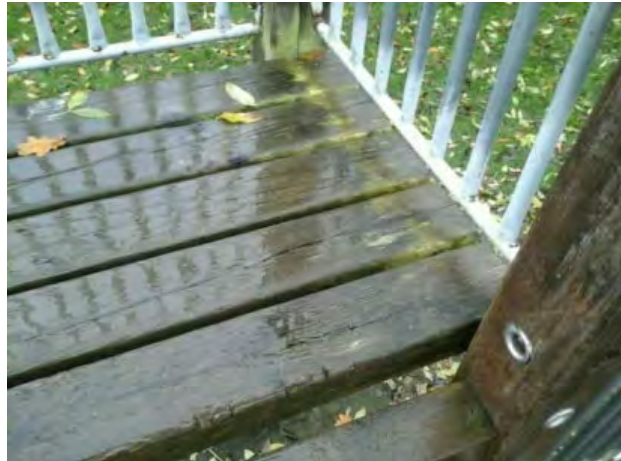
**Finding:** There is algae or moss growth on the item resulting in slippery conditions

**Action:** Clean and maintain

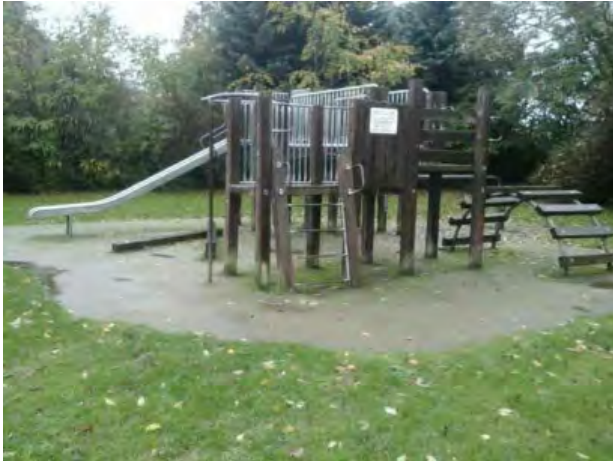
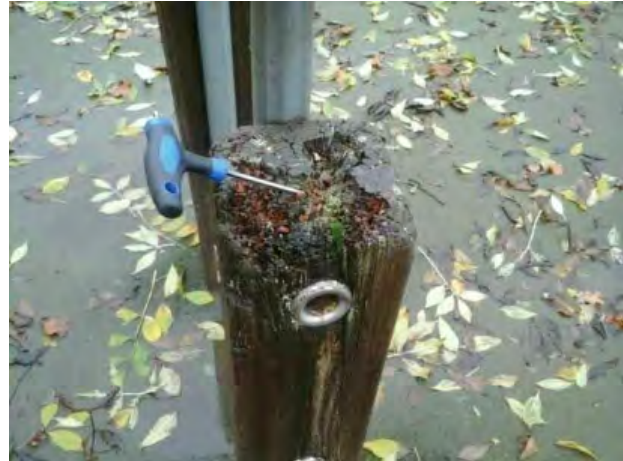
**Finding:** There is some evidence of rot in the timber **Action:** Monitor for any further deterioration and replace as required

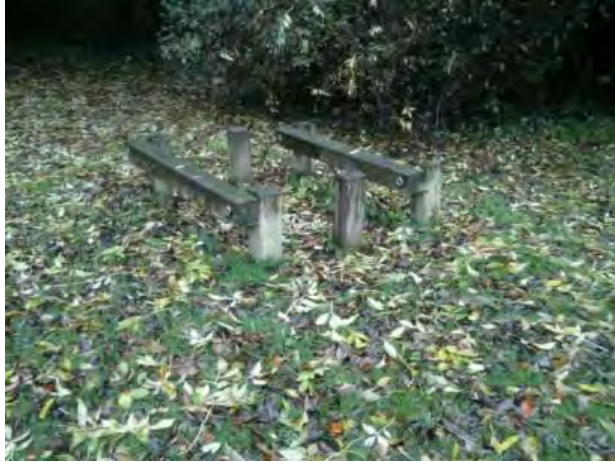
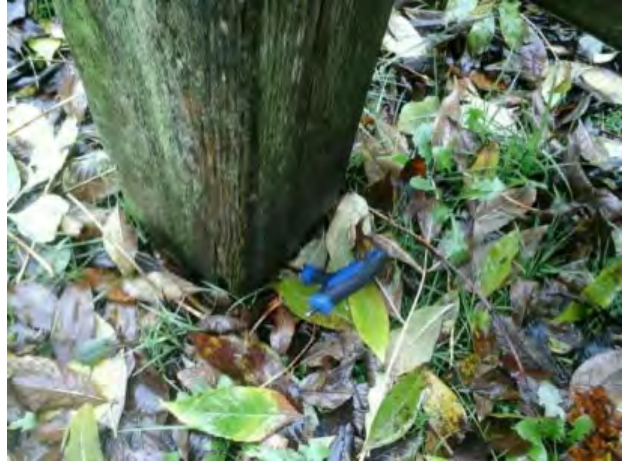
**Finding:** There are areas or parts of the timber on the structure that have rotted

**Action:** Replace all affected timbers

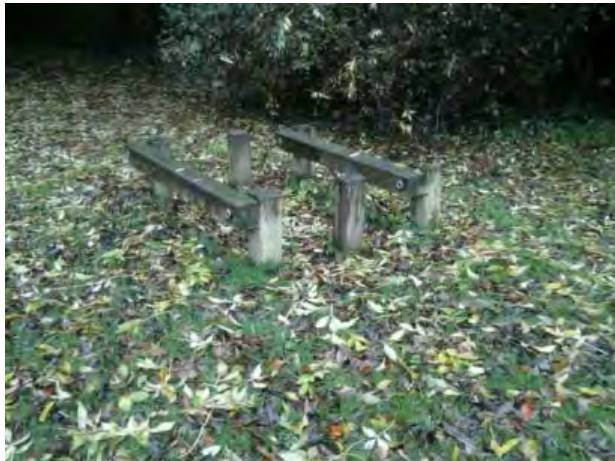
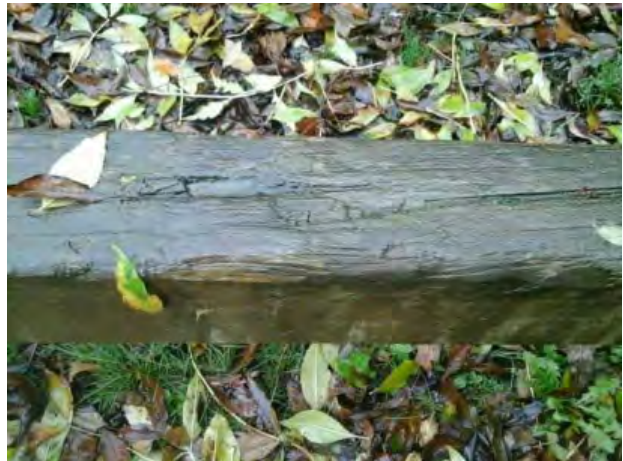
**Finding:** There is algae or moss growth on the item resulting in slippery conditions

**Action:** Clean and maintain

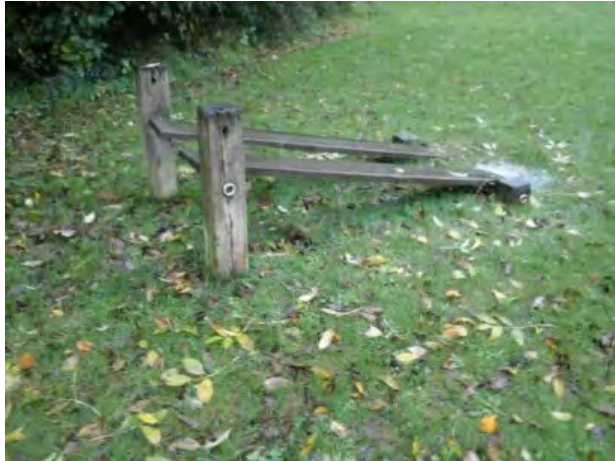
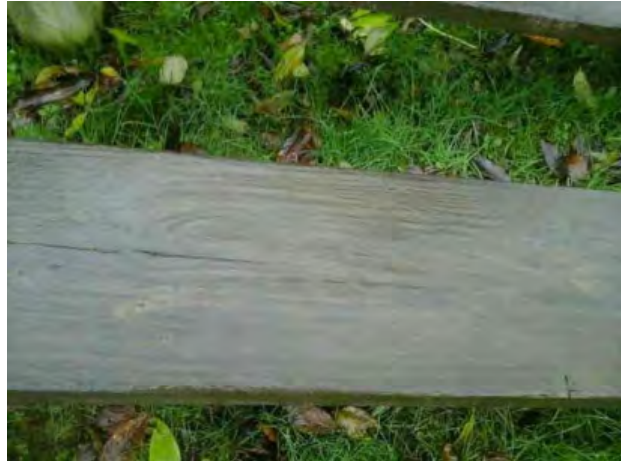
**Finding:** There is algae or moss growth on the item resulting in slippery conditions

**Action:** Clean and maintain

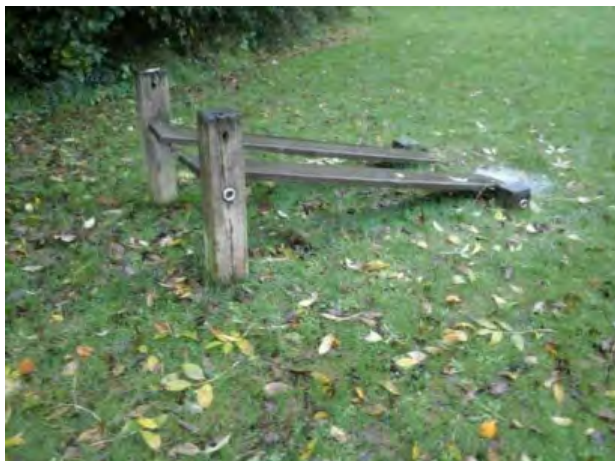
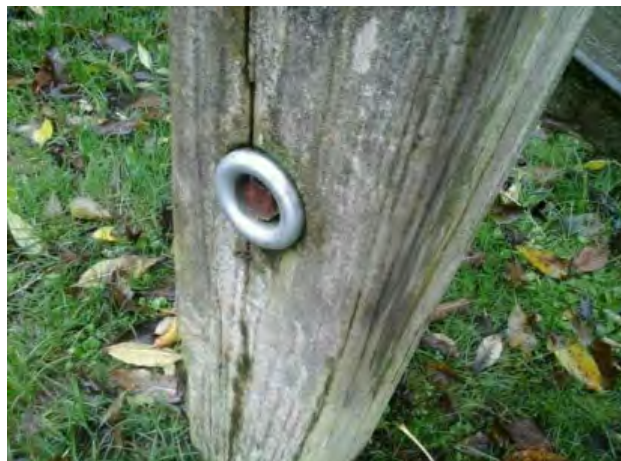
**Finding:** A number of fixing(s) have worked loose

**Action:** Secure all loose fixings

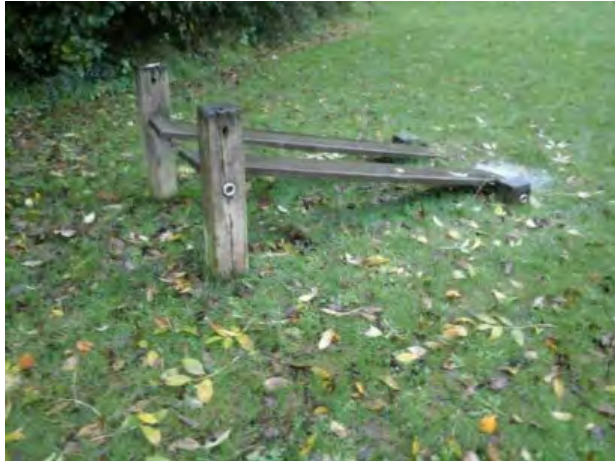
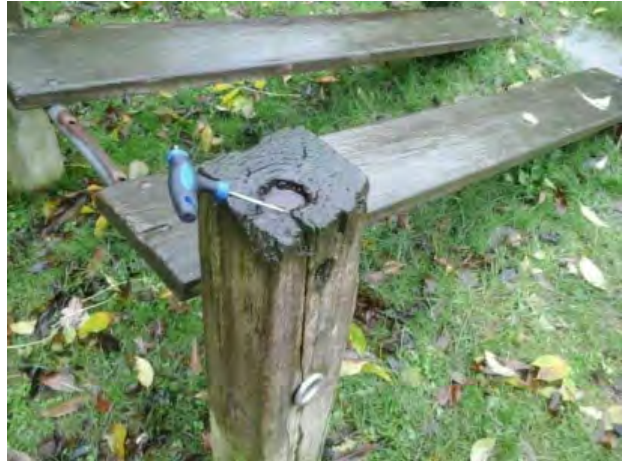
**Finding:** There is some evidence of rot in the timber

**Action:** Monitor for any further deterioration and replace as required

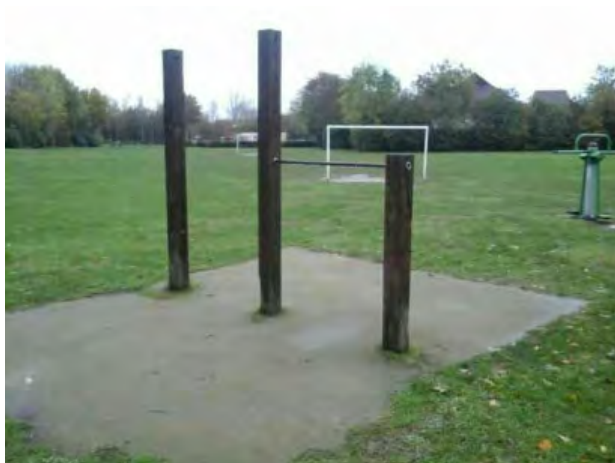
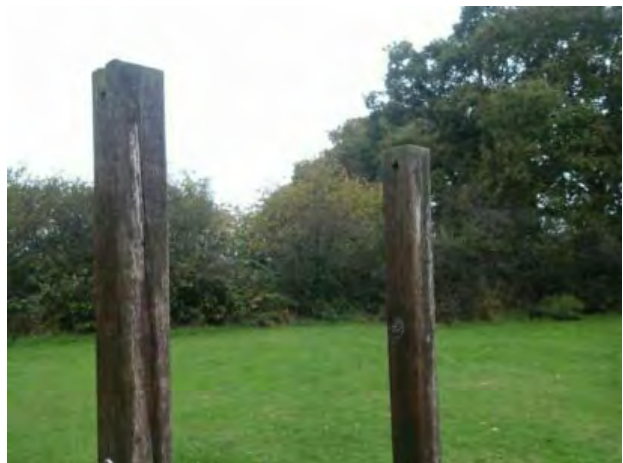
**Finding:** There is a missing pole

**Action:** Consider replacing missing element

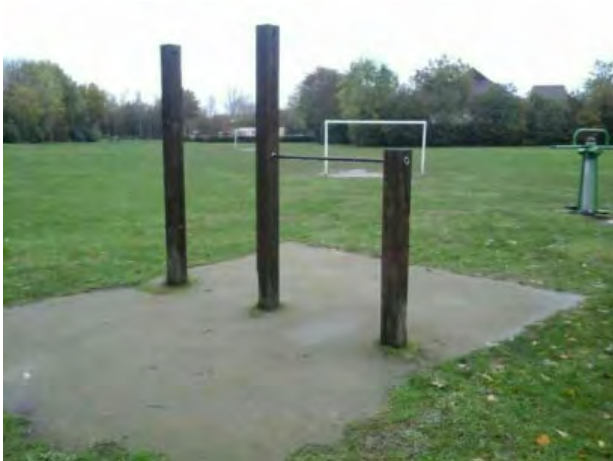
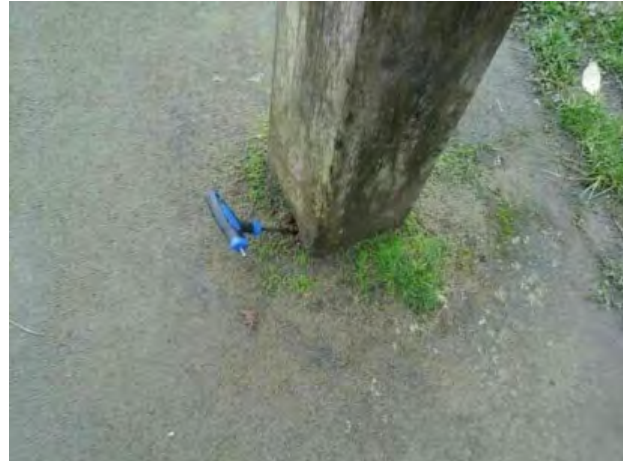
**Finding:** There are areas or parts of the timber on the structure that have rotted

**Action:** Replace all affected timbers

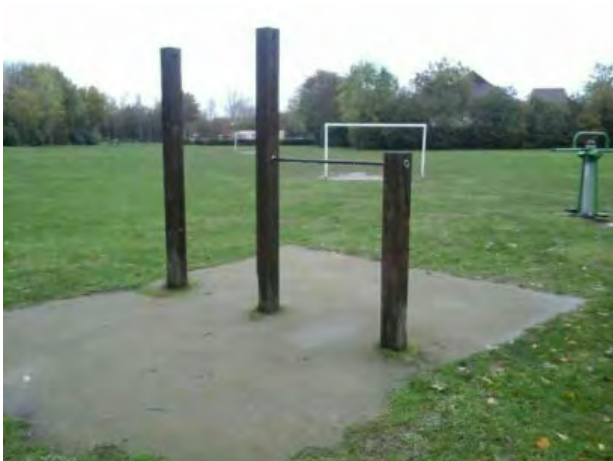
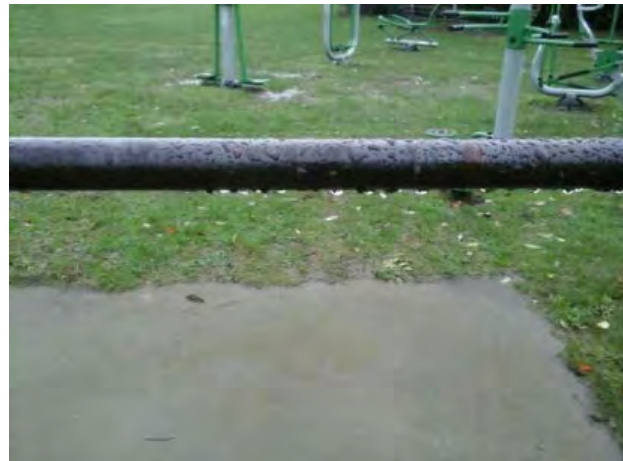
**Finding:** The paintwork on this item has been damaged or worn exposing the metal underneath which is rusting

**Action:** Treat any rusting components and repaint

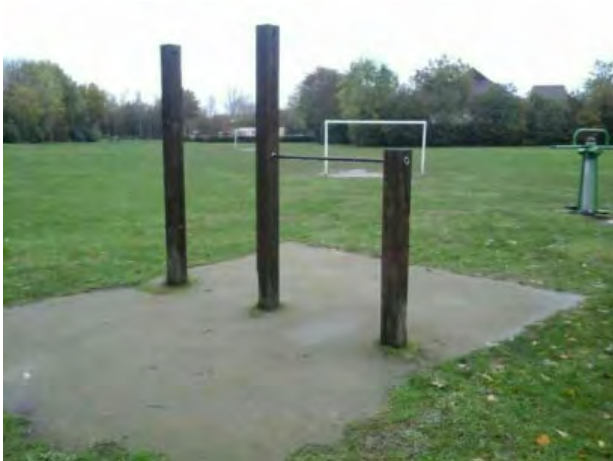
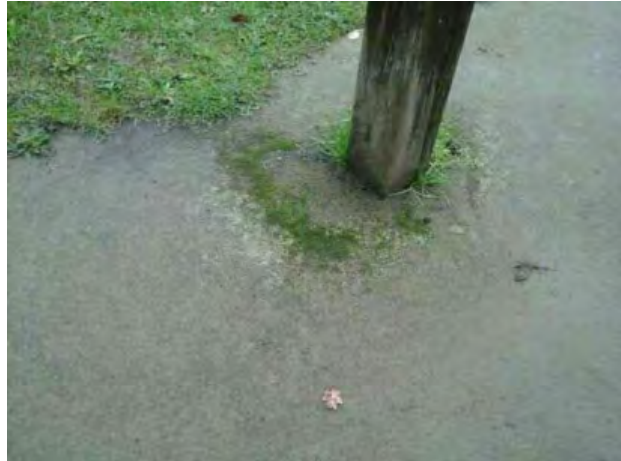
**Finding:** There is algae or moss growth on the surface resulting in slippery conditions

**Action:** Clean and treat with weed killer

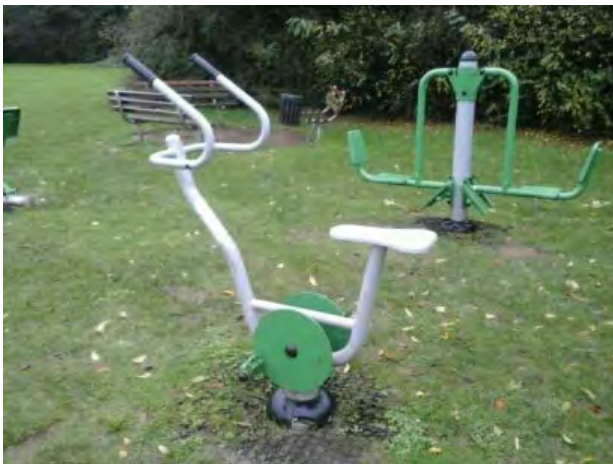
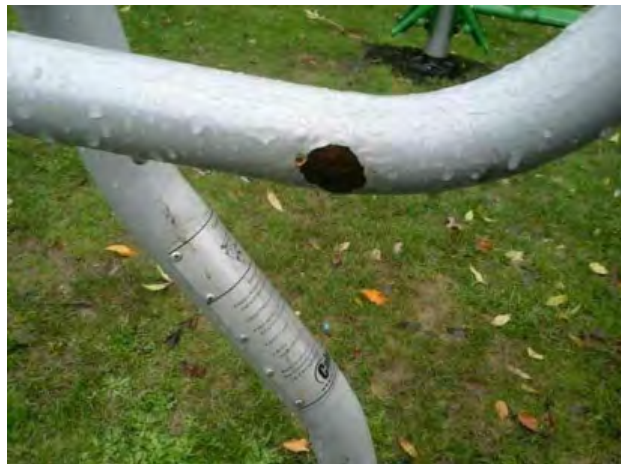
**Finding:** The paintwork on this item has been damaged or worn exposing the metal underneath which is rusting

**Action:** Treat any rusting components and repaint

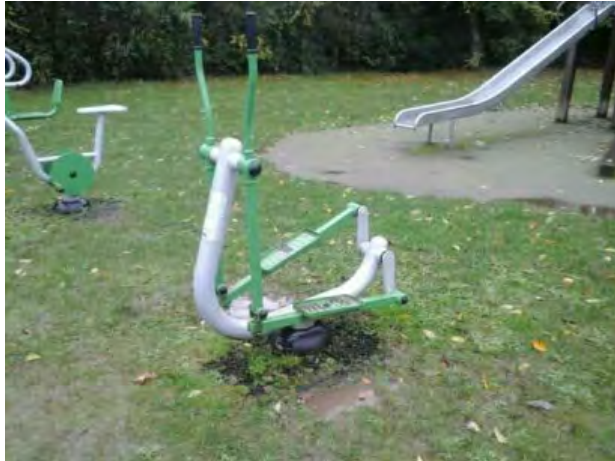
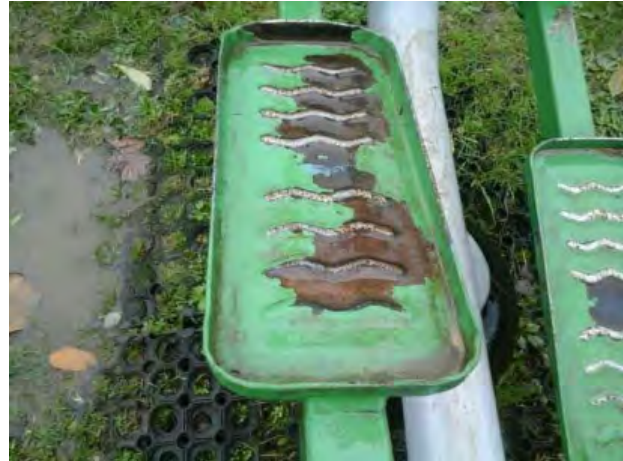
**Finding:** The paintwork on this item has been damaged or worn exposing the metal underneath which is rusting

**Action:** Treat any rusting components and repaint

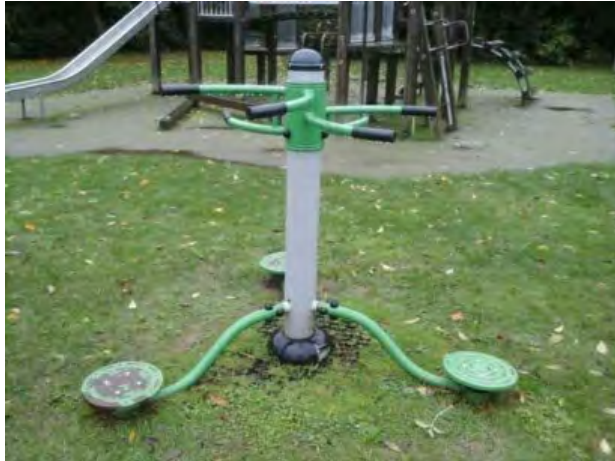
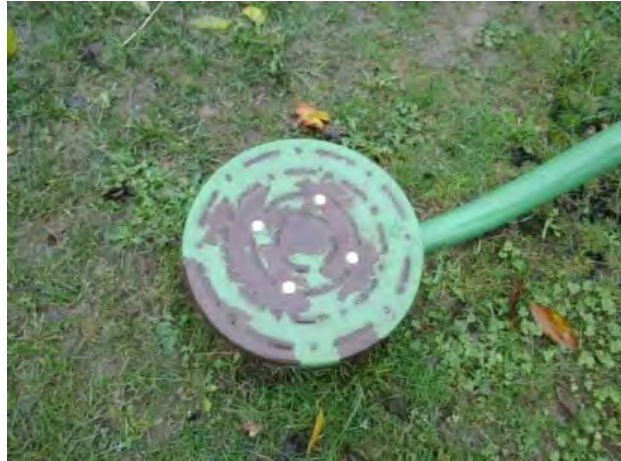
**Finding:** The paintwork on this item has been damaged or worn exposing the metal underneath which is rusting

**Action:** Treat any rusting components and repaint

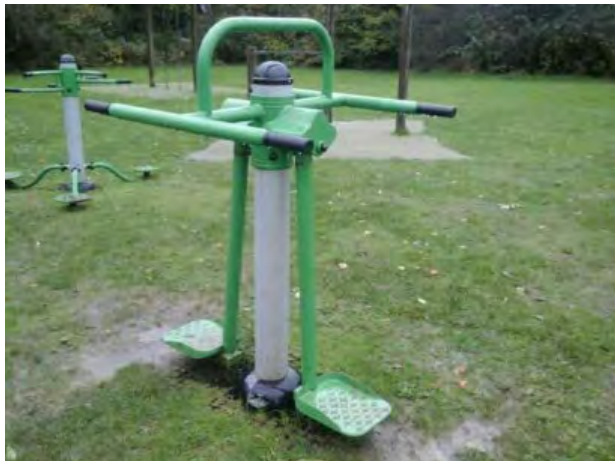
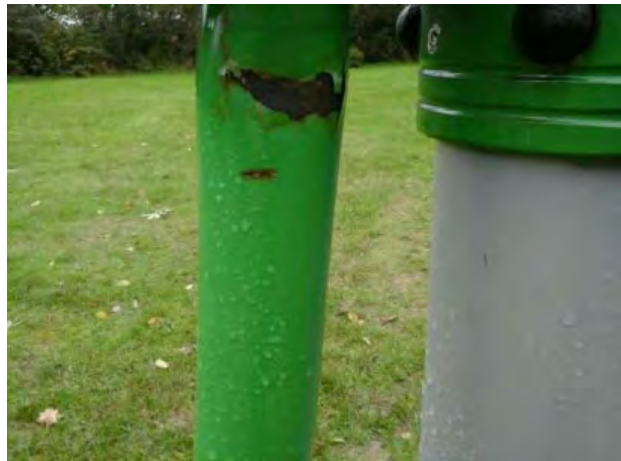
**Finding:** The paintwork on this item has been damaged or worn exposing the metal underneath which is rusting

**Action:** Treat any rusting components and repaint

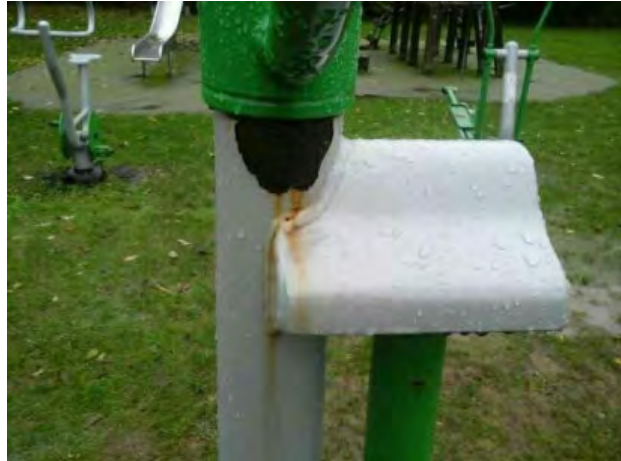
**Finding:** The paintwork on this item has been damaged or worn exposing the metal underneath which is rusting

**Action:** Treat any rusting components and repaint

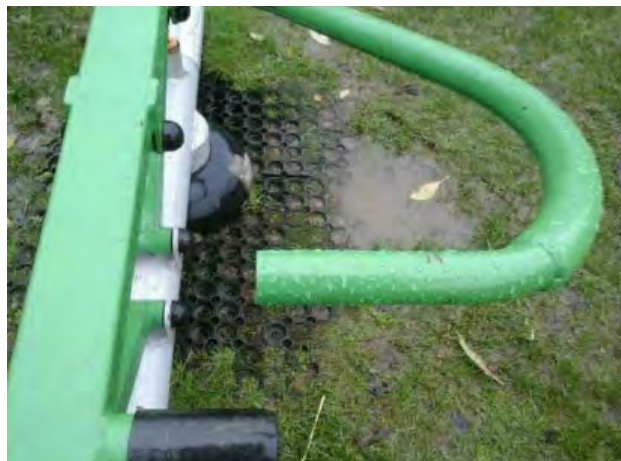
**Finding:** A handgrip(s) is/are missing

**Action:** Replace missing hand grips
