Annual Inspection

Came & Company

Marchwood under 12's Play Area

Marchwood Village Centre

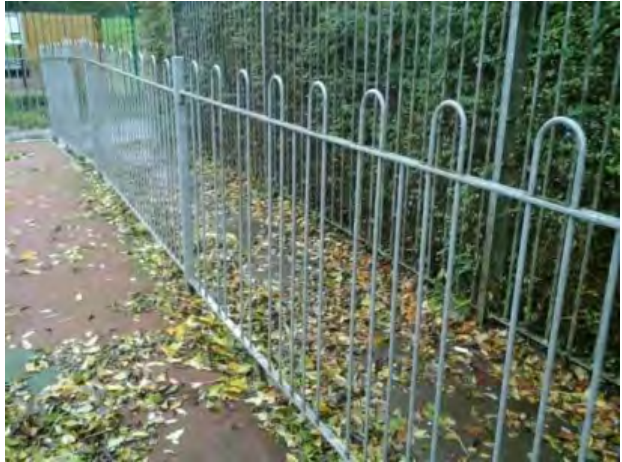
Item: Ancillary Items - Fence - Bow Top
Manufacturer: Owner/Operator
Surface Type: N/A
Equipment Compliance: N/A
Surface Area Compliance: N/A
Ref/Part Number:
Total Findings: 1

There are a number of fixings missing from the fence - Replace missing fixings

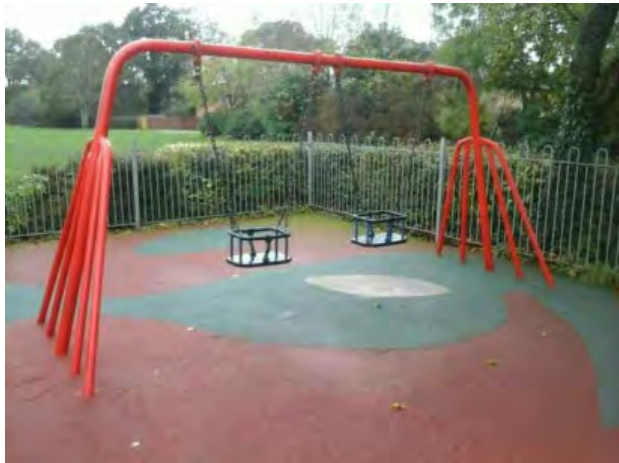
Item: Swings - 1 Bay 2 Seat (Cradle)
Manufacturer: Wicksteed Playscapes
Surface Type: Wet Pour
Equipment Compliance: No
Surface Area Compliance: Yes
Ref/Part Number:
Total Findings: 4
Life Expectancy: 5 -10 Years

The chain openings are in excess of the 8.6mm as recommended by BS EN 1176 - Monitor use and replace with compliant chains during next maintenance cycle.

There is some chain wear - Monitor for any further deterioration and replace when 40% worn

The seat has some damage or wear - Monitor for any further deterioration and replace as required

The tree canopy overhangs the equipment and is less than 2.0m away - Lift tree canopy to ensure a minimum clearance of 2.0m from the equipment

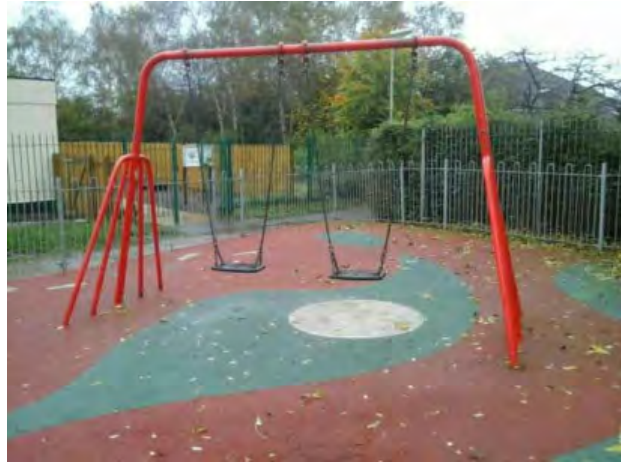
Item: Swings - 1 Bay 2 Seat (Flat)
Manufacturer: Wicksteed Playscapes
Surface Type: Wet Pour
Equipment Compliance: No
Surface Area Compliance: Yes
Ref/Part Number:
Total Findings: 3
Life Expectancy: 5 -10 Years

The chain openings are in excess of the 8.6mm as recommended by BS EN 1176 - Monitor use and replace with compliant chains during next maintenance cycle.

There is some chain wear - Monitor for any further deterioration and replace when 40% worn

The seat has minor damage or wear - Monitor for any further deterioration and replace as required

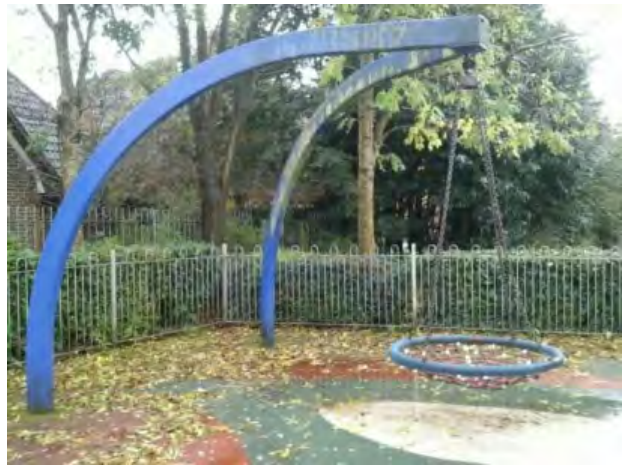
Item: Swings - Basket Swing - Type 1
Manufacturer: Not Identified
Surface Type: Wet Pour
Equipment Compliance: No
Surface Area Compliance: Yes
Ref/Part Number:
Total Findings: 6
Life Expectancy: 3 - 5 Years

The chain openings are in excess of the 8.6mm as recommended by BS EN 1176 - Monitor use and replace with compliant chains during next maintenance cycle.

The bushes are showing signs of wear - Monitor for any further deterioration and replace as required

The use of tab end shackles is not recommended as they can catch a users clothing or jewellery - Consider replacing with button end or countersunk fixings

The ropes/nets are worn/damaged in places - Monitor for any further deterioration and repair or replace as required

There is some evidence of fire damage to the item - Monitor for any further deterioration and repair as required

The tree canopy overhangs the equipment and is less than 2.0m away - Lift tree canopy to ensure a minimum clearance of 2.0m from the equipment

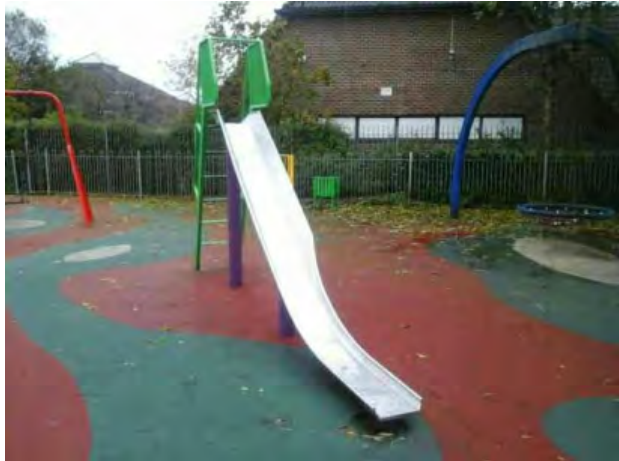
Item: Other - Free Standing Slide
Manufacturer: Wicksteed Playscapes
Surface Type: Wet Pour
Equipment Compliance: No
Surface Area Compliance: Yes
Ref/Part Number:
Total Findings: 2
Life Expectancy: 5 -10 Years

There is/are finger entrapment/s at the top of the slide - Monitor use

There is a toggle entrapment at the top of the slide - Monitor Use

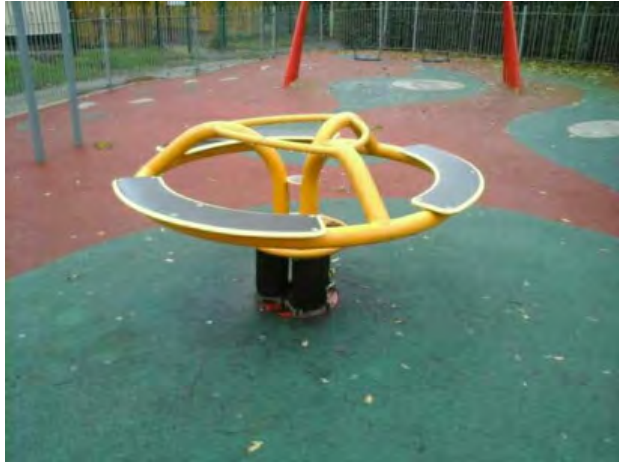
Item: Rocking Equipment - See Saw
Manufacturer: Wicksteed Playscapes
Surface Type: Wet Pour
Equipment Compliance: Yes
Surface Area Compliance: Yes
Ref/Part Number:
Total Findings: 1
Life Expectancy: 5 -10 Years

There is/are missing fixing/s on the seat - Replace all missing fixings

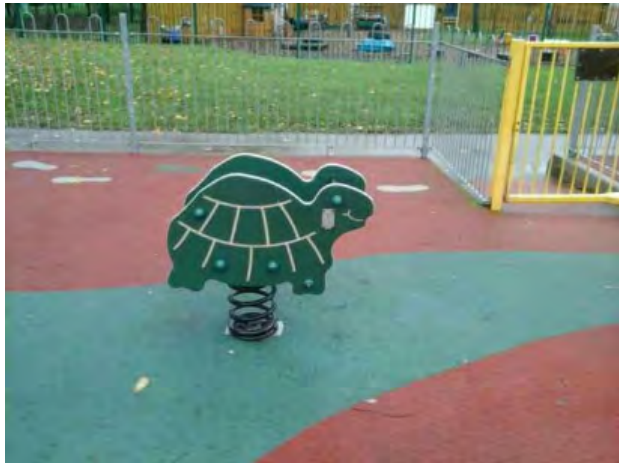
Item: Rocking Equipment - Spring Turtle
Manufacturer: Wicksteed Playscapes
Surface Type: Wet Pour
Equipment Compliance: Yes
Surface Area Compliance: Yes
Ref/Part Number:
Total Findings: 1
Life Expectancy: 5 -10 Years

There is/are bolt cap covers missing or damaged on the item - Replace missing or damaged bolt cap covers

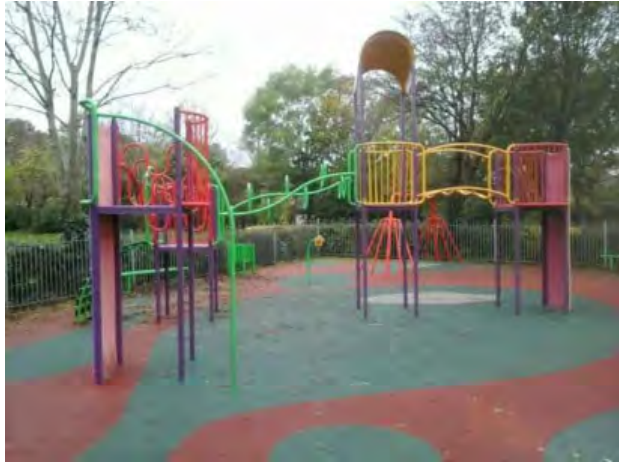
Item: Activity Equipment - Multi Play (Junior)
Manufacturer: Wicksteed Playscapes
Surface Type: Wet Pour
Equipment Compliance: No
Surface Area Compliance: Yes
Ref/Part Number:
Total Findings: 1
Life Expectancy: 5 -10 Years

There is/are finger entrapment/s in the framework - Monitor use

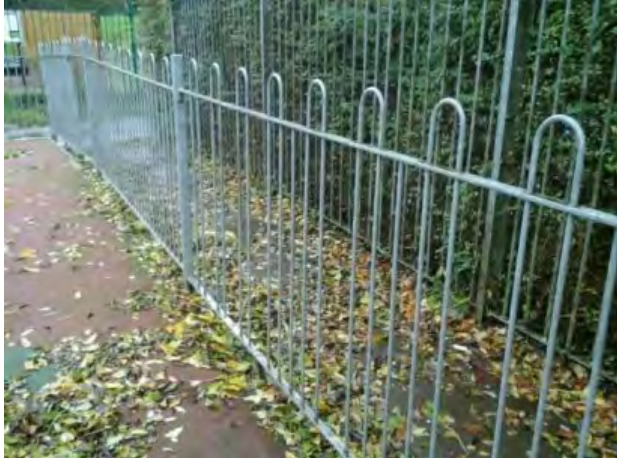
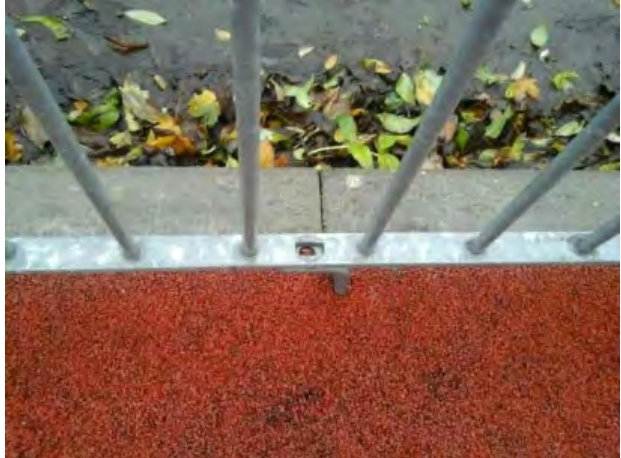
Item: Ancillary Items - Fence - Bow Top
Manufacturer: Owner/Operator

Finding: There are a number of fixings missing from the fence

Action: Replace missing fixings

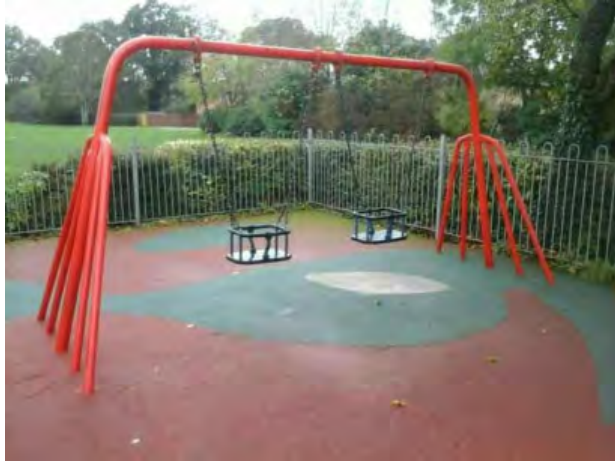
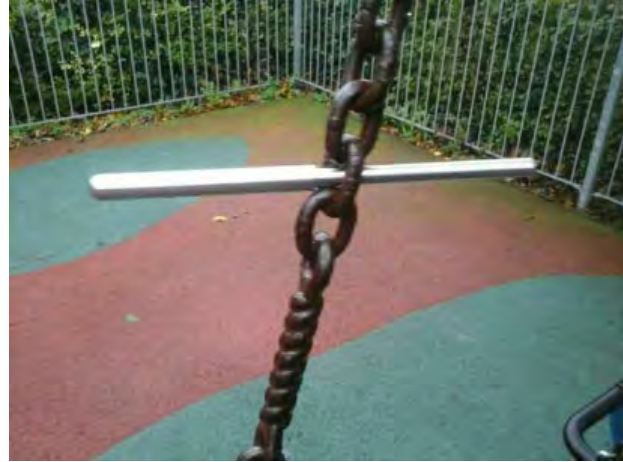
Item: Swings - 1 Bay 2 Seat (Cradle)
Manufacturer: Wicksteed Playscapes

Finding: The chain openings are in excess of the 8.6mm as recommended by BS EN 1176

Action: Monitor use and replace with compliant chains during next maintenance cycle.

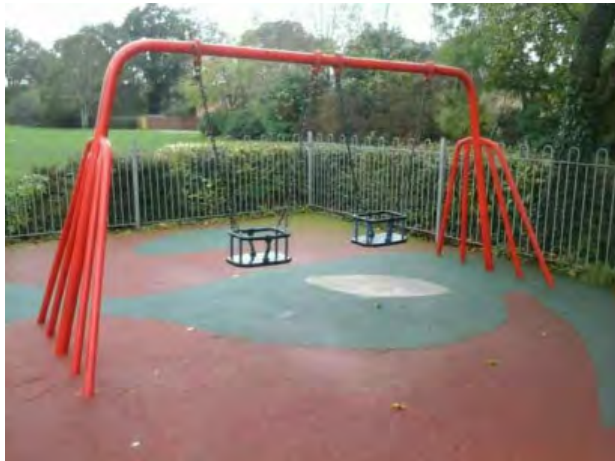
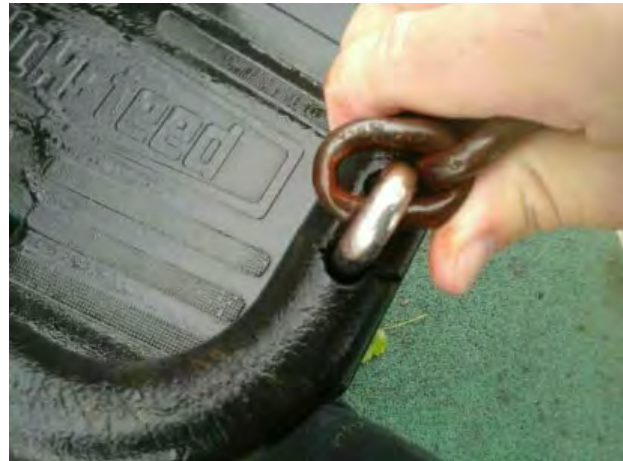
Item: Swings - 1 Bay 2 Seat (Cradle)
Manufacturer: Wicksteed Playscapes

Finding: There is some chain wear

Action: Monitor for any further deterioration and replace when 40% worn

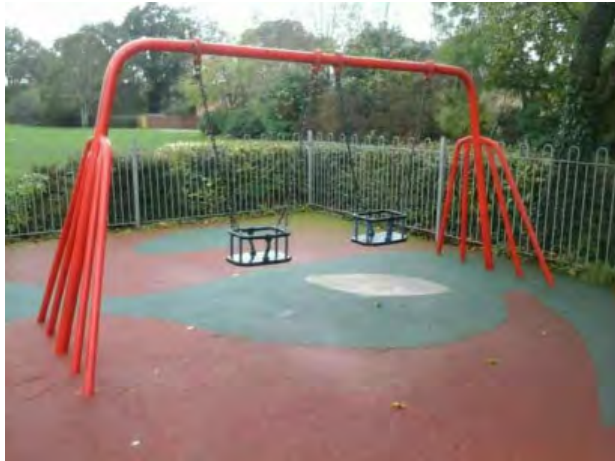
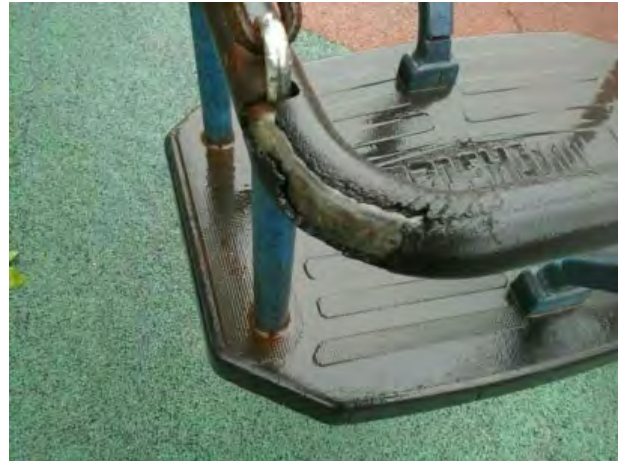
Item: Swings - 1 Bay 2 Seat (Cradle)
Manufacturer: Wicksteed Playscapes

Finding: The seat has some damage or wear

Action: Monitor for any further deterioration and replace as required

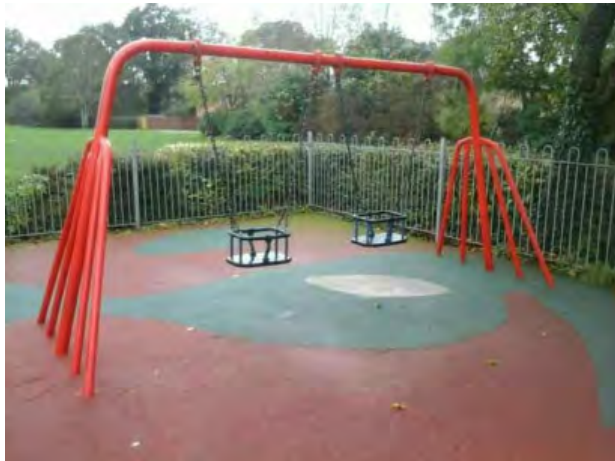
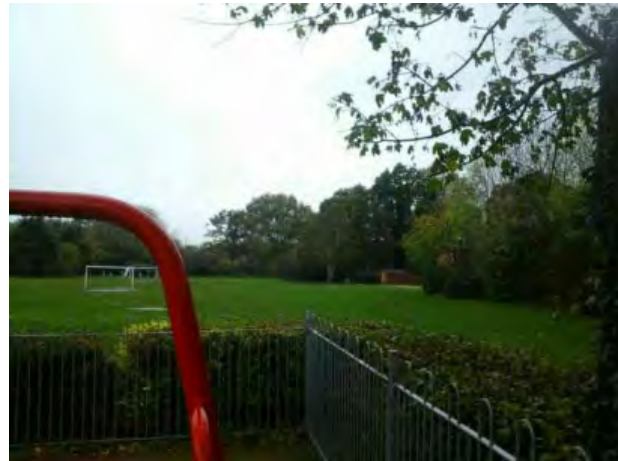
Item: Swings - 1 Bay 2 Seat (Cradle)
Manufacturer: Wicksteed Playscapes

Finding: The tree canopy overhangs the equipment and is less than 2.0m away

Action: Lift tree canopy to ensure a minimum clearance of 2.0m from the equipment

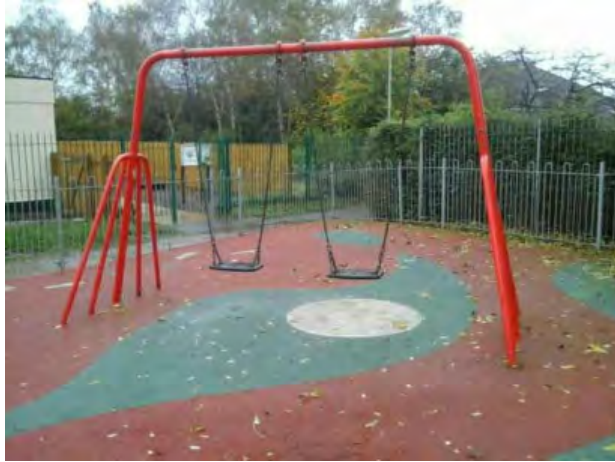
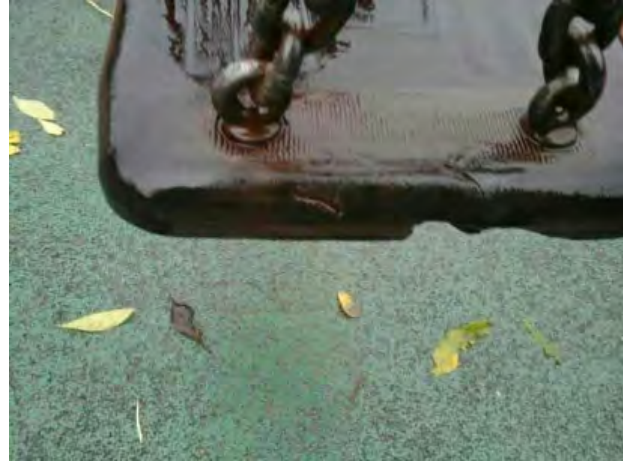
Item: Swings - 1 Bay 2 Seat (Flat)
Manufacturer: Wicksteed Playscapes

Finding: The seat has minor damage or wear

Action: Monitor for any further deterioration and replace as required

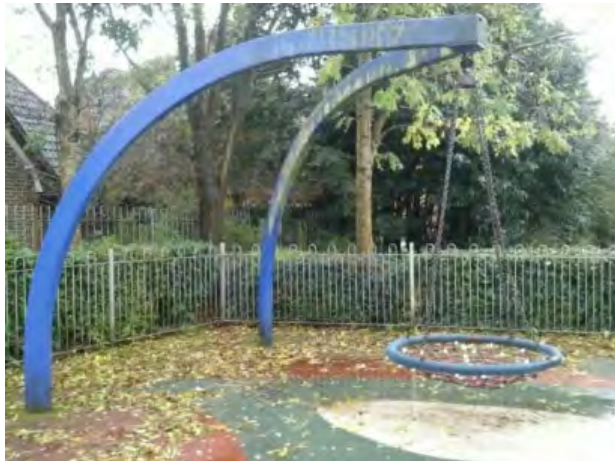
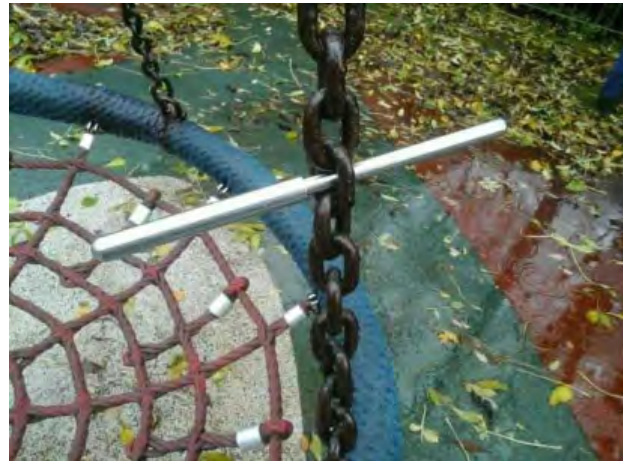
Item: Swings - Basket Swing - Type 1
Manufacturer: Not Identified

Finding: The chain openings are in excess of the 8.6mm as recommended by BS EN 1176

Action: Monitor use and replace with compliant chains during next maintenance cycle.

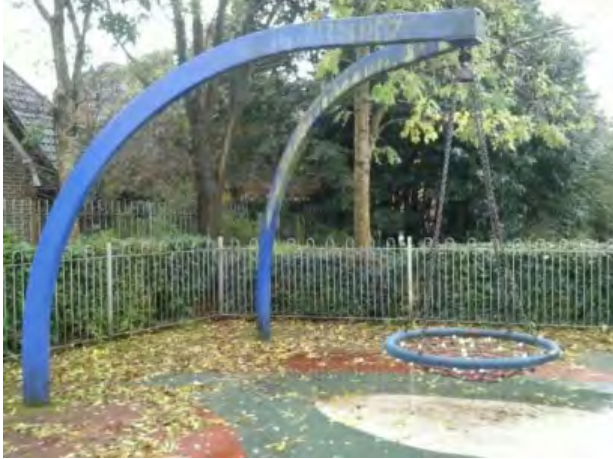
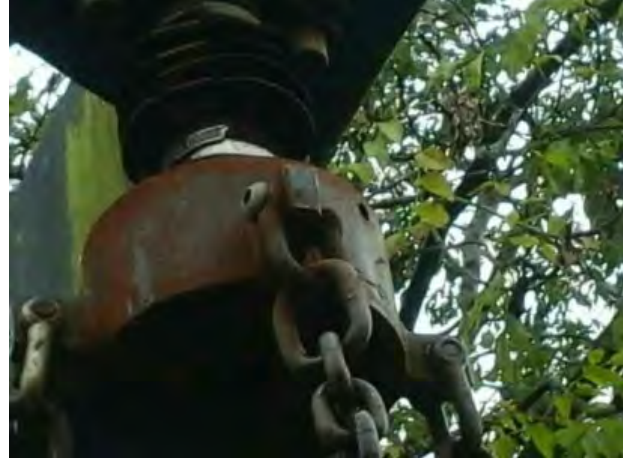
Item: Swings - Basket Swing - Type 1
Manufacturer: Not Identified

Finding: The bushes are showing signs of wear

Action: Monitor for any further deterioration and replace as required

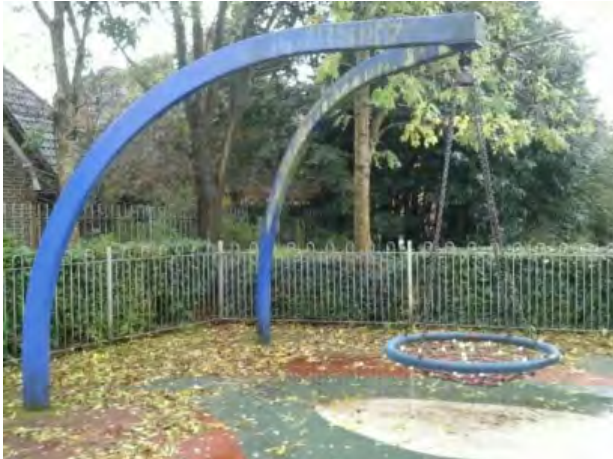
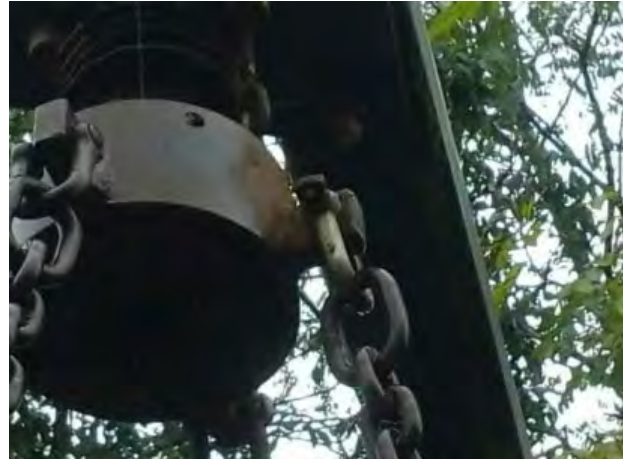
Item: Swings - Basket Swing - Type 1
Manufacturer: Not Identified

Finding: The use of tab end shackles is not recommended as they can catch a users clothing or jewellery

Action: Consider replacing with button end or countersunk fixings

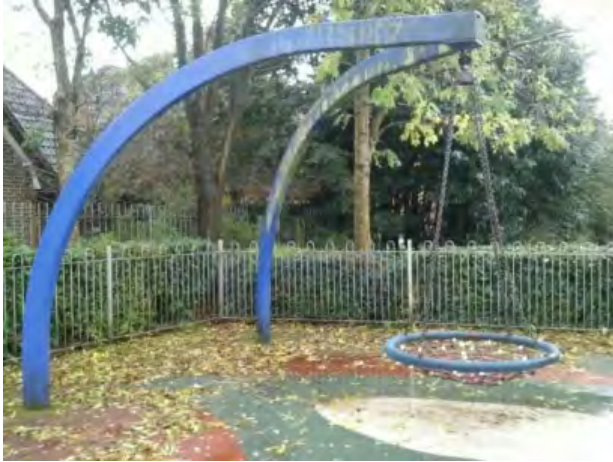
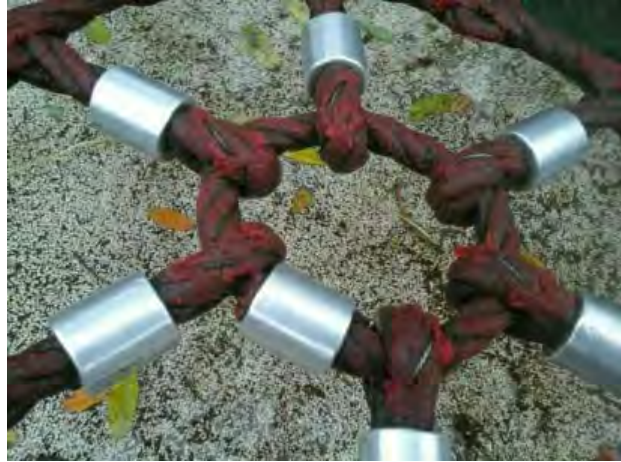
Item: Swings - Basket Swing - Type 1
Manufacturer: Not Identified

Finding: The ropes/nets are worn/damaged in places

Action: Monitor for any further deterioration and repair or replace as required

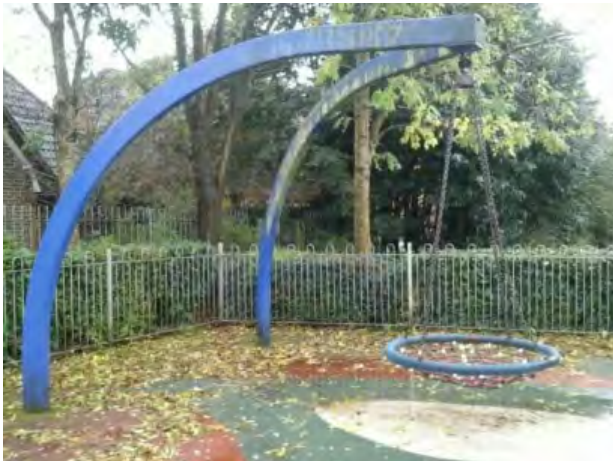
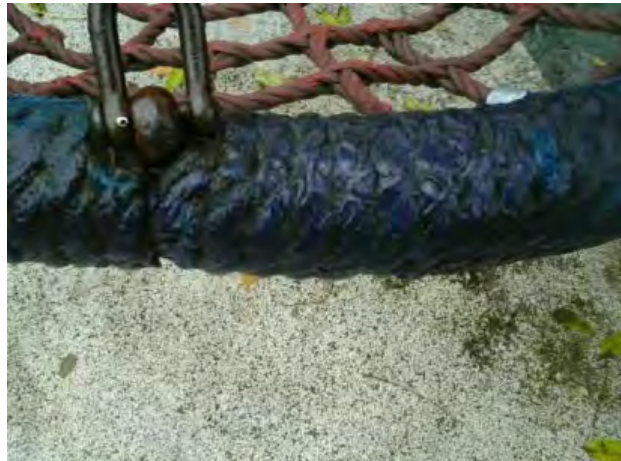
Item: Swings - Basket Swing - Type 1
Manufacturer: Not Identified

Finding: There is some evidence of fire damage to the item

Action: Monitor for any further deterioration and repair as required

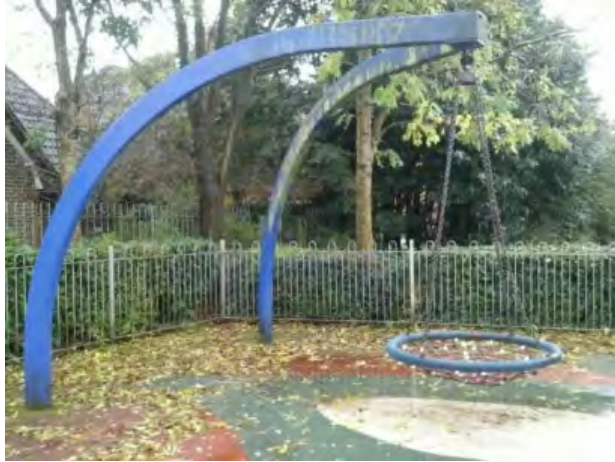
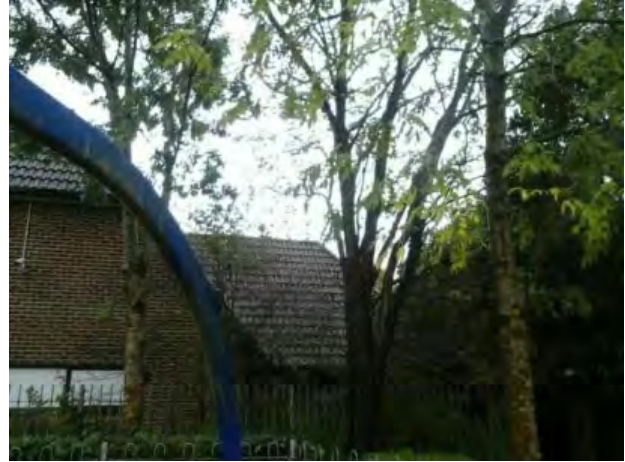
Item: Swings - Basket Swing - Type 1
Manufacturer: Not Identified

Finding: The tree canopy overhangs the equipment and is less than 2.0m away

Action: Lift tree canopy to ensure a minimum clearance of 2.0m from the equipment

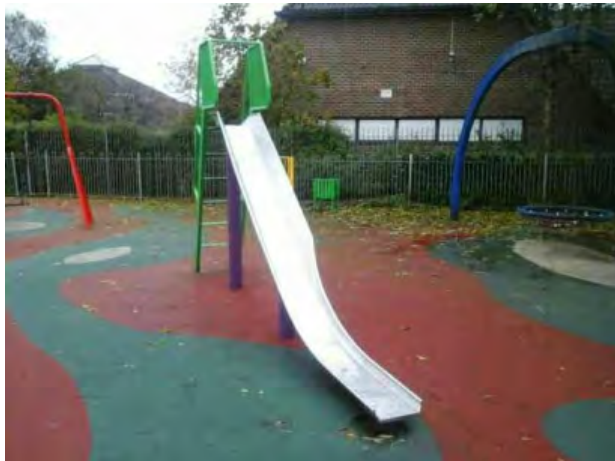
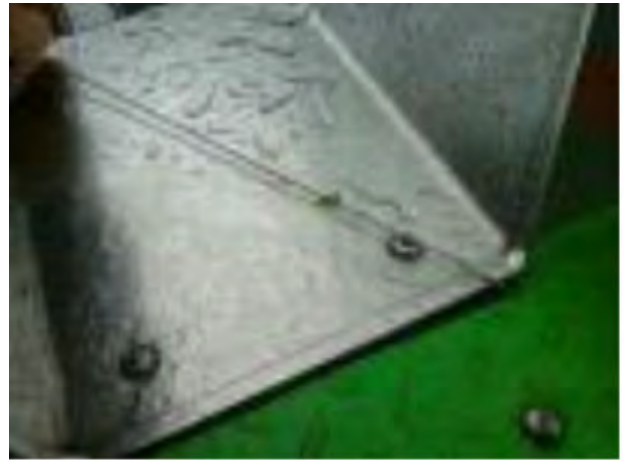
Item: Other - Free Standing Slide
Manufacturer: Wicksteed Playscapes

Finding: There is a toggle entrapment at the top of the slide

Action: Monitor Use

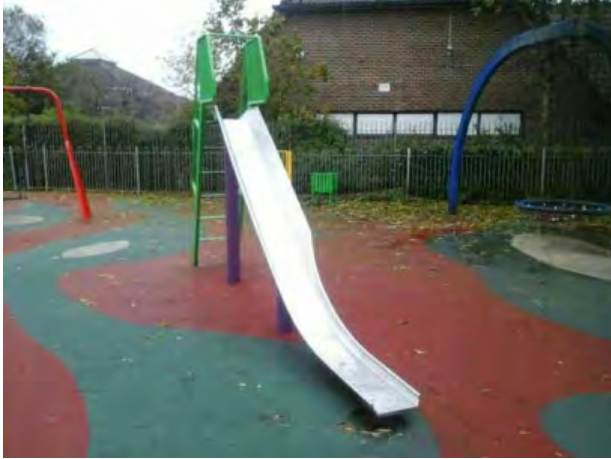
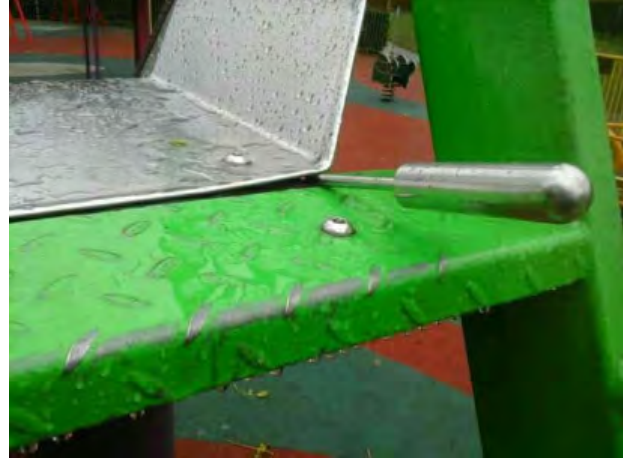
Item: Other - Free Standing Slide
Manufacturer: Wicksteed Playscapes

Finding: There is/are finger entrapment/s at the top of the slide

Action: Monitor use

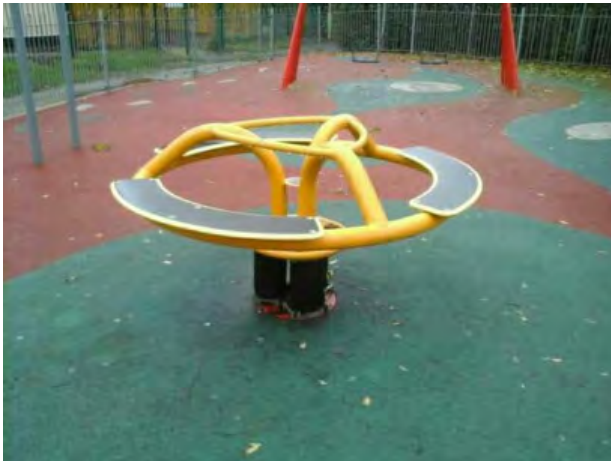
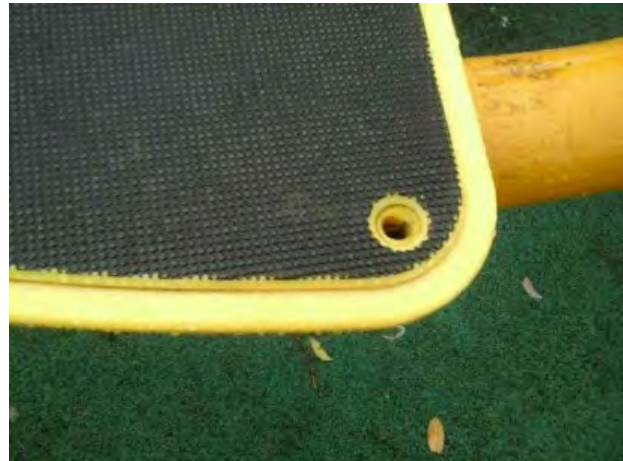
Item: Rocking Equipment - See Saw
Manufacturer: Wicksteed Playscapes

Finding: There is/are missing fixing/s on the seat

Action: Replace all missing fixings

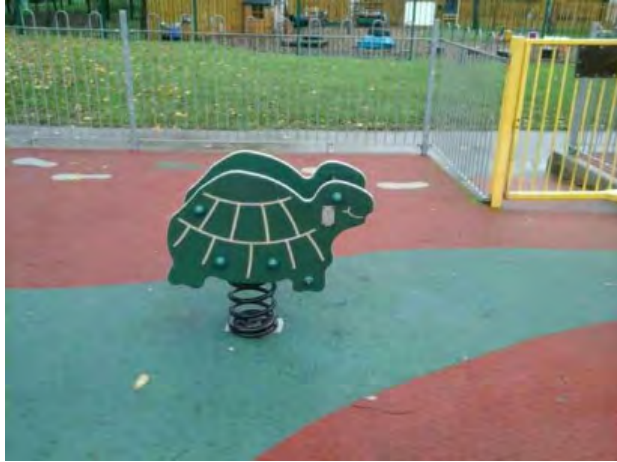
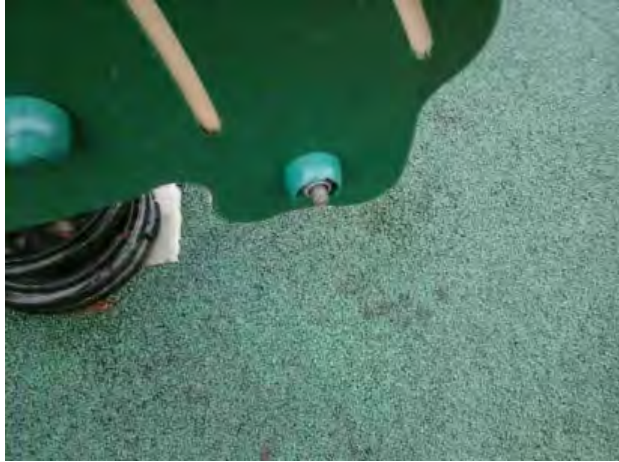
Item: Rocking Equipment - Spring Turtle
Manufacturer: Wicksteed Playscapes

Finding: There is/are bolt cap covers missing or damaged on the item

Action: Replace missing or damaged bolt cap covers

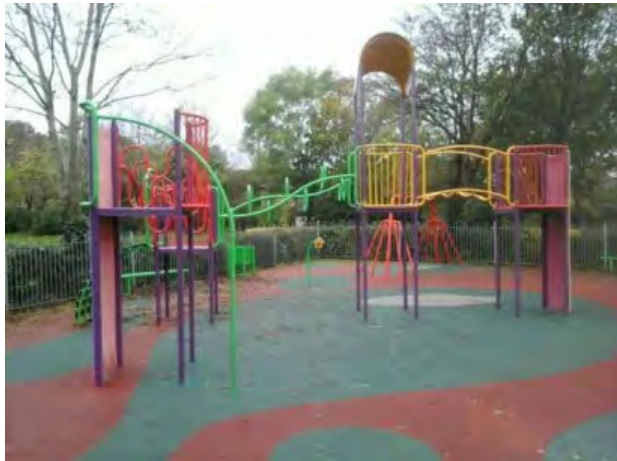
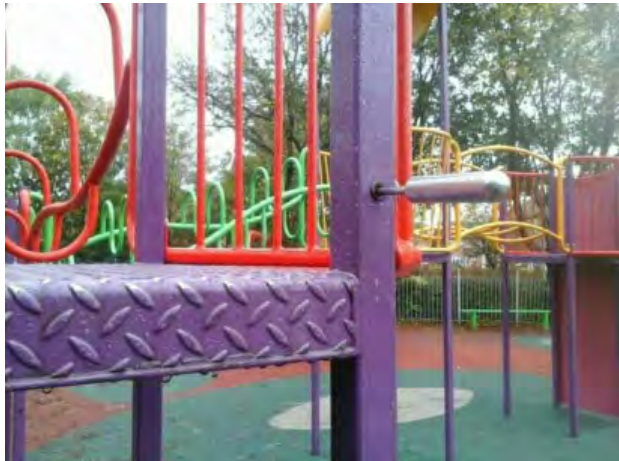
Item: Activity Equipment - Multi Play (Junior)
Manufacturer: Wicksteed Playscapes

Finding: There is/are finger entrapment/s in the framework

Action: Monitor use
