Annual Inspection

Admiralty Quay Play Area

Off Ordnance Way, Admiralty Quay, SO40 4AR

Inspection Ref: 79845

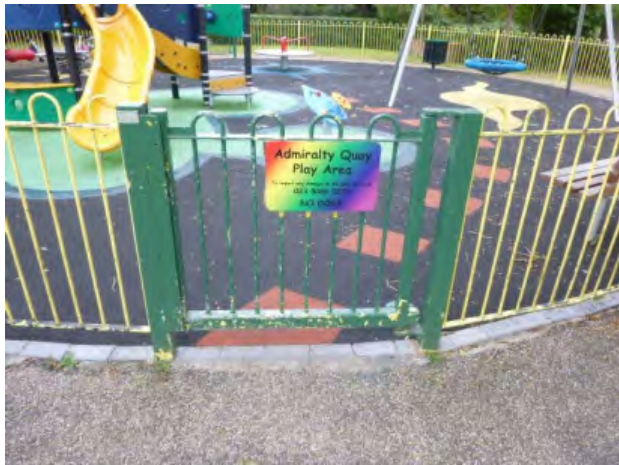
Item: Ancillary Items - Gate
Manufacturer: Owner/Operator
Surface Type: N/A
Equipment Compliance: N/A
Surface Area Compliance: N/A
Ref/Part Number:
Total Findings: 1

This item is satisfactory - no work required

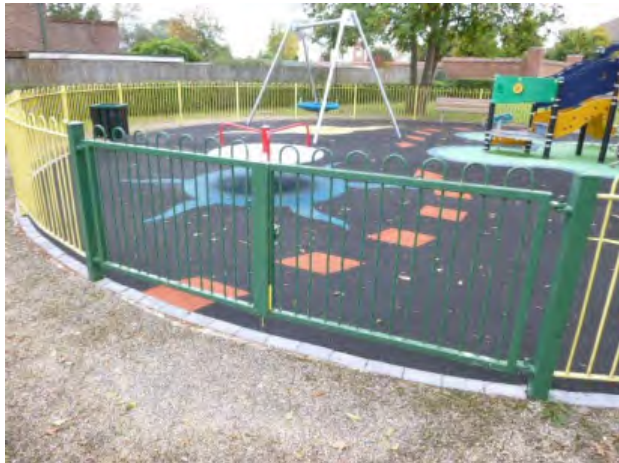
Item: Ancillary Items - Maintenance Gate
Manufacturer: Owner/Operator
Surface Type: N/A
Equipment Compliance: N/A
Surface Area Compliance: N/A
Ref/Part Number:
Total Findings: 1

This item is satisfactory - no work required

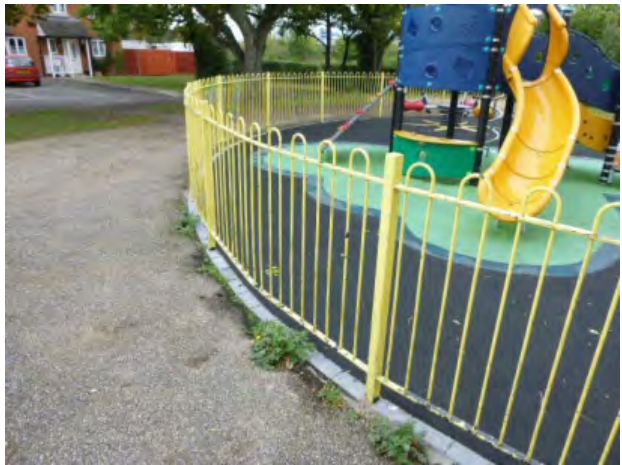
6 - Low Risk

Item: Ancillary Items - Bow Top Fence (Steel)
Manufacturer: Owner/Operator
Surface Type: N/A
Equipment Compliance: N/A
Surface Area Compliance: N/A
Ref/Part Number:
Total Findings: 1

There is some damage to the fence sections - Repair the fence

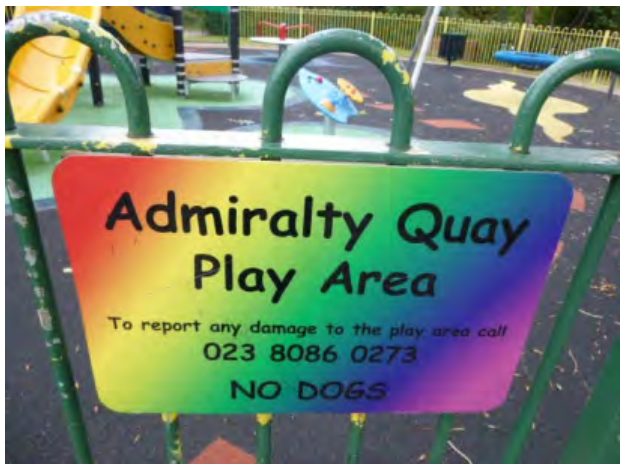
Item: Ancillary Items - Sign
Manufacturer: Owner/Operator
Surface Type: N/A
Equipment Compliance: N/A
Surface Area Compliance: N/A
Ref/Part Number:
Total Findings: 1

This item is satisfactory - no work required

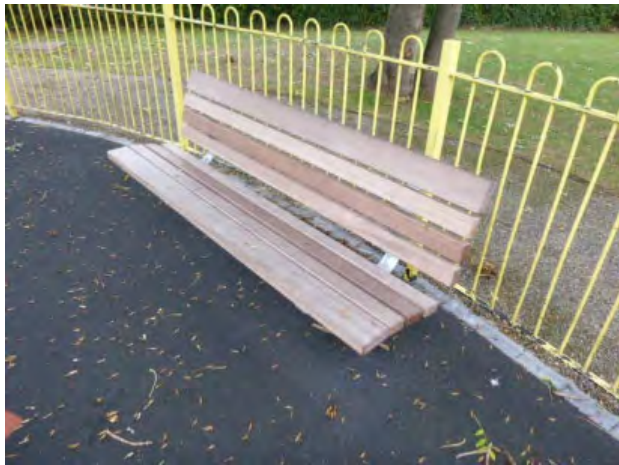
Item: Ancillary Items - Bench - Timber
Manufacturer: Owner/Operator
Surface Type: N/A
Equipment Compliance: N/A
Surface Area Compliance: N/A
Ref/Part Number:
Total Findings: 1

This item is satisfactory - no work required

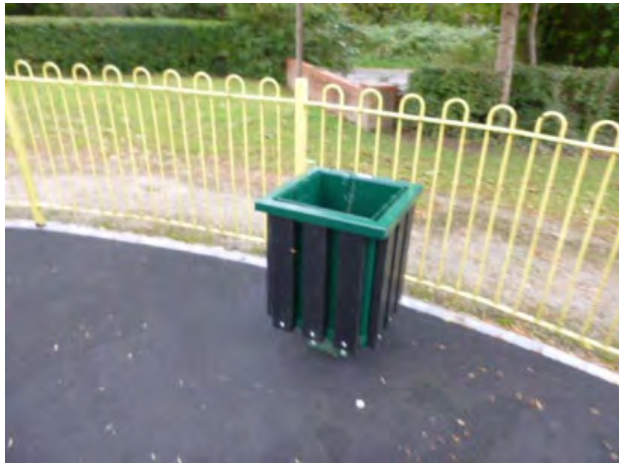
Item: Ancillary Items - Bin - Ground Based
Manufacturer: Owner/Operator
Surface Type: N/A
Equipment Compliance: N/A
Surface Area Compliance: N/A
Ref/Part Number:
Total Findings: 1

This item is satisfactory - no work required

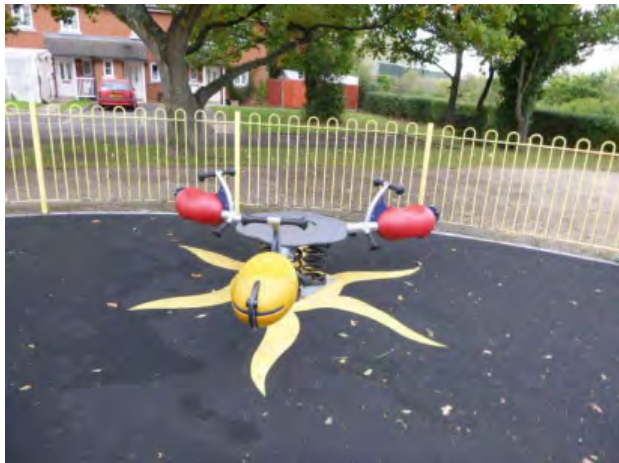
Item: Spring - Three Way Springer
Manufacturer: Kompan Ltd
Surface Type: Wet Pour
Equipment Compliance: Yes
Surface Area Compliance: Yes
Ref/Part Number:
Total Findings: 1
Life Expectancy: 5 -10 Years

This item is satisfactory - no work required

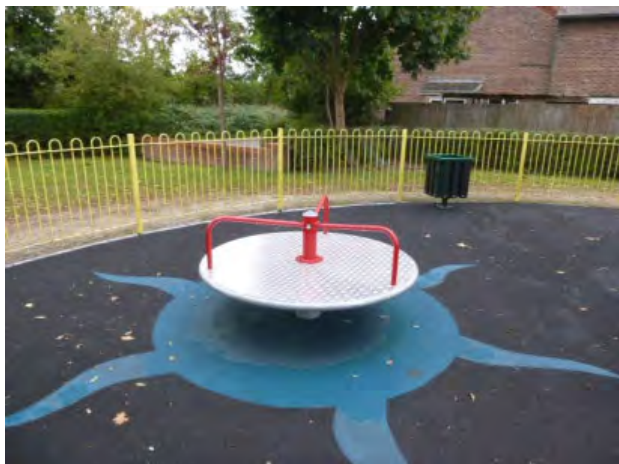
8 - Low Risk

Item: Rotor Play - Roundabout
Manufacturer: Kompan Ltd
Surface Type: Wet Pour
Equipment Compliance: No
Surface Area Compliance: Yes
Ref/Part Number:
Total Findings: 1
Life Expectancy: 5 -10 Years

The height of the roundabout platform is less than 400mm and fails the requirements of BS EN 1176 Part 5 - Monitor use

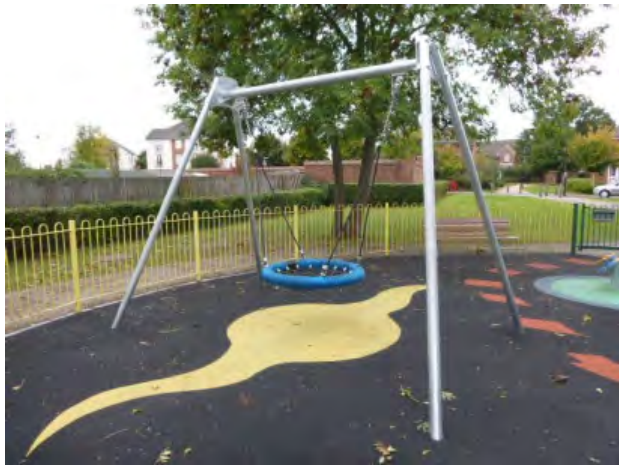
Item: Swings - Basket Swing
Manufacturer: Kompan Ltd
Surface Type: Wet Pour
Equipment Compliance: Yes
Surface Area Compliance: Yes
Ref/Part Number:
Total Findings: 1
Life Expectancy: 5 -10 Years

This item is satisfactory - no work required

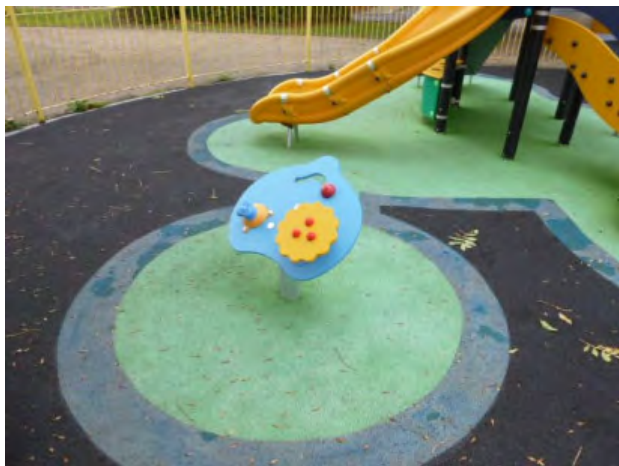
Item: Other - Play Panel
Manufacturer: Kompan Ltd
Surface Type: Wet Pour
Equipment Compliance: Yes
Surface Area Compliance: Yes
Ref/Part Number:
Total Findings: 1
Life Expectancy: 5 -10 Years

This item is satisfactory - no work required

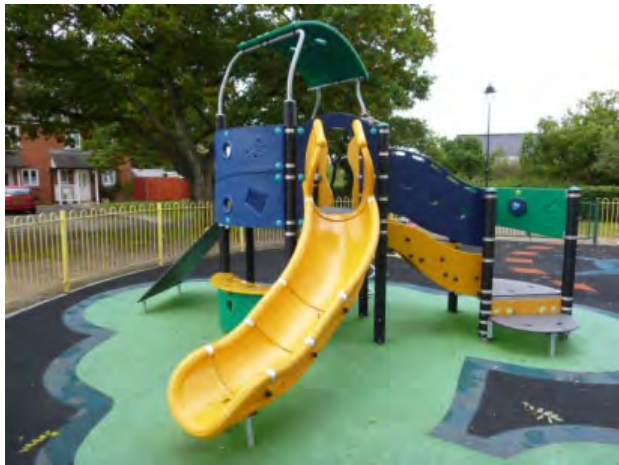
Item: Agility - Multi Play with Slide
Manufacturer: Kompan Ltd
Surface Type: Wet Pour
Equipment Compliance: Yes
Surface Area Compliance: Yes
Ref/Part Number:
Total Findings: 1
Life Expectancy: 5 -10 Years

This item is satisfactory - no work required

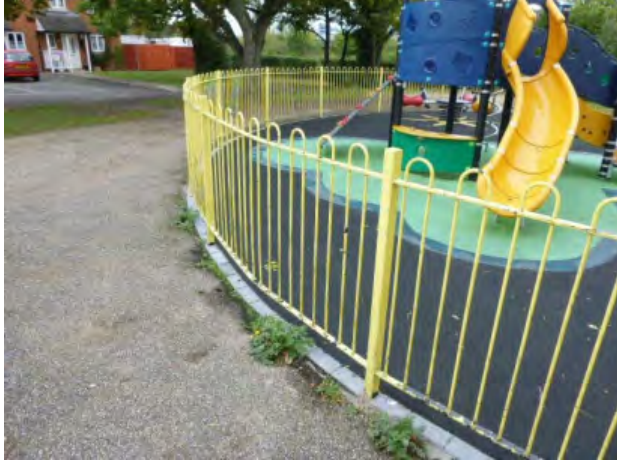
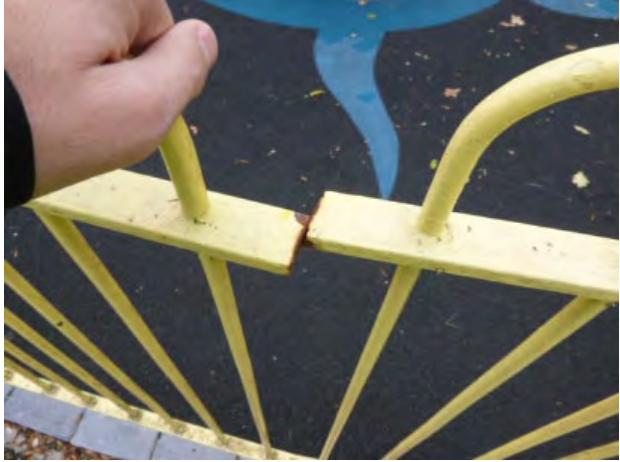
6 - Low Risk			
Item:	Ancillary Items - Bow Top Fence (Steel)	Risk Level:	L - Low Risk
Manufacturer:	Owner/Operator	Surface:	N/A

Finding:	There is some damage to the fence sections		Action: Repair the fence

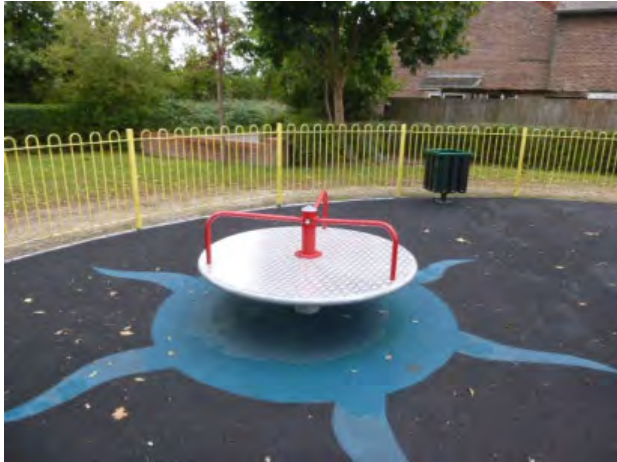
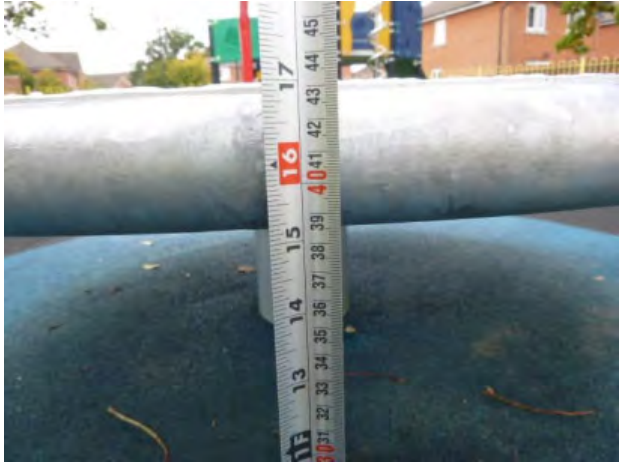
8 - Low Risk			
Item:	Rotor Play - Roundabout	Risk Level:	L - Low Risk
Manufacturer:	Kompan Ltd	Surface:	Wet Pour

Finding:	The height of the roundabout platform is less than 400mm and fails the requirements of BS EN 1176 Part 5		Action: Monitor use
