Annual Inspection

Came & Company

Lloyd Play Area

Main Road, Marchwood, SO40 4US

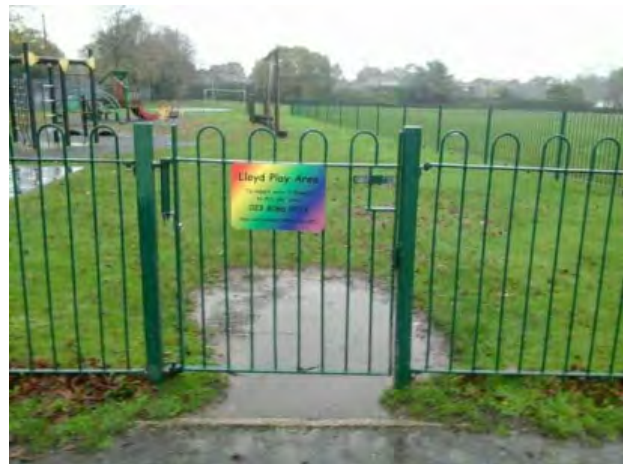
Item: Ancillary Items - Gate - Self Closing
Manufacturer: Owner/Operator
Surface Type: N/A
Equipment Compliance: N/A
Surface Area Compliance: N/A
Ref/Part Number:
Total Findings: 3

The gate is not a contrasting colour to the fencing making it difficult for users with impaired sight to distinguish it from the fence - We would recommend that the gates are painted a distinguishable colour to that of the fence

The opening between the gate and the post is less than 12mm and could trap users fingers - Adjust gate to ensure a 12mm opening all around

The gate is closing too quickly (less than 4 seconds) - Take corrective action to ensure that the gate closes in 4-8 seconds

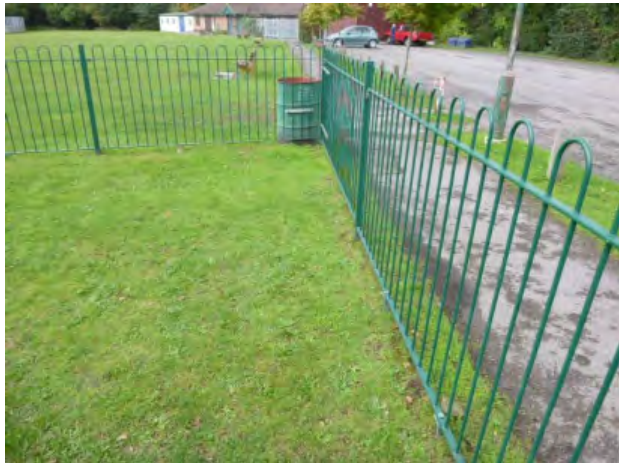
Item: Ancillary Items - Fence - Bow Top
Manufacturer: Owner/Operator
Surface Type: N/A
Equipment Compliance: N/A
Surface Area Compliance: N/A
Ref/Part Number:
Total Findings: 2

There are gaps in excess of 100mm under the fence/gate that may allow the passage of small animals into the area - Monitor playground for animal faeces and adjust height of the gates/fence if necessary

A number of fixings have worked loose around the fencing - Secure all loose fixings

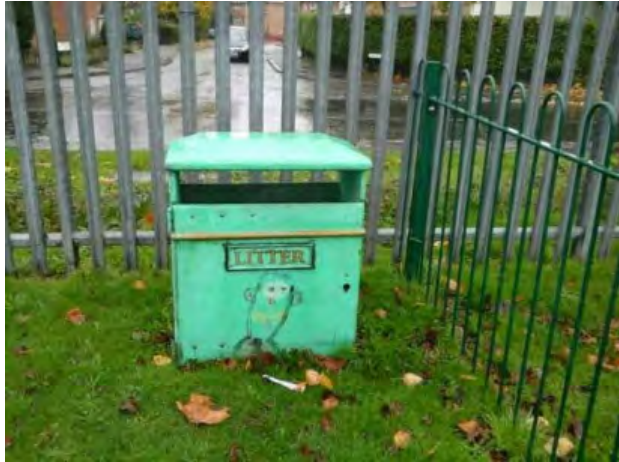
Item: Ancillary Items - Litter Bin
Manufacturer: Owner/Operator
Surface Type: N/A
Equipment Compliance: N/A
Surface Area Compliance: N/A
Ref/Part Number:
Total Findings: 1

There is some graffiti present on site - Remove the graffiti

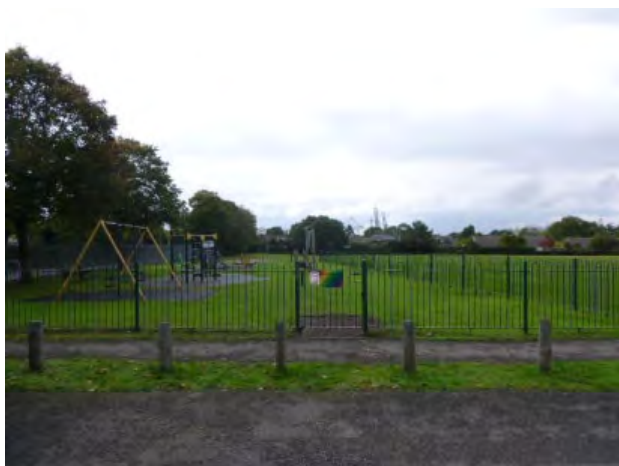
Item: Ancillary Items - Site General
Manufacturer: Owner/Operator
Surface Type: N/A
Equipment Compliance: N/A
Surface Area Compliance: N/A
Ref/Part Number:
Total Findings: 1

There are gaps opening between the wet pour surfacing and the edging surround or between the joints in the surfacing - Monitor for any further deterioration and repair as required

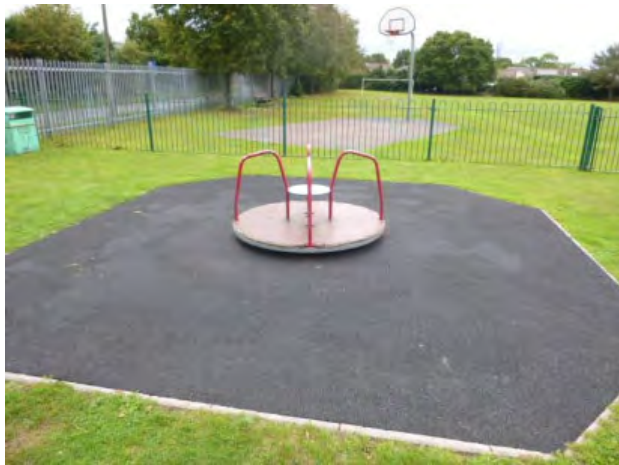
Item: Rotor Play - Roundabout
Manufacturer: Hags SMP
Surface Type: Wet Pour
Equipment Compliance: No
Surface Area Compliance: No
Ref/Part Number:
Total Findings: 7
Life Expectancy: 3 - 5 Years

The surfacing dimensions do not meet with the requirements of BS EN 1176 - We consider this to be a low risk failure and no remedial action is recommended - monitor use

The ground clearance is not maintained under the roundabout level for 300mm as required by BS EN 1176 Part 5 - Monitor Use

There is/are finger entrapment/s in the platform - Monitor use

There is/are missing fixing/s on the item - Replace all missing fixings

A number of fixing(s) have worked loose - Secure all loose fixings

There are areas or parts of the timber on the structure that have rotted - Replace all affected timbers

The paintwork on this item has been damaged or worn exposing the metal underneath which is rusting - Treat any rusting components and repaint

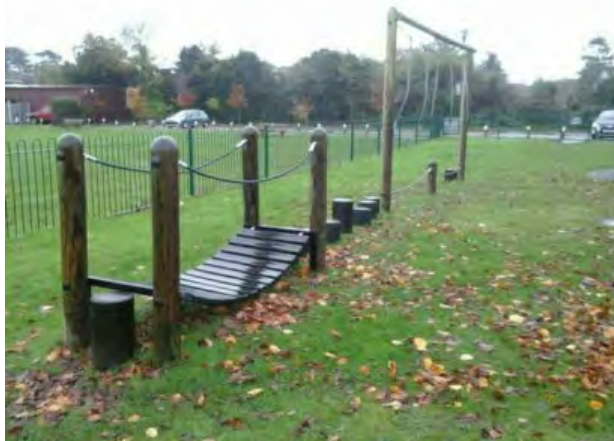
Item: Activity Equipment - Activity Trail
Manufacturer: Not Identified
Surface Type: Grass Matrix Tiles
Equipment Compliance: Yes
Surface Area Compliance: Yes
Ref/Part Number:
Total Findings: 3
Life Expectancy: 5 -10 Years

The ropes on this item have been taped and we are unable to fully assess the condition of the rope, ensure no wire strands are broken beneath the tape - Repair or replace as required

The ropes are worn/damaged in places - Monitor for any further deterioration and repair or replace as required

There is/are bolt cap covers missing or damaged on the item - Replace missing or damaged bolt cap covers

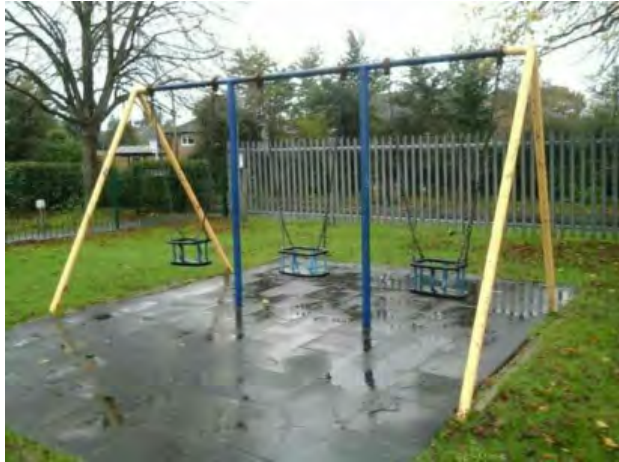
Item: Swings - 3 Bay Swing
Manufacturer: Not Identified
Surface Type: Rubber Tiles
Equipment Compliance: No
Surface Area Compliance: No
Ref/Part Number:
Total Findings: 9
Life Expectancy: 5 -10 Years

The seats are too close to the frame as defined in BS EN 1176 Part 2; this is a low risk failure and no remedial action is required - Monitor use

The chain openings are in excess of the 8.6mm as recommended by BS EN 1176 - Monitor use and replace with compliant chains during next maintenance cycle.

The surfacing width under each seat is less than 1.75 metres and fails the requirements of BS EN 1176 Part 2 - Monitor use

The seat has minor damage or wear - Monitor for any further deterioration and replace as required

There is some chain wear - Monitor for any further deterioration and replace when 40% worn

The paintwork on this item has been damaged or worn exposing the metal underneath which is rusting - Treat any rusting components and repaint

There are gaps opening in between the tiles - Monitor for any further deterioration and repair as required

The surface has subsided in some areas - Monitor for any further deterioration and repair as required

The surfacing dimensions do not meet with the requirements of BS EN 1176 - We consider this to be a low risk failure and no remedial action is recommended - monitor use

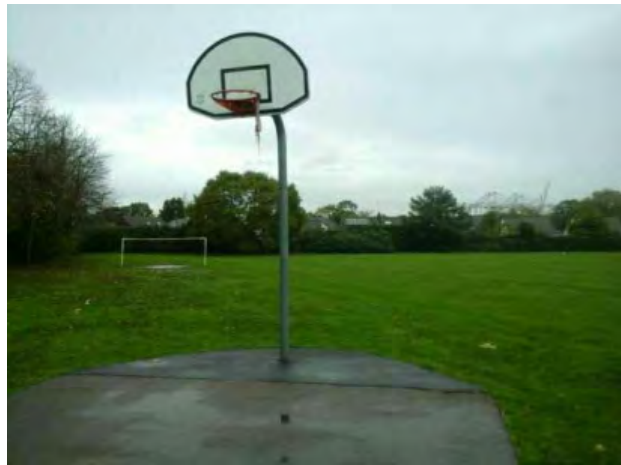
Item: Multi Use Games Area - Basket Ball Goal
Manufacturer: Sure Shot
Surface Type: Bitmac
Equipment Compliance: No
Surface Area Compliance: N/A
Ref/Part Number:
Total Findings: 2
Life Expectancy: 3 - 5 Years

A clearly visible sign should be provided in a prominent position with the wording as detailed BS EN 15312 - the equipment is not intended for children less than 3 years old - the warning Do not climb on the framework or nets - the warning Do not hang on the ring (if provided) - the warning Do not wear rings or other jewellery - name and telephone number of the administrator - number to call in case of accident - Provide signage to BS EN 15312

The net is damaged - Replace/remove net

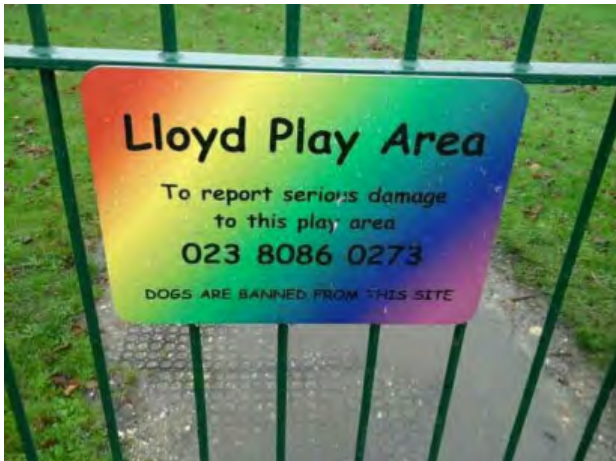
2 - Very Low Risk			
Item:	Ancillary Items - Sign	Risk Level:	V - Very Low Risk
Manufacturer:	Owner/Operator	Surface:	N/A

Finding:	It is recommended that information signs with emergency contact details are installed at each entrance/exit point to the playground	Action:	Provide in accordance with the recommendations set out in BS EN 1176

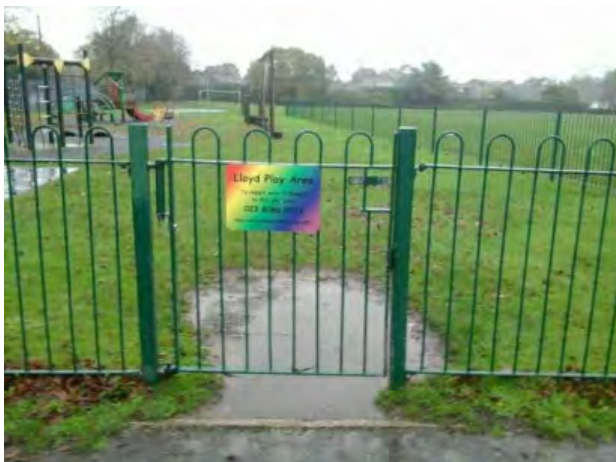
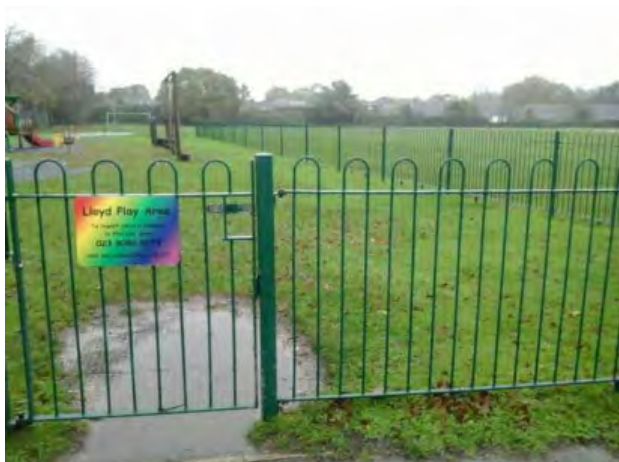
6 - Low Risk			
Item:	Ancillary Items - Gate - Self Closing	Risk Level:	L - Low Risk
Manufacturer:	Owner/Operator	Surface:	N/A

Finding:	The gate is not a contrasting colour to the fencing making it difficult for users with impaired sight to distinguish it from the fence	Action:	We would recommend that the gates are painted a distinguishable colour to that of the fence

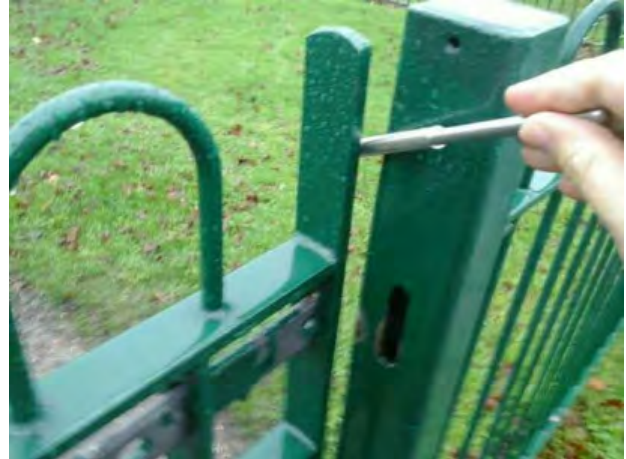
Item: Ancillary Items - Gate - Self Closing
Manufacturer: Owner/Operator

Finding: The opening between the gate and the post is less than 12mm and could trap users fingers
Action: Adjust gate to ensure a 12mm opening all around

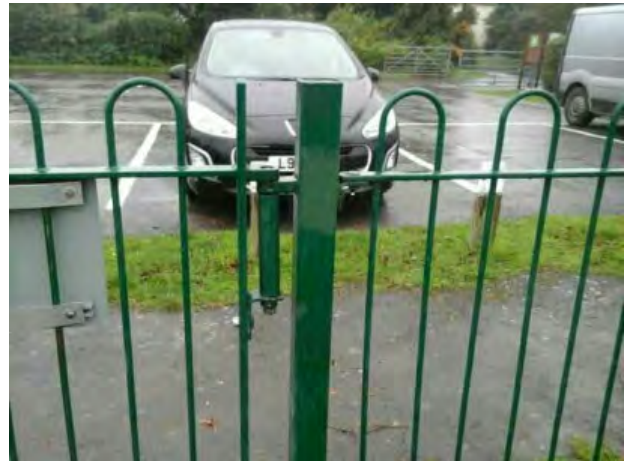
Item: Ancillary Items - Gate - Self Closing
Manufacturer: Owner/Operator

Finding: The gate is closing too quickly (less than 4 seconds)
Action: Take corrective action to ensure that the gate closes in 4-8 seconds

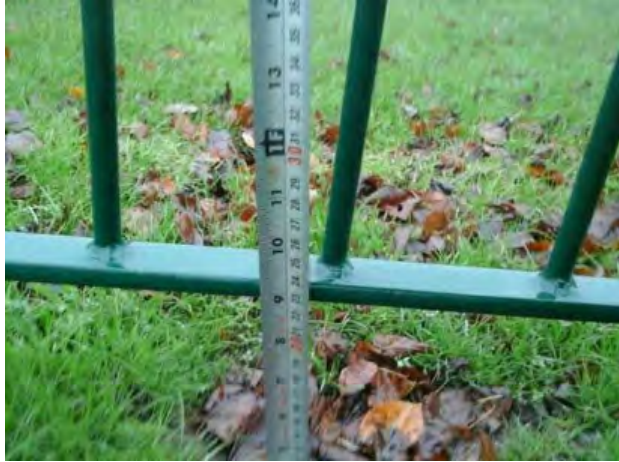
Item: Ancillary Items - Fence - Bow Top
Manufacturer: Owner/Operator

Finding: There are gaps in excess of 100mm under the fence/gate that may allow the passage of small animals into the area

Action: Monitor playground for animal faeces and adjust height of the gates/fence if necessary

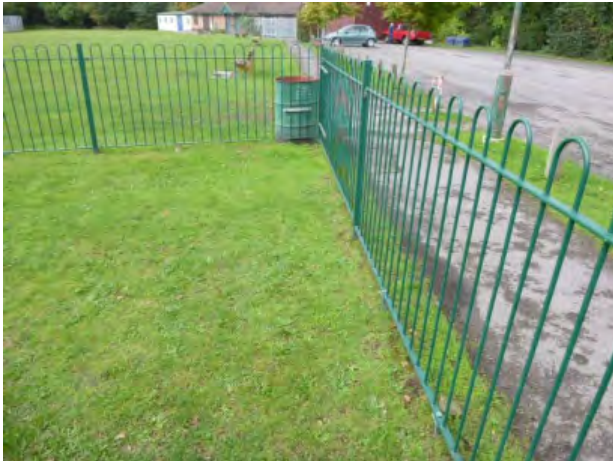
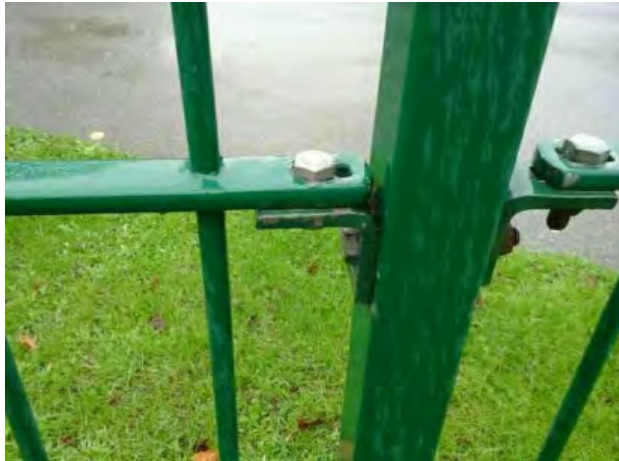
Item: Ancillary Items - Fence - Bow Top
Manufacturer: Owner/Operator

Finding: A number of fixings have worked loose around the fencing

Action: Secure all loose fixings

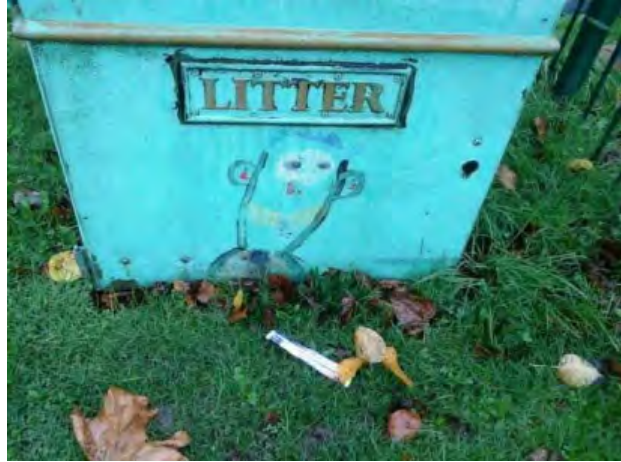
Item: Ancillary Items - Litter Bin
Manufacturer: Owner/Operator

Finding: There is some graffiti present on site

Action: Remove the graffiti

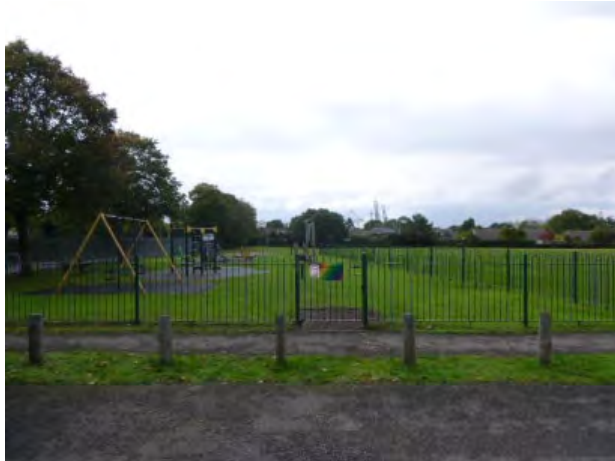
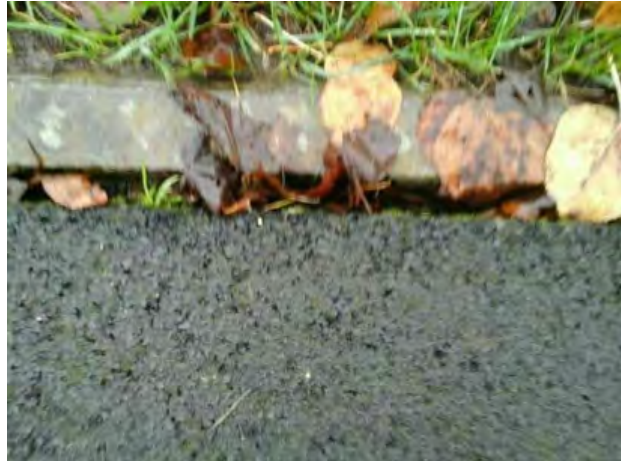
Item: Ancillary Items - Site General
Manufacturer: Owner/Operator

Finding: There are gaps opening between the wet pour surfacing and the edging surround or between the joints in the surfacing

Action: Monitor for any further deterioration and repair as required

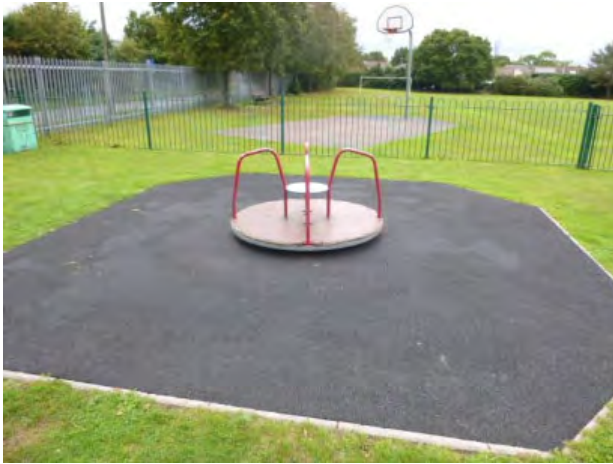
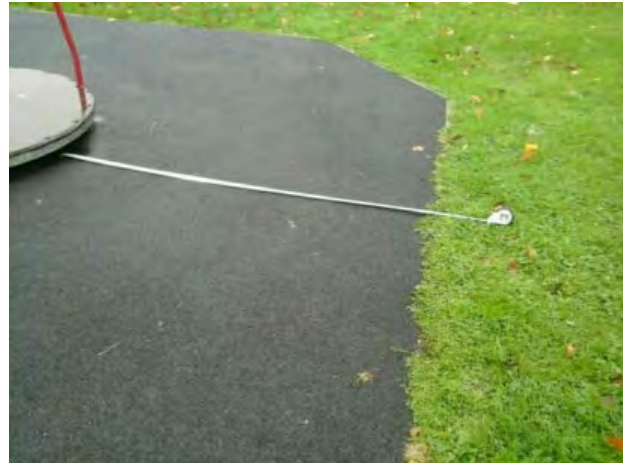
Item: Rotor Play - Roundabout
Manufacturer: Hags SMP

Finding: The surfacing dimensions do not meet with the requirements of BS EN 1176

Action: We consider this to be a low risk failure and no remedial action is recommended - monitor use

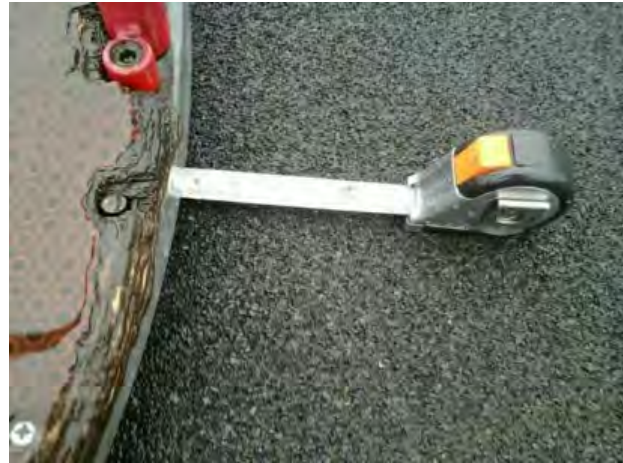
Item: Rotor Play - Roundabout
Manufacturer: Hags SMP

Finding: The ground clearance is not maintained under the roundabout level for 300mm as required by BS EN 1176 Part 5

Action: Monitor Use

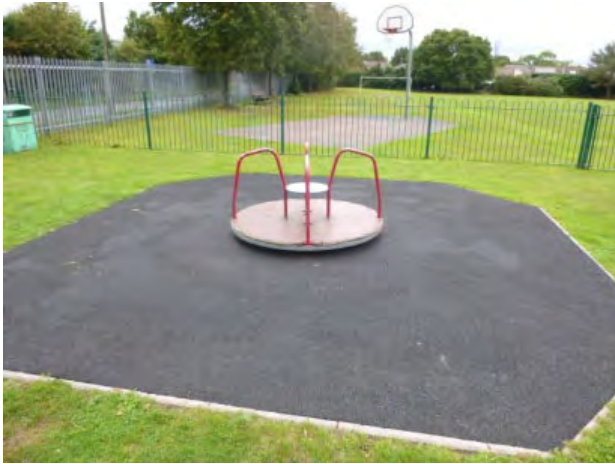
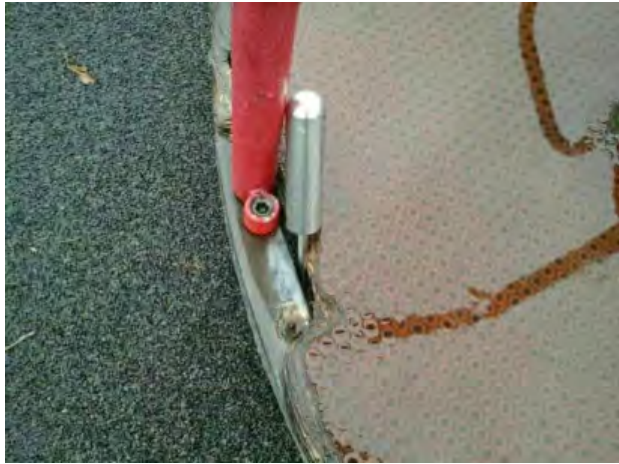
Item: Rotor Play - Roundabout
Manufacturer: Hags SMP

Finding: There is/are finger entrapment/s in the platform

Action: Monitor use

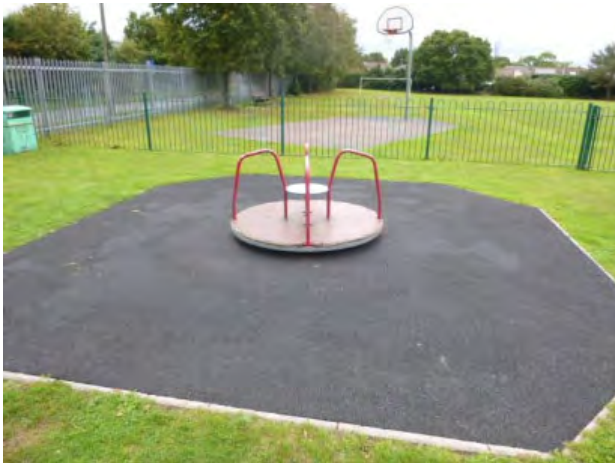
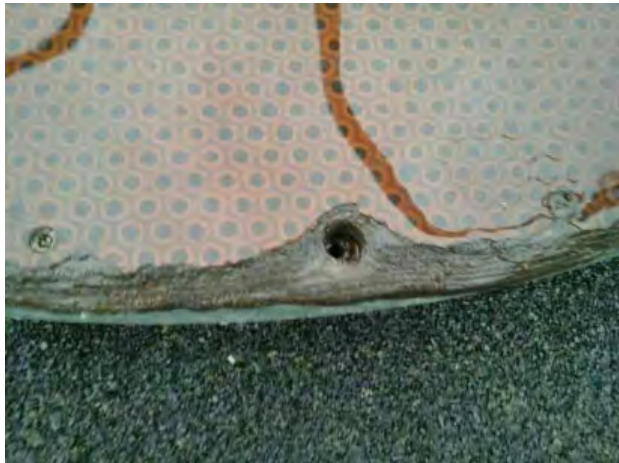
Item: Rotor Play - Roundabout
Manufacturer: Hags SMP

Finding: There is/are missing fixing/s on the item

Action: Replace all missing fixings

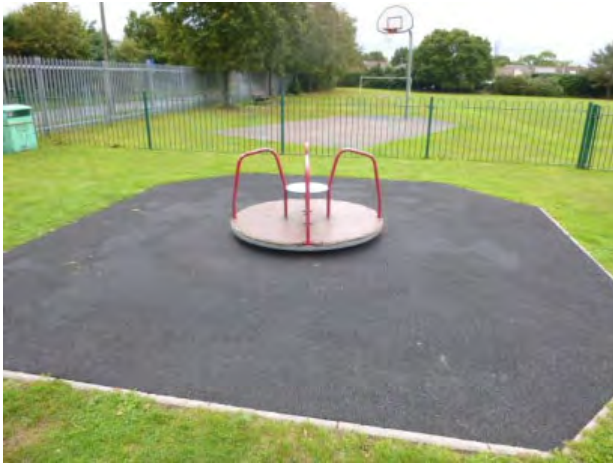
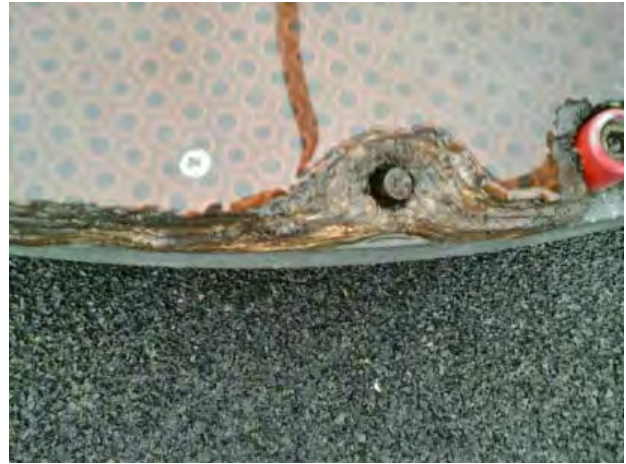
Item: Rotor Play - Roundabout
Manufacturer: Hags SMP

Finding: A number of fixing(s) have worked loose

Action: Secure all loose fixings

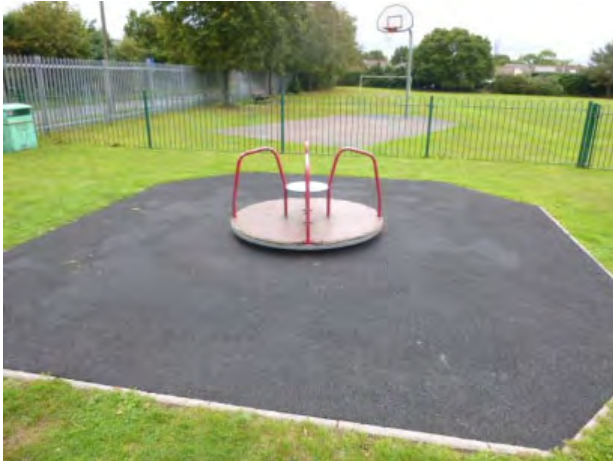
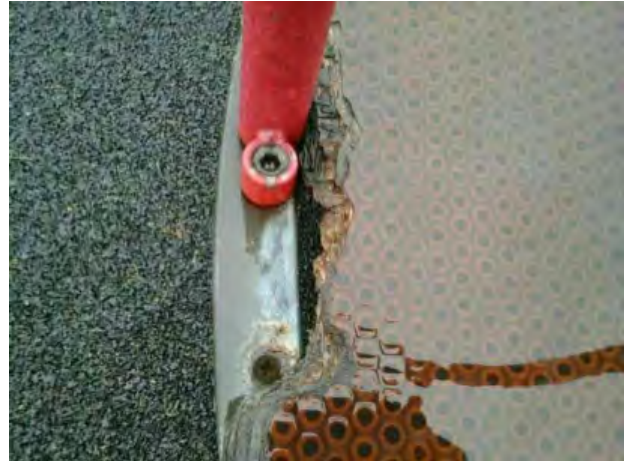
Item: Rotor Play - Roundabout
Manufacturer: Hags SMP

Finding: There are areas or parts of the timber on the structure that have rotted

Action: Replace all affected timbers

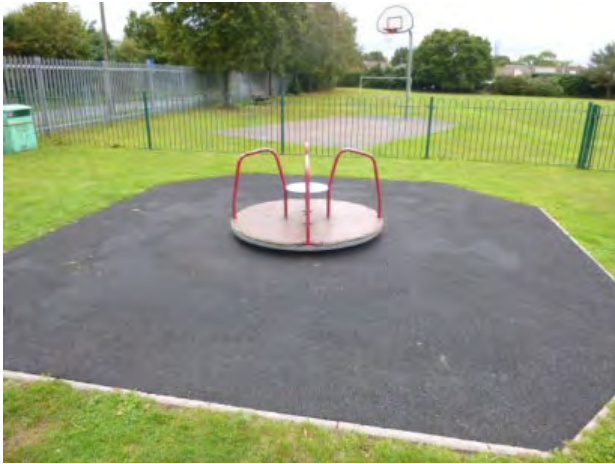
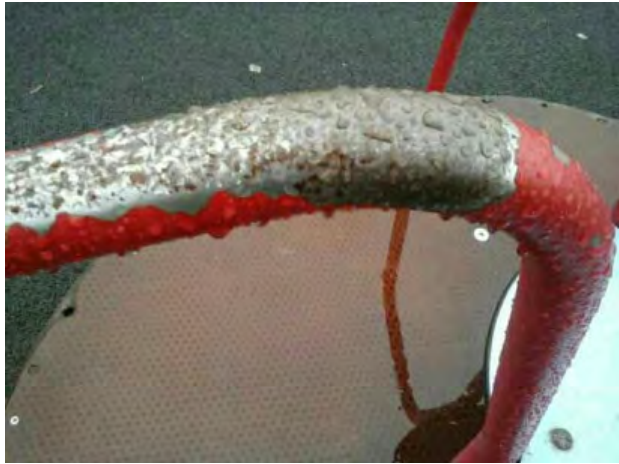
Item: Rotor Play - Roundabout
Manufacturer: Hags SMP

Finding: The paintwork on this item has been damaged or worn exposing the metal underneath which is rusting

Action: Treat any rusting components and repaint

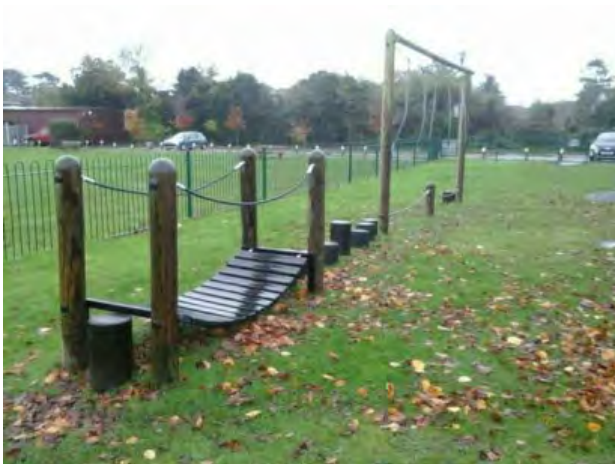
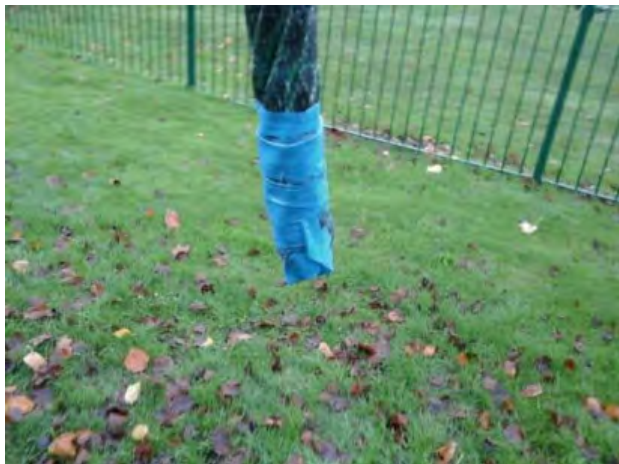
Item: Activity Equipment - Activity Trail
Manufacturer: Not Identified

Finding: The ropes on this item have been taped and we are unable to fully assess the condition of the rope, ensure no wire strands are broken beneath the tape

Action: Repair or replace as required

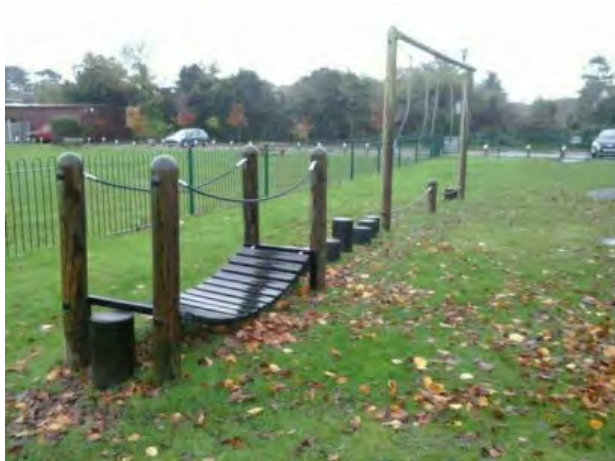
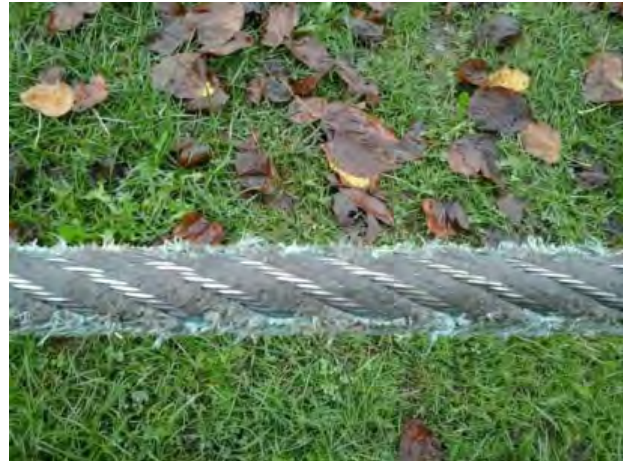
Item: Activity Equipment - Activity Trail
Manufacturer: Not Identified

Finding: The ropes are worn/damaged in places

Action: Monitor for any further deterioration and repair or replace as required

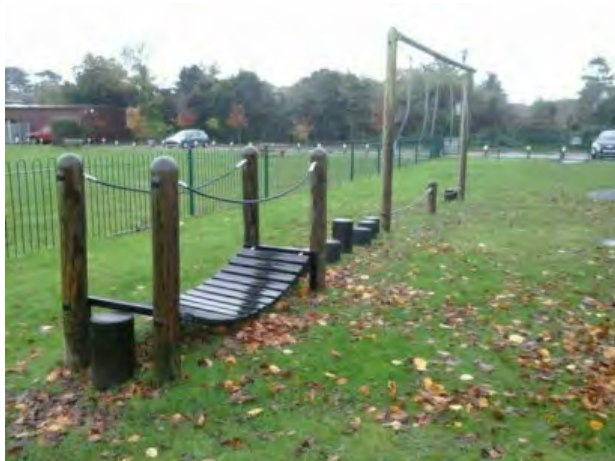
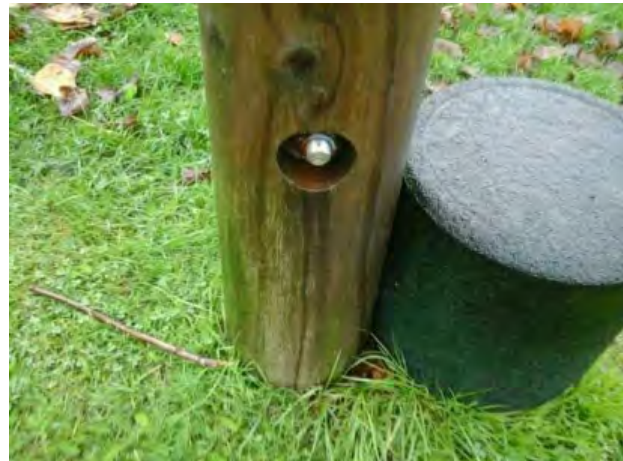
Item: Activity Equipment - Activity Trail
Manufacturer: Not Identified

Finding: There is/are bolt cap covers missing or damaged on the item

Action: Replace missing or damaged bolt cap covers

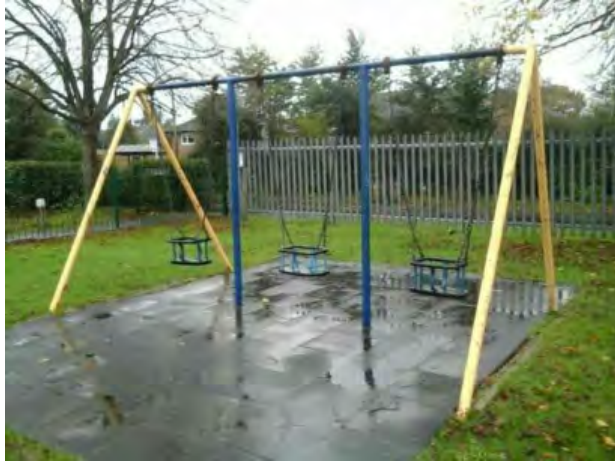
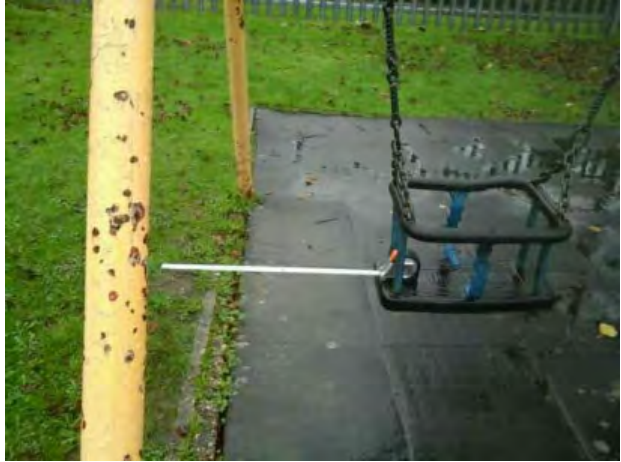
Item: Swings - 3 Bay Swing
Manufacturer: Not Identified

Finding: The seats are too close to the frame as defined in BS EN 1176 Part 2; this is a low risk failure and no remedial action is required

Action: Monitor use

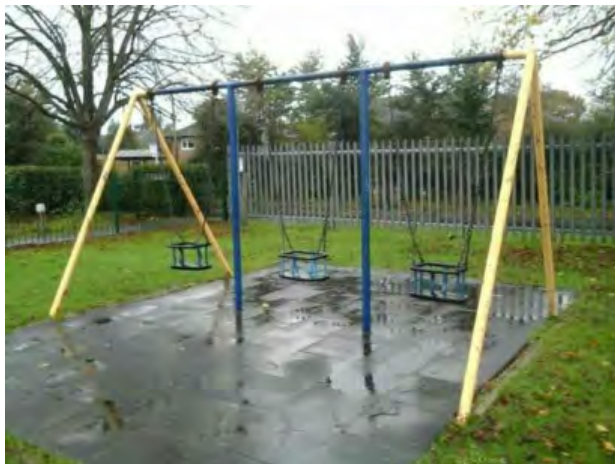
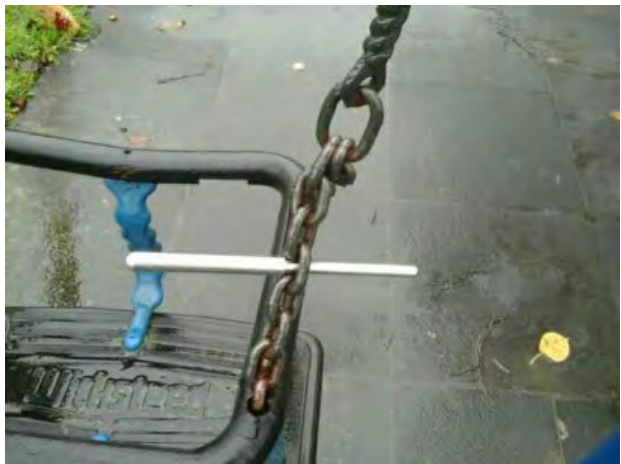
Item: Swings - 3 Bay Swing
Manufacturer: Not Identified

Finding: The chain openings are in excess of the 8.6mm as recommended by BS EN 1176

Action: Monitor use and replace with compliant chains during next maintenance cycle.

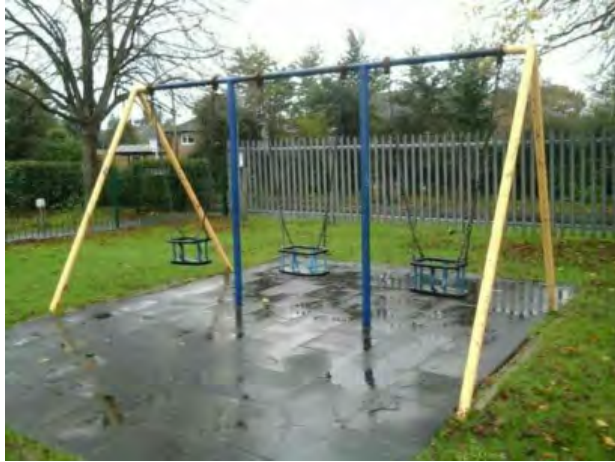
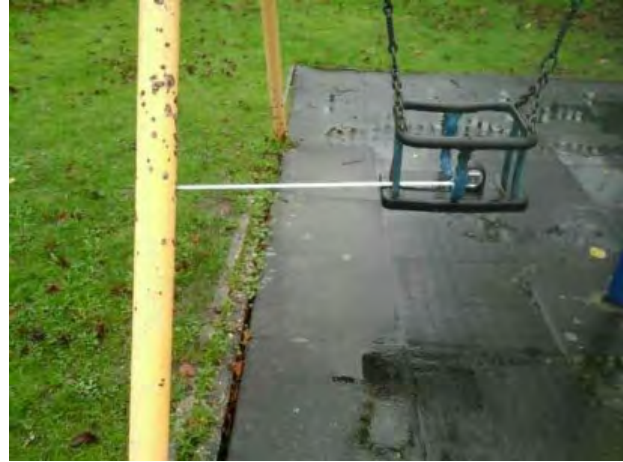
Item: Swings - 3 Bay Swing
Manufacturer: Not Identified

Finding: The surfacing width under each seat is less than 1.75 metres and fails the requirements of BS EN 1176 Part 2

Action: Monitor use

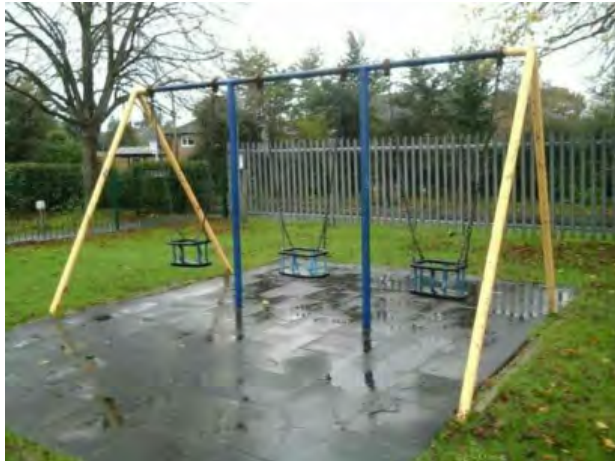
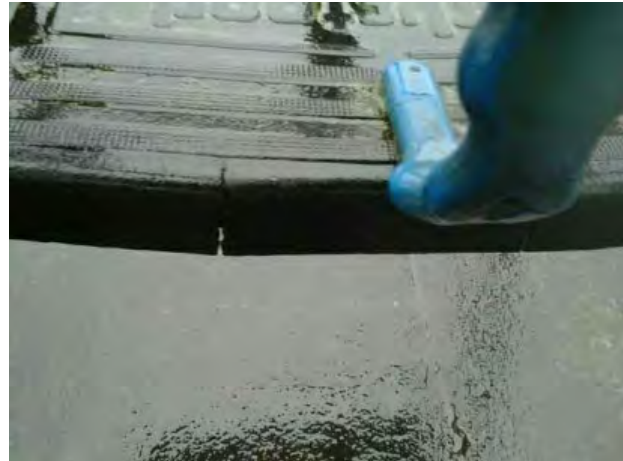
Item: Swings - 3 Bay Swing
Manufacturer: Not Identified

Finding: The seat has minor damage or wear

Action: Monitor for any further deterioration and replace as required

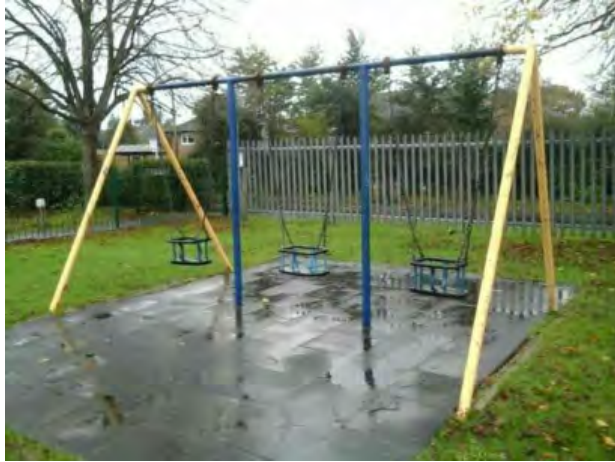
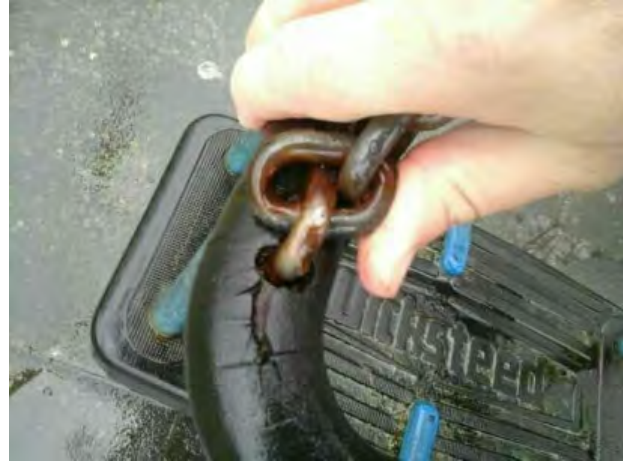
Item: Swings - 3 Bay Swing
Manufacturer: Not Identified

Finding: There is some chain wear

Action: Monitor for any further deterioration and replace when 40% worn

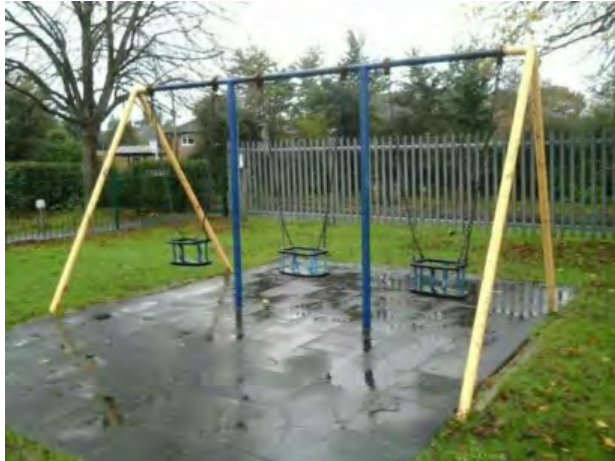
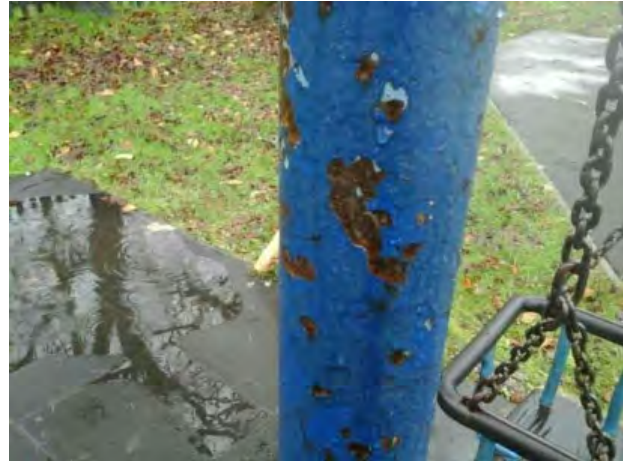
Item: Swings - 3 Bay Swing
Manufacturer: Not Identified

Finding: The paintwork on this item has been damaged or worn exposing the metal underneath which is rusting

Action: Treat any rusting components and repaint

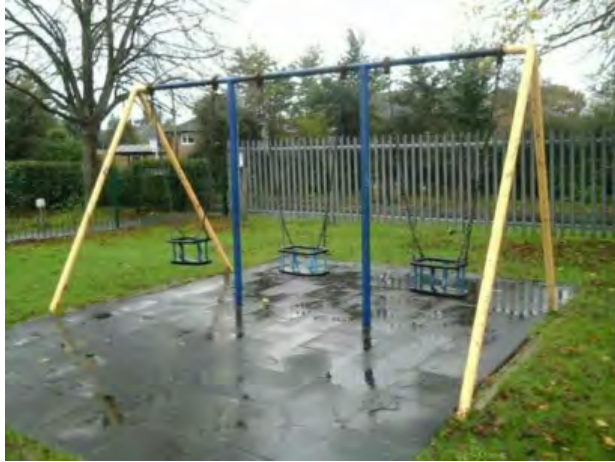
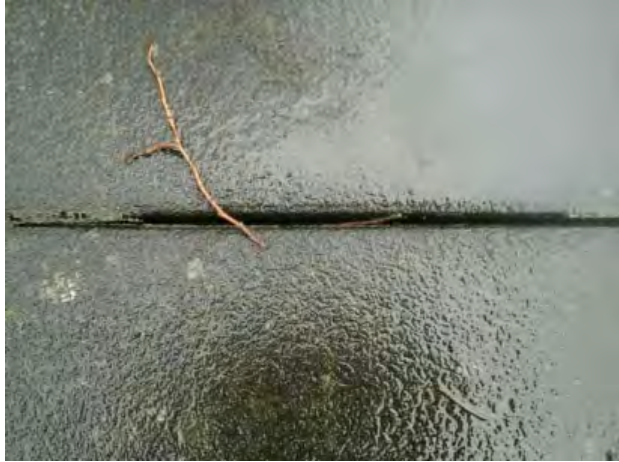
Item: Swings - 3 Bay Swing
Manufacturer: Not Identified

Finding: There are gaps opening in between the tiles

Action: Monitor for any further deterioration and repair as required

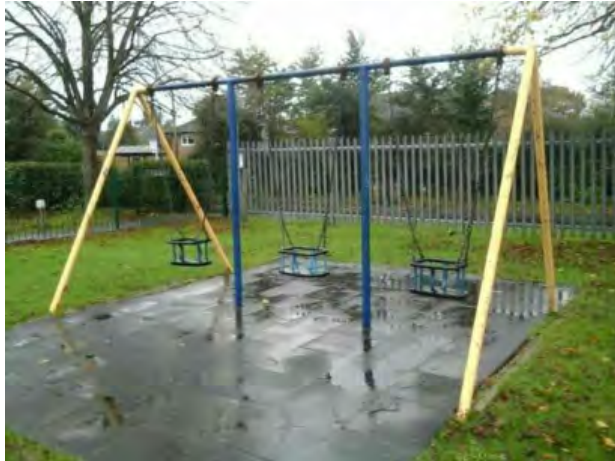
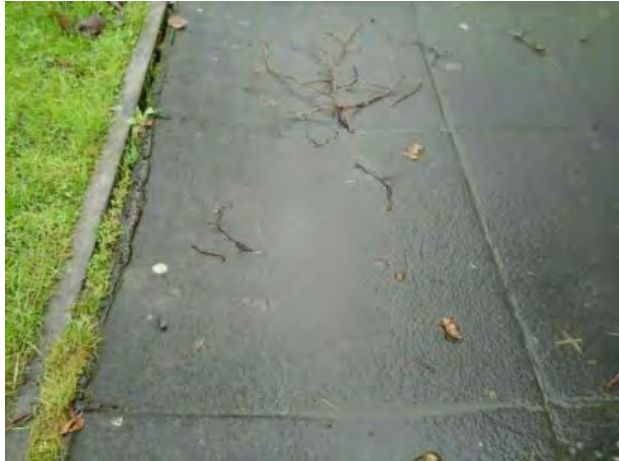
Item: Swings - 3 Bay Swing
Manufacturer: Not Identified

Finding: The surface has subsided in some areas

Action: Monitor for any further deterioration and repair as required

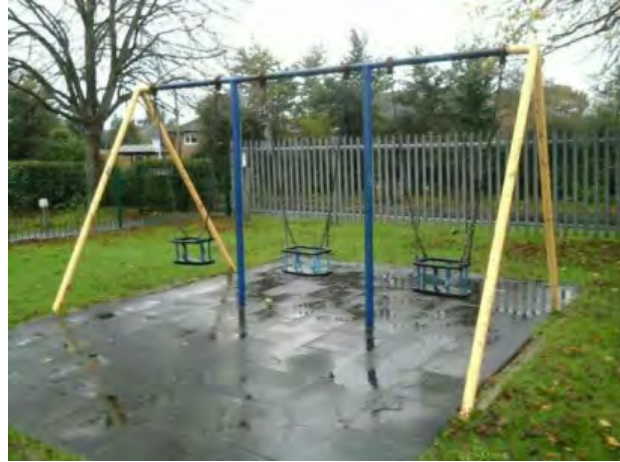
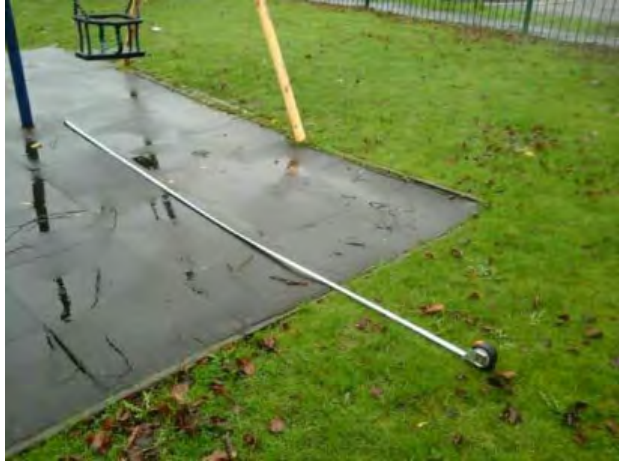
Item: Swings - 3 Bay Swing
Risk Level: L - Low Risk
Manufacturer: Not Identified
Surface: Rubber Tiles

Finding: The surfacing dimensions do not meet with the requirements of BS EN 1176
Action: We consider this to be a low risk failure and no remedial action is recommended - monitor use

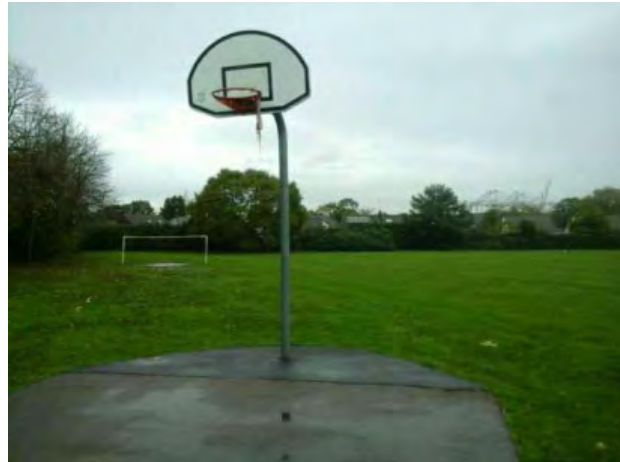
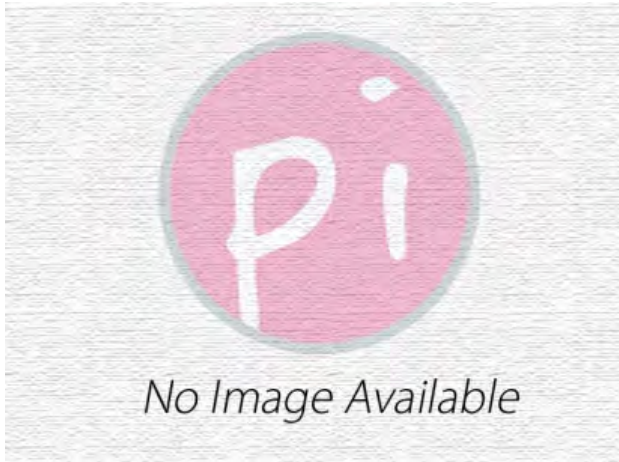
Item: Multi Use Games Area - Basket Ball Goal
Risk Level: V - Very Low Risk
Manufacturer: Sure Shot
Surface: Bitmac

Finding: A clearly visible sign should be provided in a prominent position with the wording as detailed BS EN 15312 - the equipment is not intended for children less than 3 years old - the warning Do not climb on the framework or nets - the warning Do not hang on the ring (if provided) - the warning Do not wear rings or other jewellery - name and telephone number of the administrator - number to call in case of accident
Action: Provide signage to BS EN 15312

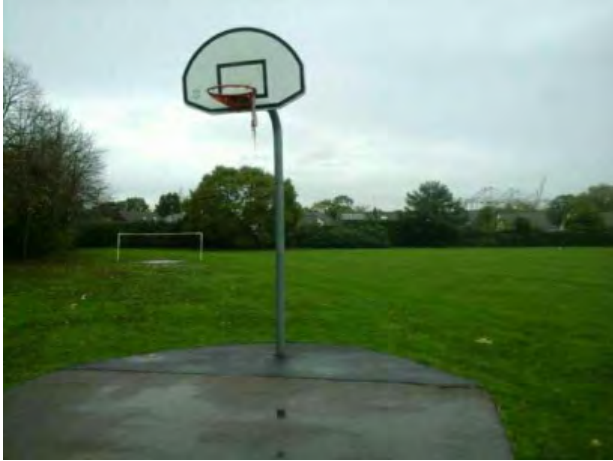
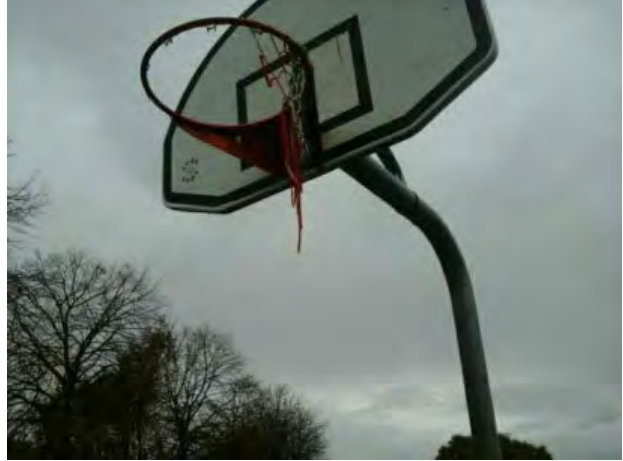
Item: Multi Use Games Area - Basket Ball Goal

Finding: The net is damaged

Action: Replace/remove net
