Annual Inspection Came & Company @ Marchwood over 12's Play Area

Inspection Ref: 79855

Inspected: 14 October 2013 at 1443 Inspector: Didrik Wold RPII Annual Inspector

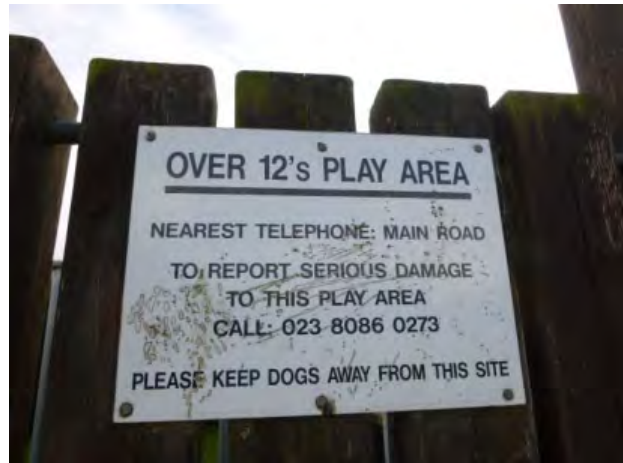
Item: Ancillary Items - Sign
Manufacturer: Owner/Operator
Surface Type: N/A
Equipment Compliance: N/A
Surface Area Compliance: N/A
Ref/Part Number:
Total Findings: 1

This item is satisfactory - no work required

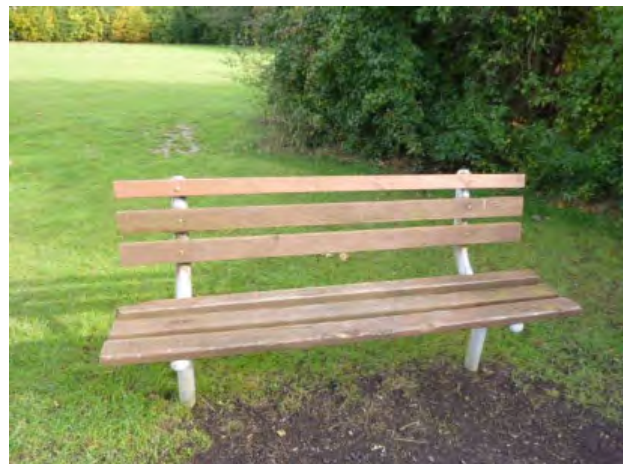
Item: Ancillary Items - Bench - Timber
Manufacturer: Owner/Operator
Surface Type: N/A
Equipment Compliance: N/A
Surface Area Compliance: N/A
Ref/Part Number:
Total Findings: 1

Parts of the timber are rough or splintered on all the benches - Remove all rough or sharp edges

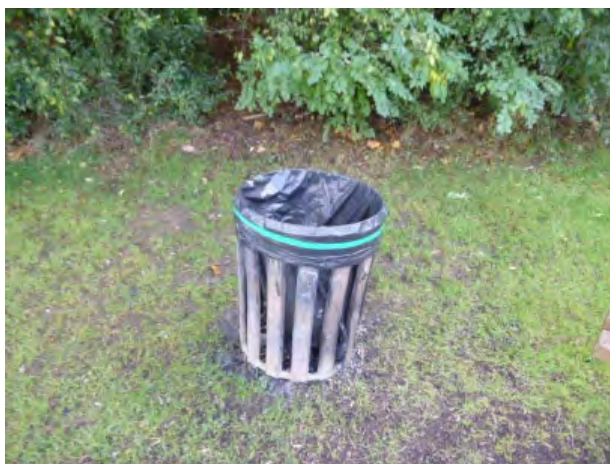
Item: Ancillary Items - Bin - Ground Based
Manufacturer: Owner/Operator
Surface Type: N/A
Equipment Compliance: N/A
Surface Area Compliance: N/A
Ref/Part Number:
Total Findings: 1

This item is satisfactory - no work required

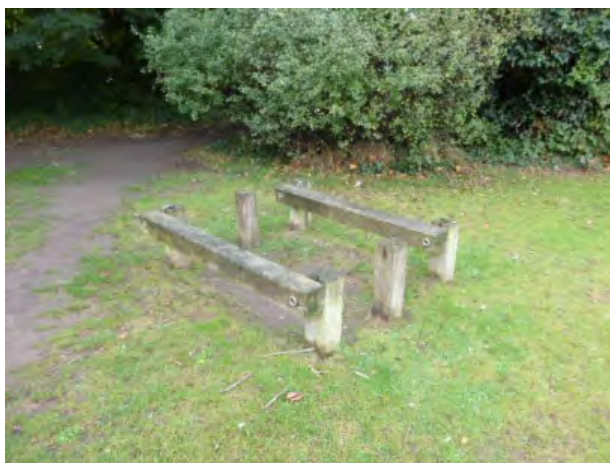
Item: Agility - Hurdles
Manufacturer: Not Identified
Surface Type: Grass
Equipment Compliance: Yes
Surface Area Compliance: Yes
Ref/Part Number:
Total Findings: 2
Life Expectancy: <12 Months

One beam is missing - Replace the beam

The timber on this item has severe rot - Remove and replace all affected timber sections

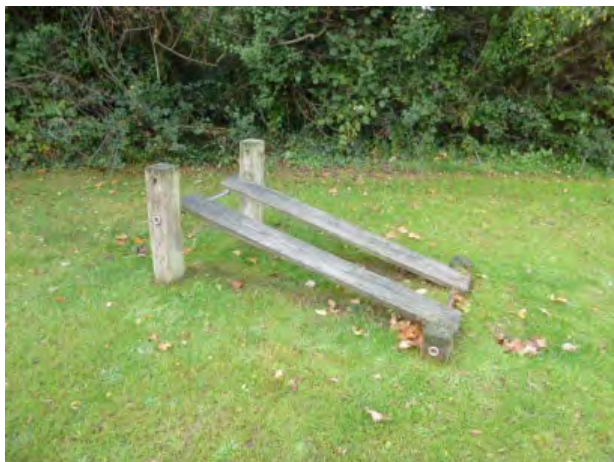
Item: Agility - Sit Up
Manufacturer: Not Identified
Surface Type: Grass
Equipment Compliance: Yes
Surface Area Compliance: Yes
Ref/Part Number:
Total Findings: 2
Life Expectancy: 1 - 3 Years

A board is missing - Replace the board

There is some evidence of rot in the timber - Monitor for any further deterioration and replace as required

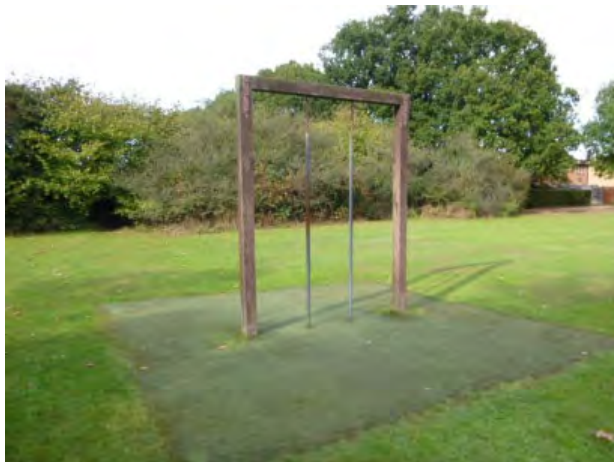
Item: Agility - Vertical Pole Climb
Manufacturer: Not Identified
Surface Type: Carpet System
Equipment Compliance: No
Surface Area Compliance: Yes
Ref/Part Number:
Total Findings: 3
Life Expectancy: 1 - 3 Years

The chain openings are in excess of the 8.6mm recommended by BS EN 1176 - Monitor use and replace with compliant chains during next maintenance cycle.

Parts of the timber are rough or splintered - Remove all rough or sharp edges

The item is loose in its foundation - Reinstall item to secure.

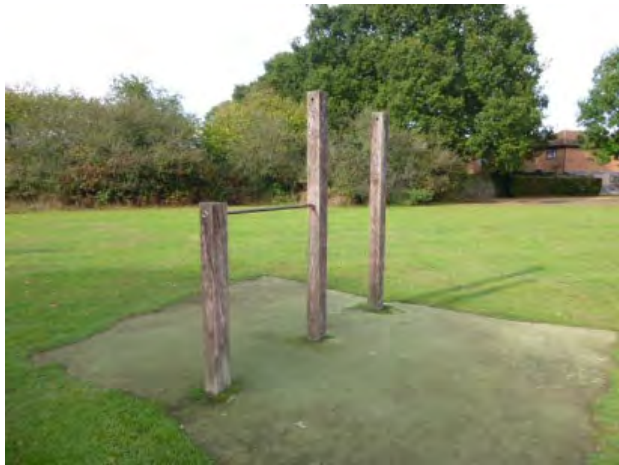
Item: Other - Pull Up Bars
Manufacturer: Not Identified
Surface Type: Carpet System
Equipment Compliance: Yes
Surface Area Compliance: Yes
Ref/Part Number:
Total Findings: 3
Life Expectancy: 1 - 3 Years

There is some evidence of rot in the timber - Monitor for any further deterioration and replace as required

A bar is missing - Replace the bar

Parts of the timber are rough or splintered - Remove all rough or sharp edges

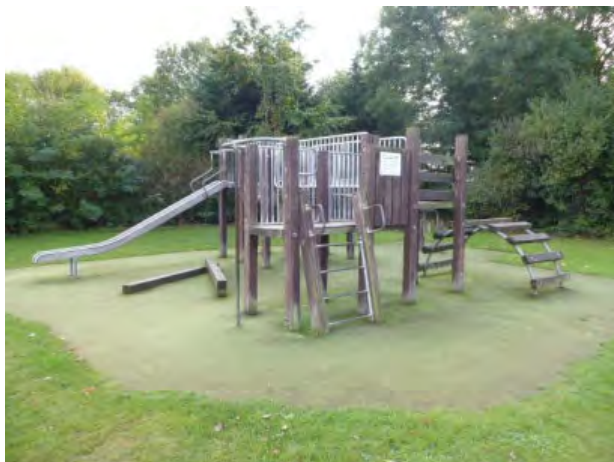
Item: Agility - Multi Play with Slide
Manufacturer: Not Identified
Surface Type: Carpet System
Equipment Compliance: No
Surface Area Compliance: Yes
Ref/Part Number:
Total Findings: 8
Life Expectancy: 1 - 3 Years

There is some evidence of rot in the timber - Monitor for any further deterioration and replace as required

The timber beams form a hard object within the falling space of the equipment in contravention of the requirements of BS EN 1176 Part 1 - Monitor use

A number of fixings have worked loose - Secure the fixings

There is a crack in the sliding surface - Monitor to ensure it doesn't lift up to create a sharp edge

The slide start doesn't meet the requirements for guarding section - Monitor use

The item fails to meet the requirements of BS EN 1176:2008 for head and neck entrapment in the barriers and/or steps. - Monitor use

There is a finger entrapment in between the timbers - Monitor Use

Some of the timbers are damaged in places - Replace the timbers

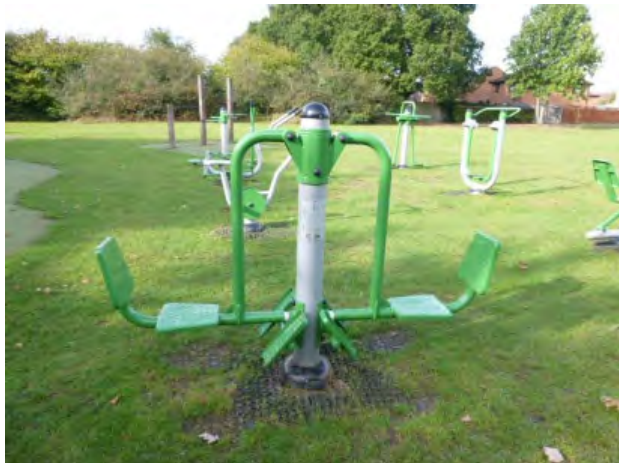
Item: Adult Fitness Equipment - Leg Press
Manufacturer: Caloo
Surface Type: Grass Matrix Tiles
Equipment Compliance: N/A
Surface Area Compliance: N/A
Ref/Part Number:
Total Findings: 1

This item is satisfactory - no work required

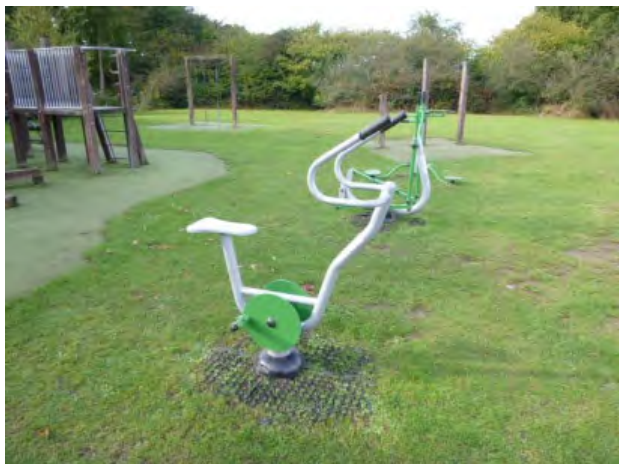
Item: Adult Fitness Equipment - Bike
Manufacturer: Caloo
Surface Type: Grass Matrix Tiles
Equipment Compliance: N/A
Surface Area Compliance: N/A
Ref/Part Number:
Total Findings: 1

This item is satisfactory - no work required

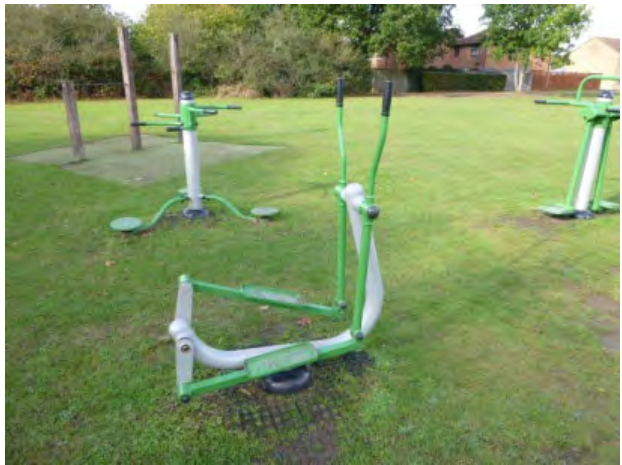
Item: Adult Fitness Equipment - Cross Rider
Manufacturer: Caloo
Surface Type: Grass Matrix Tiles
Equipment Compliance: N/A
Surface Area Compliance: N/A
Ref/Part Number:
Total Findings: 1

Bolt cap covers are missing - Replace missing bolt cap covers

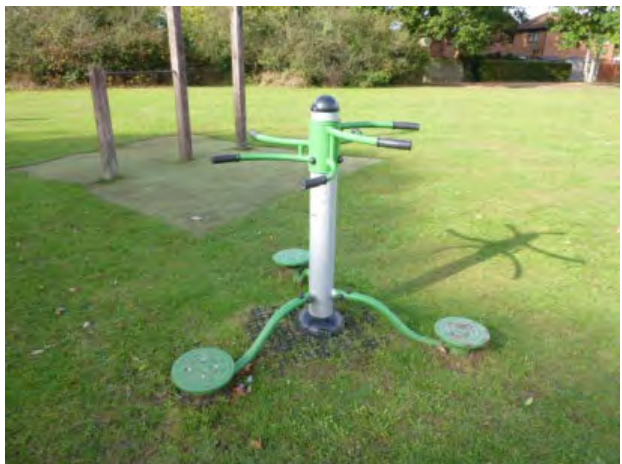
Item: Adult Fitness Equipment - Body Twister
Manufacturer: Caloo
Surface Type: Grass Matrix Tiles
Equipment Compliance: N/A
Surface Area Compliance: N/A
Ref/Part Number:
Total Findings: 1

This item is satisfactory - no work required

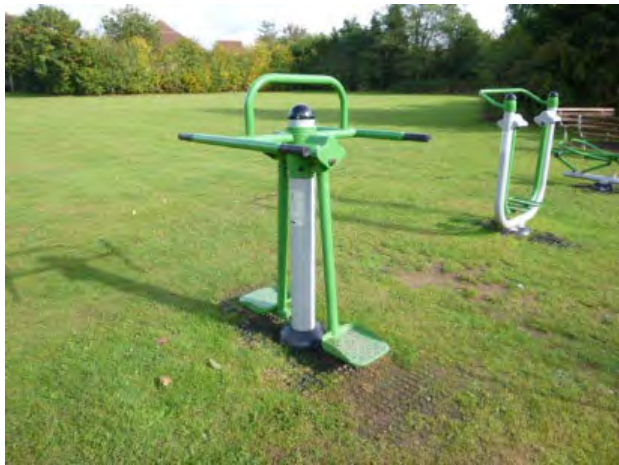
Item: Adult Fitness Equipment - Air Skier
Manufacturer: Caloo
Surface Type: Grass Matrix Tiles
Equipment Compliance: N/A
Surface Area Compliance: N/A
Ref/Part Number:
Total Findings: 1

There is minor damage and the paint is rusty where the bar hits the supporting unit - Repair and repaint

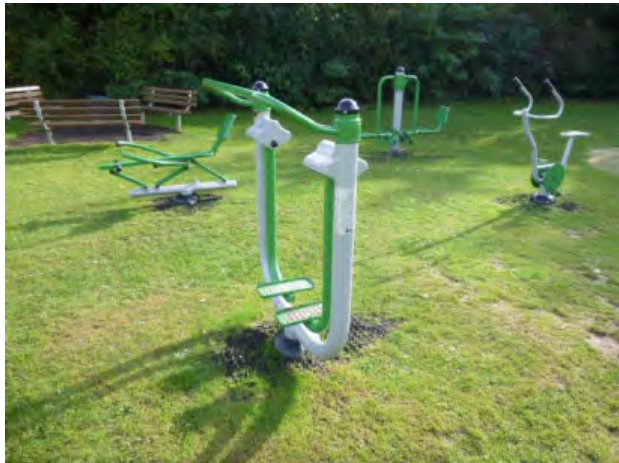
Item: Adult Fitness Equipment - Air Walker
Manufacturer: Caloo
Surface Type: Grass Matrix Tiles
Equipment Compliance: N/A
Surface Area Compliance: N/A
Ref/Part Number:
Total Findings: 2

Fixings have worked loose at the top of the posts - Secure the fixings

There is minor damage and the paint is rusty where the bar hits the supporting unit - Repair and repaint

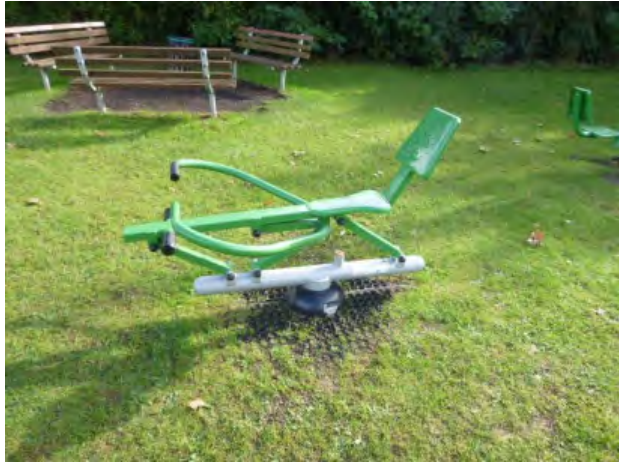
Item: Adult Fitness Equipment - Rower
Manufacturer: Caloo
Surface Type: Grass Matrix Tiles
Equipment Compliance: N/A
Surface Area Compliance: N/A
Ref/Part Number:
Total Findings: 2

A hand grip rubber is missing - Replace the hand grip

There is some evidence of rust around the weld point - Monitor for any further deterioration and repaint as required

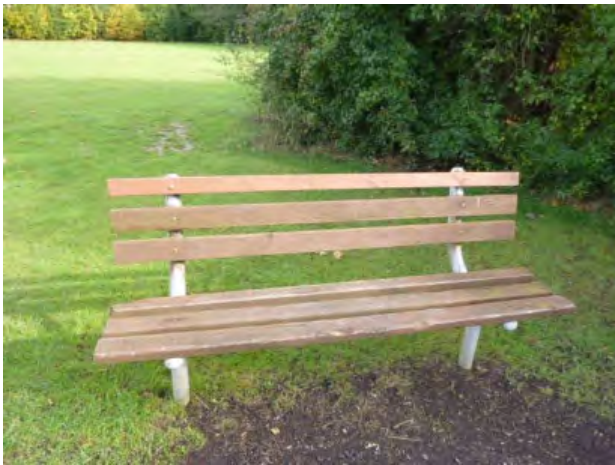
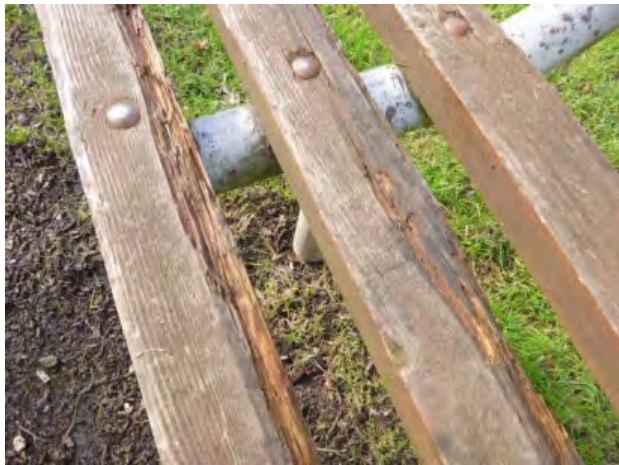
Item:	Ancillary Items - Bench - Timber	Risk Level:	L - Low Risk
Manufacturer:	Owner/Operator	Surface:	N/A

Finding: Parts of the timber are rough or splintered on all the benches
Action: Remove all rough or sharp edges

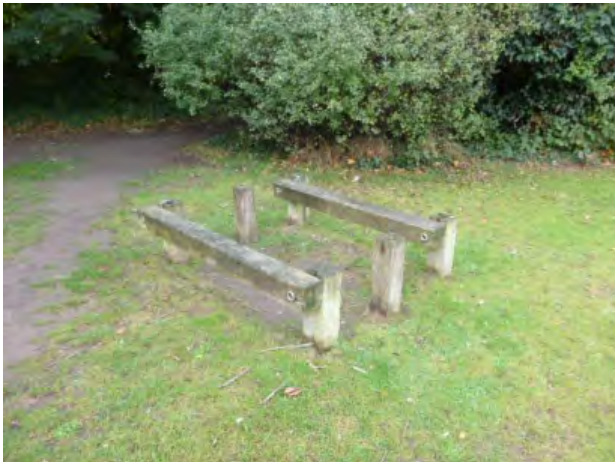
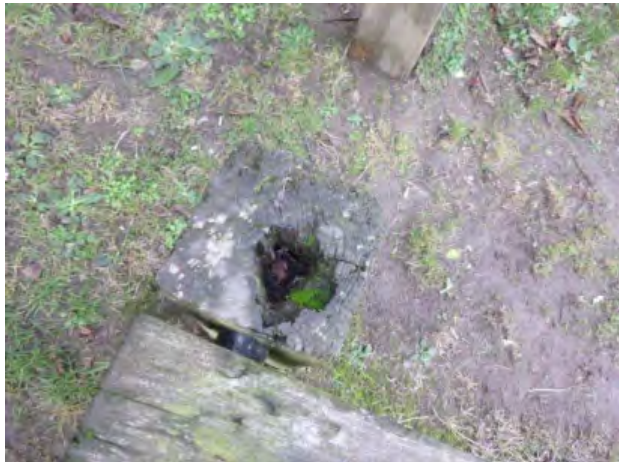
Item:	Agility - Hurdles	Risk Level:	V - Very Low Risk
Manufacturer:	Not Identified	Surface:	Grass

Finding: One beam is missing
Action: Replace the beam

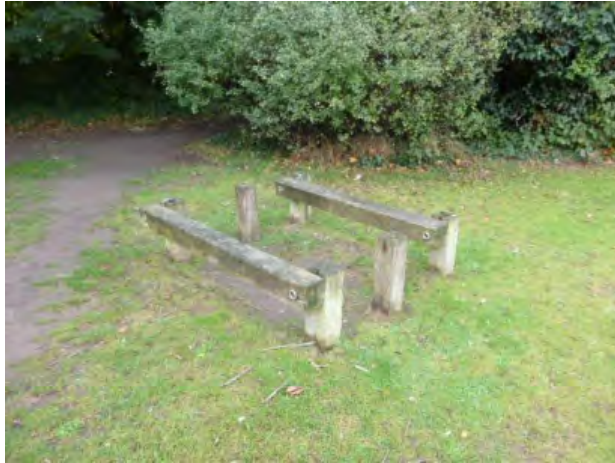
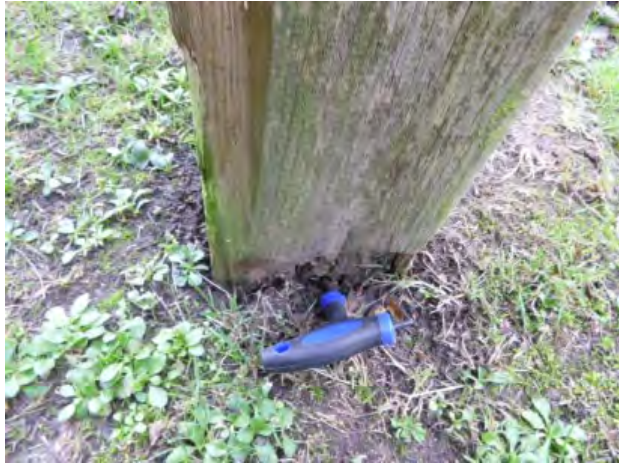
Item: Agility - Hurdles
Manufacturer: Not Identified

Finding: The timber on this item has severe rot

Action: Remove and replace all affected timber sections

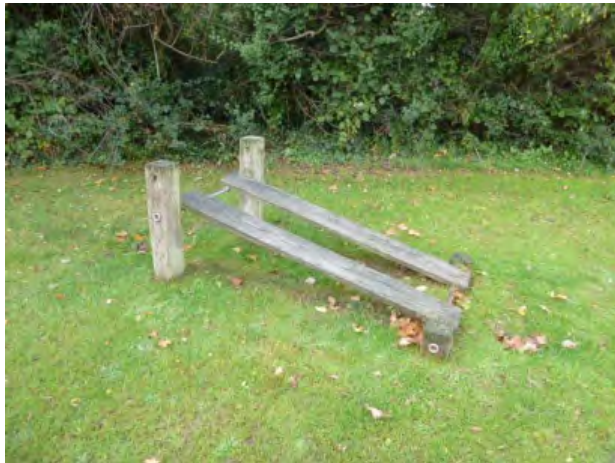
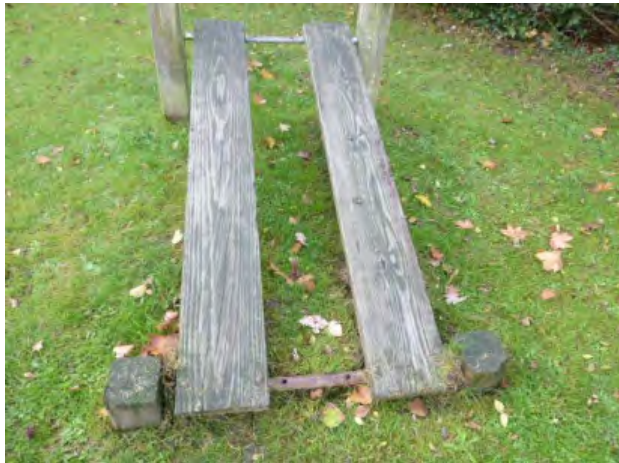
Item: Agility - Sit Up
Manufacturer: Not Identified

Finding: A board is missing

Action: Replace the board

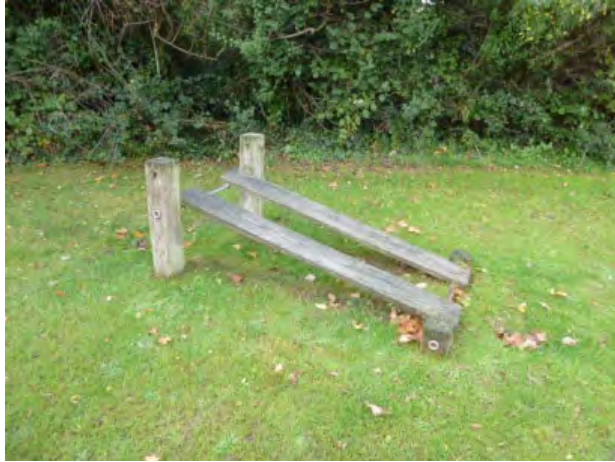
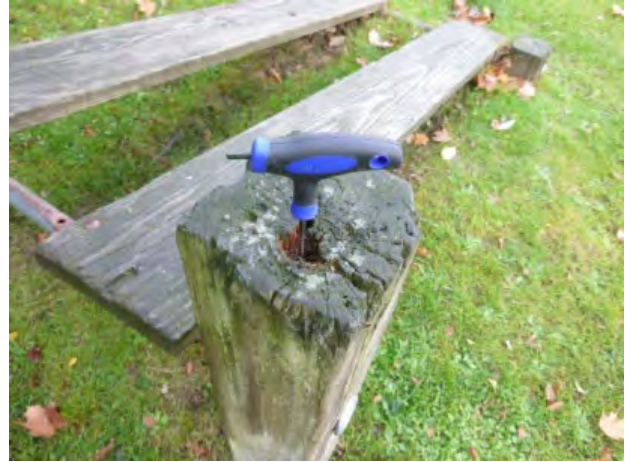
Item: Agility - Sit Up
Manufacturer: Not Identified

Finding: There is some evidence of rot in the timber

Action: Monitor for any further deterioration and replace as required

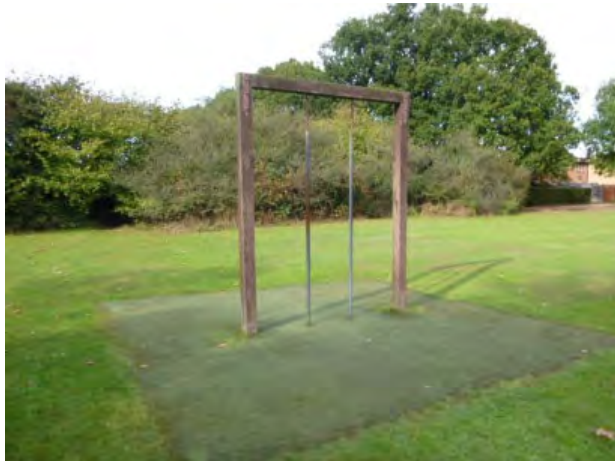
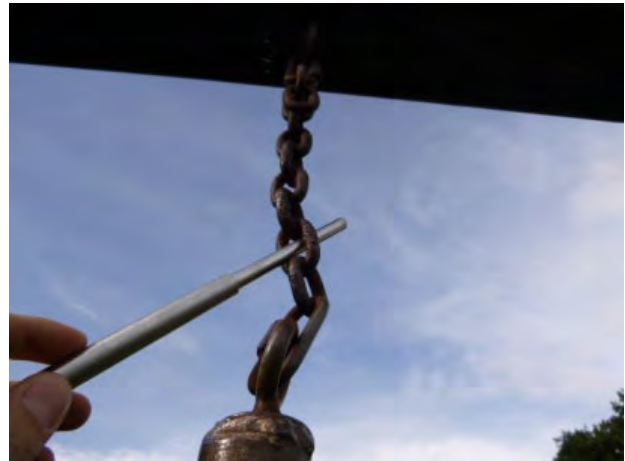
Item: Agility - Vertical Pole Climb
Manufacturer: Not Identified

Finding: The chain openings are in excess of the 8.6mm recommended by BS EN 1176

Action: Monitor use and replace with compliant chains during next maintenance cycle.

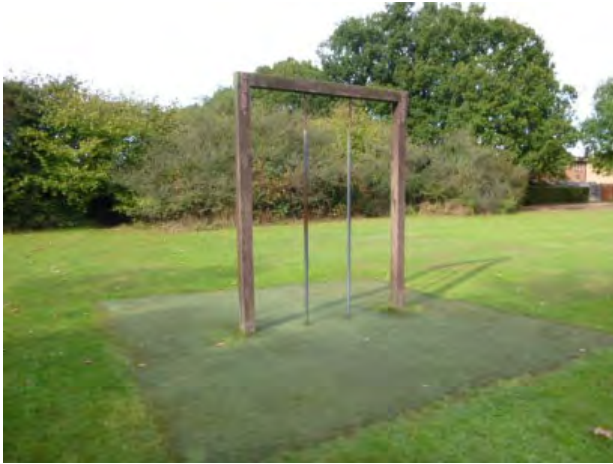
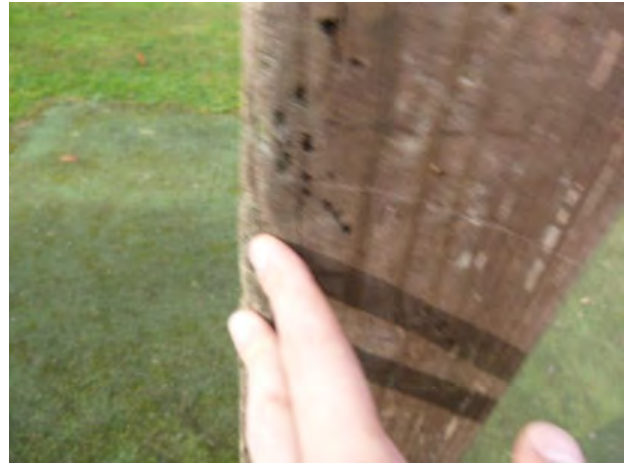
Item: Agility - Vertical Pole Climb
Manufacturer: Not Identified

Finding: Parts of the timber are rough or splintered

Action: Remove all rough or sharp edges

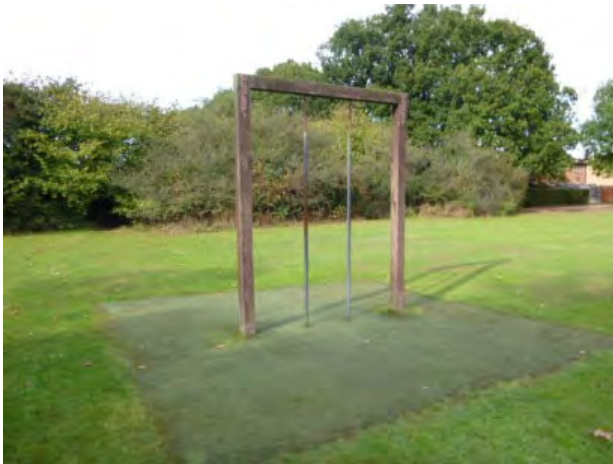
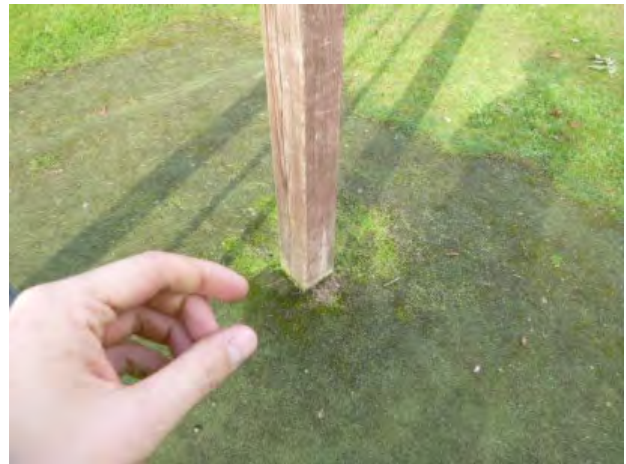
Item: Agility - Vertical Pole Climb
Manufacturer: Not Identified

Finding: The item is loose in its foundation

Action: Reinstall item to secure.

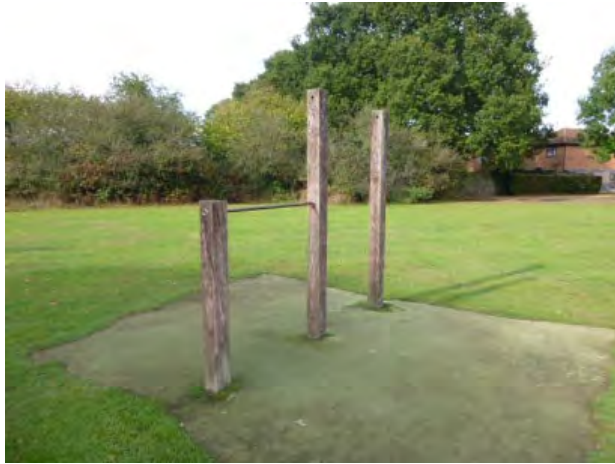
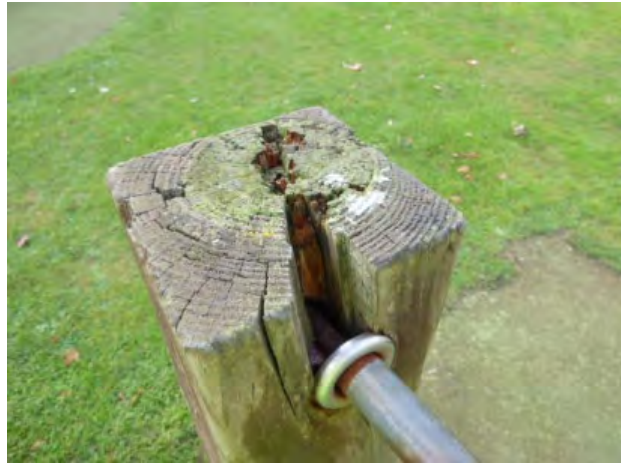
Item: Other - Pull Up Bars
Manufacturer: Not Identified

Finding: There is some evidence of rot in the timber

Action: Monitor for any further deterioration and replace as required

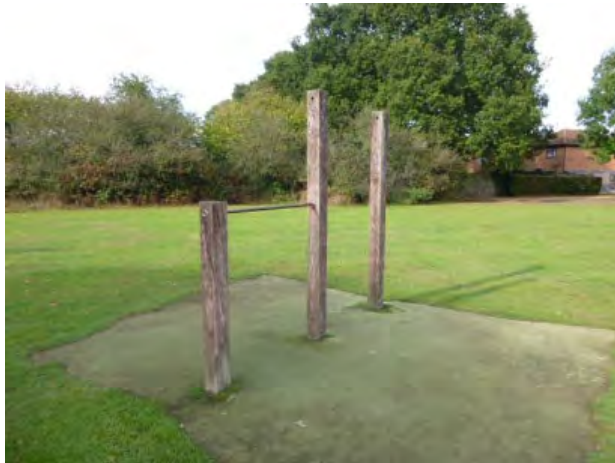
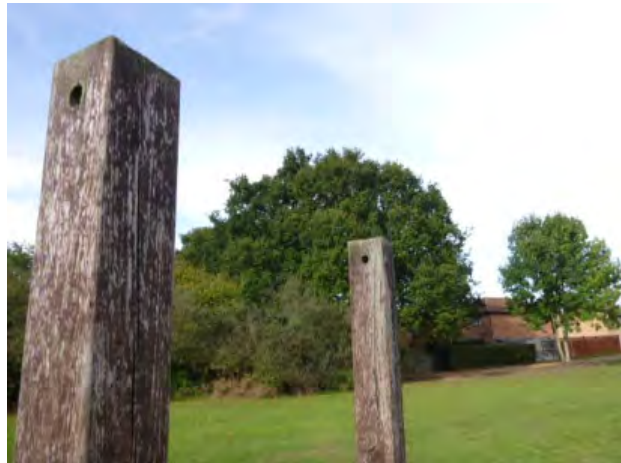
Item: Other - Pull Up Bars
Manufacturer: Not Identified

Finding: A bar is missing

Action: Replace the bar

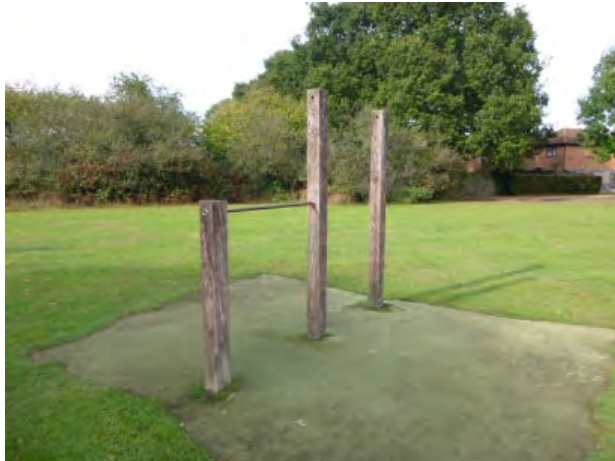
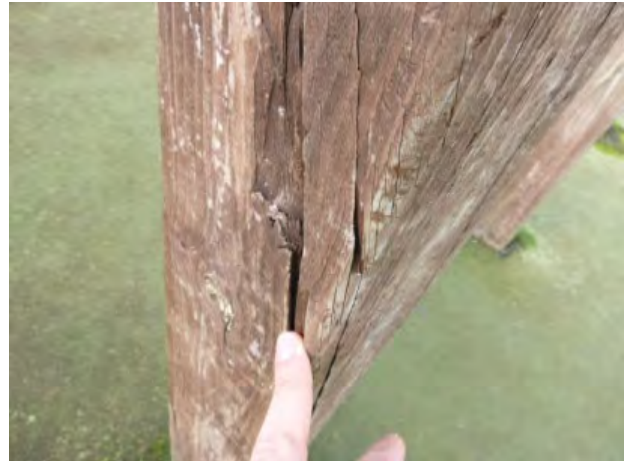
Item: Other - Pull Up Bars
Manufacturer: Not Identified

Finding: Parts of the timber are rough or splintered

Action: Remove all rough or sharp edges

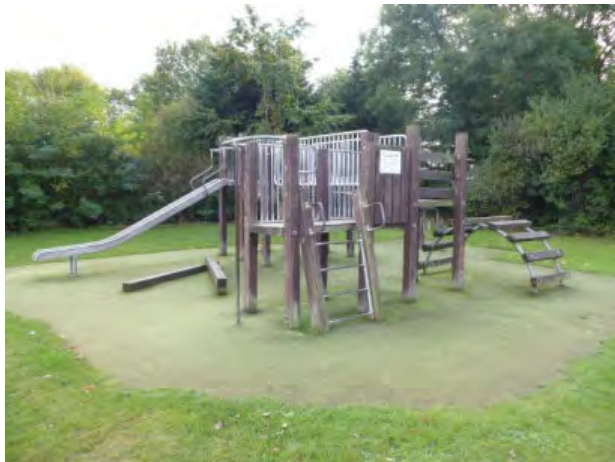
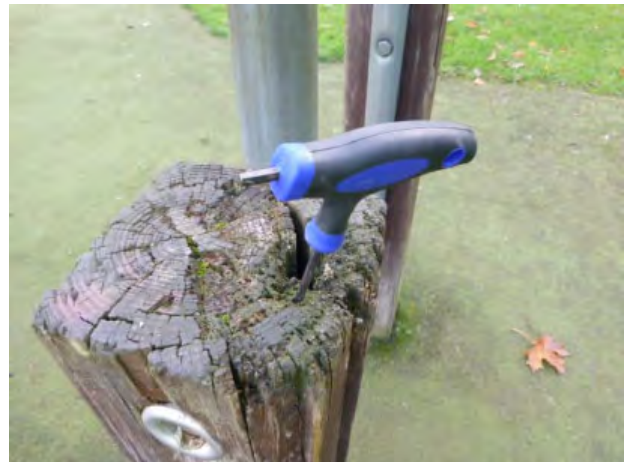
Item: Agility - Multi Play with Slide
Manufacturer: Not Identified

Finding: There is some evidence of rot in the timber

Action: Monitor for any further deterioration and replace as required

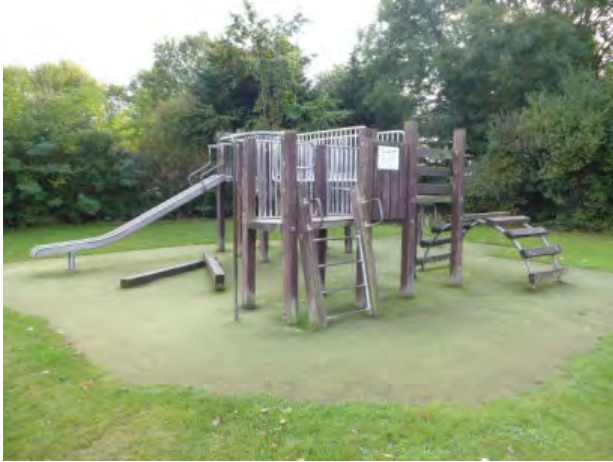
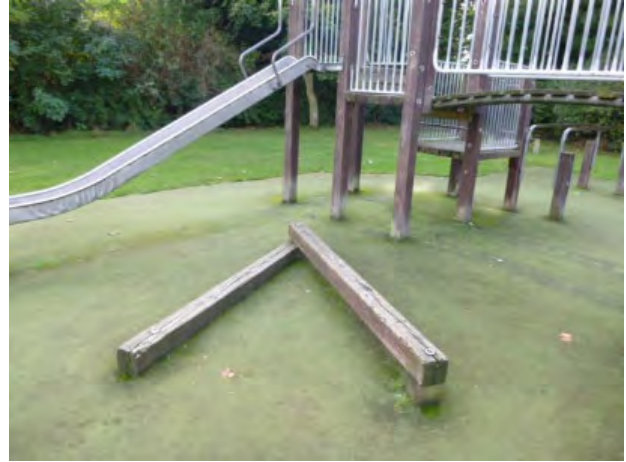
Item: Agility - Multi Play with Slide
Manufacturer: Not Identified

Finding: The timber beams form a hard object within the falling space of the equipment in contravention of the requirements of BS EN 1176 Part 1

Action: Monitor use

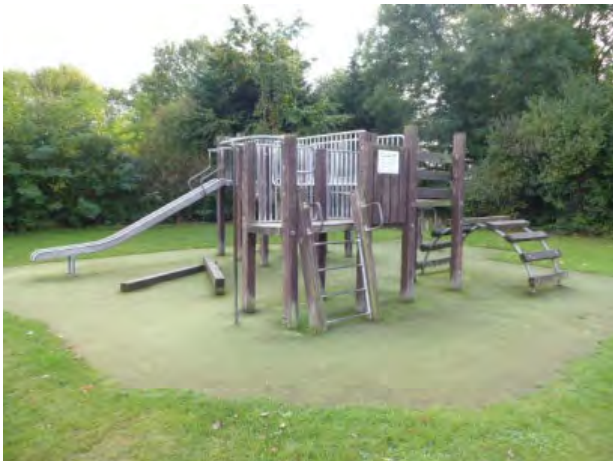
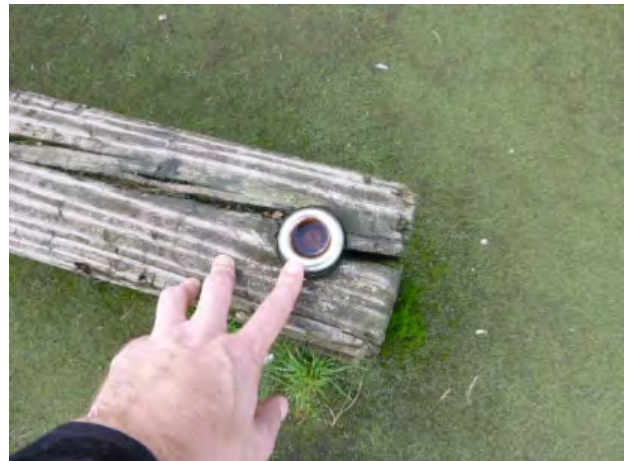
Item: Agility - Multi Play with Slide
Manufacturer: Not Identified

Finding: A number of fixings have worked loose

Action: Secure the fixings

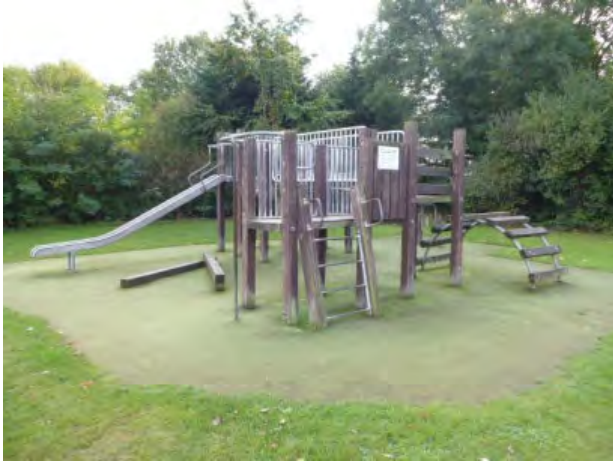
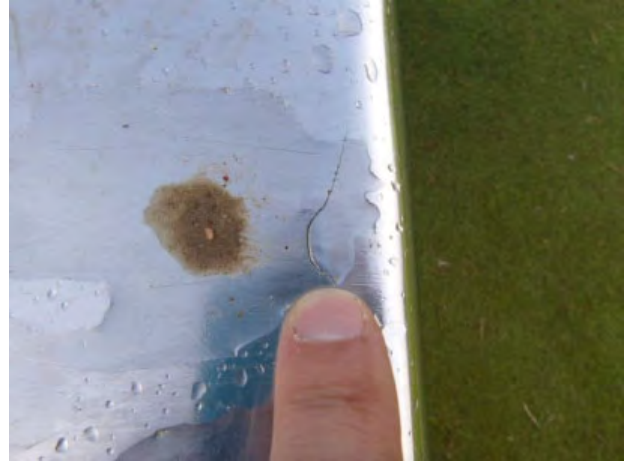
Item: Agility - Multi Play with Slide
Manufacturer: Not Identified

Finding: There is a crack in the sliding surface

Action: Monitor to ensure it doesn't lift up to create a sharp edge

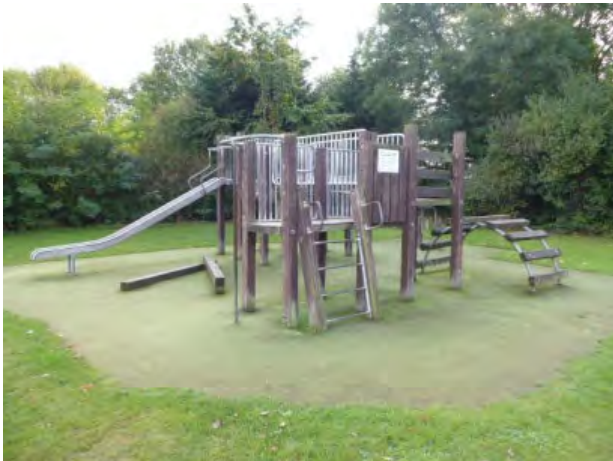
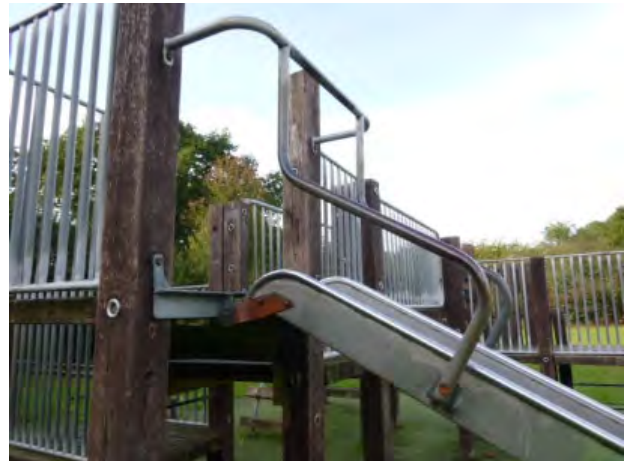
Item: Agility - Multi Play with Slide
Manufacturer: Not Identified

Finding: The slide start doesn't meet the requirements for guarding section

Action: Monitor use

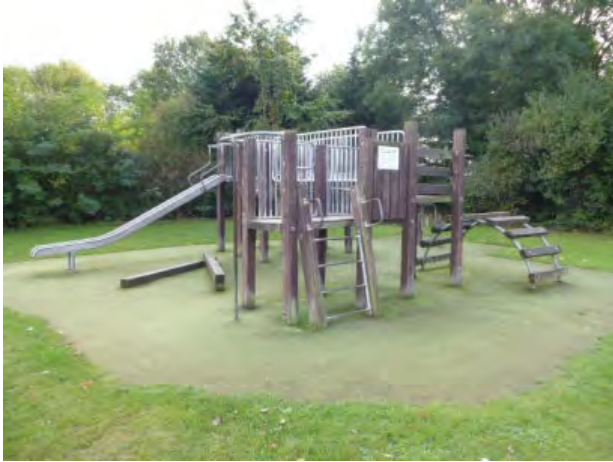
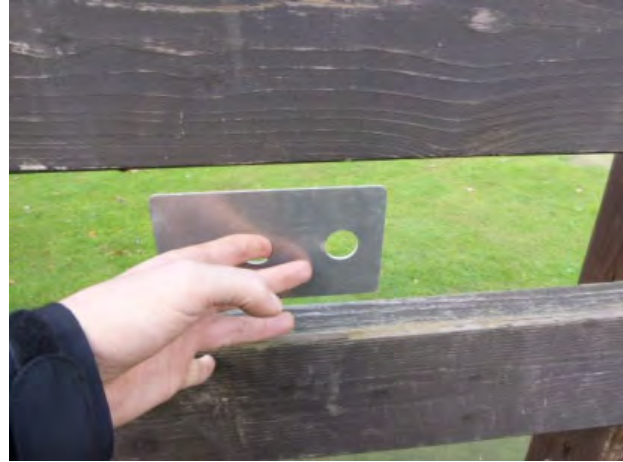
Item: Agility - Multi Play with Slide
Manufacturer: Not Identified

Finding: The item fails to meet the requirements of BS EN 1176:2008 for head and neck entrapment in the barriers and/or steps.

Action: Monitor use

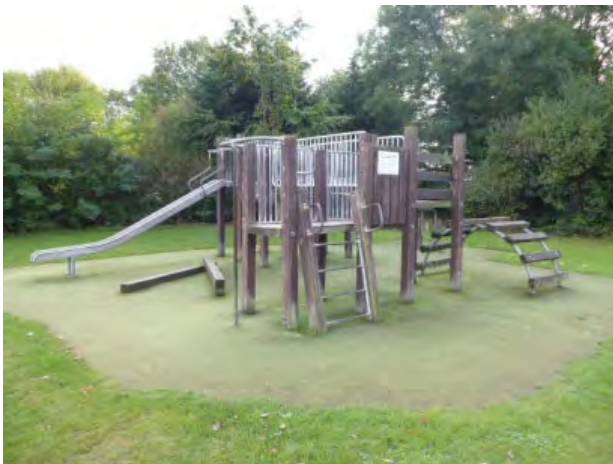
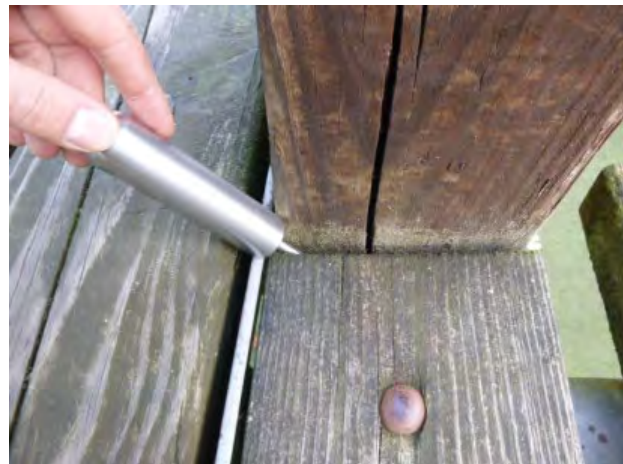
Item: Agility - Multi Play with Slide
Manufacturer: Not Identified

Finding: There is a finger entrapment in between the timbers

Action: Monitor Use

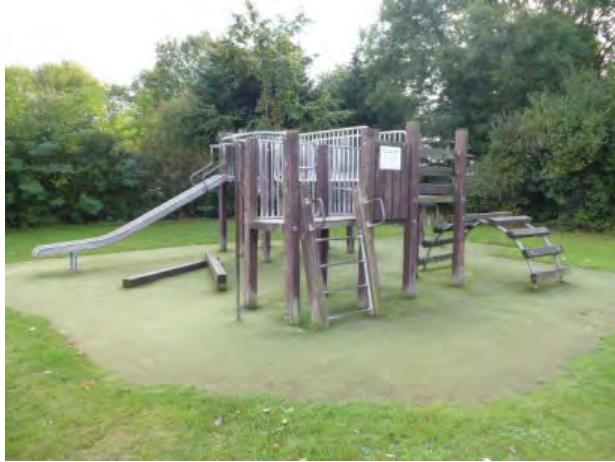
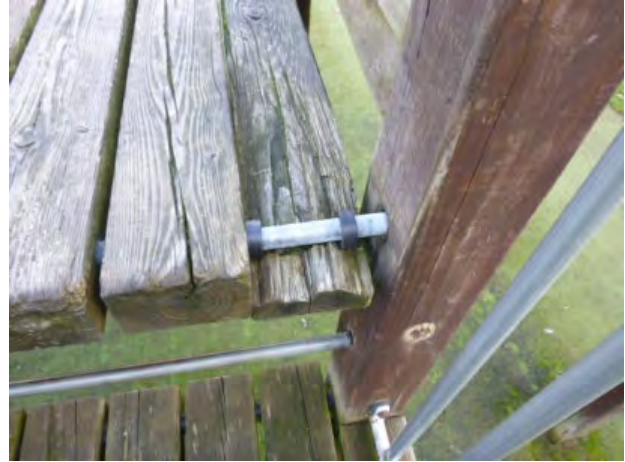
Item: Agility - Multi Play with Slide
Manufacturer: Not Identified

Finding: Some of the timbers are damaged in places

Action: Replace the timbers

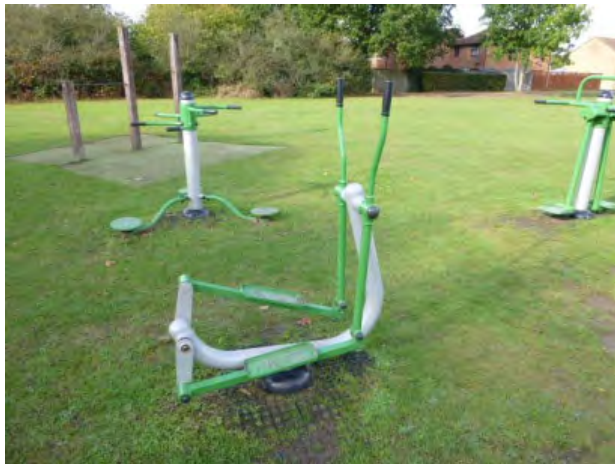
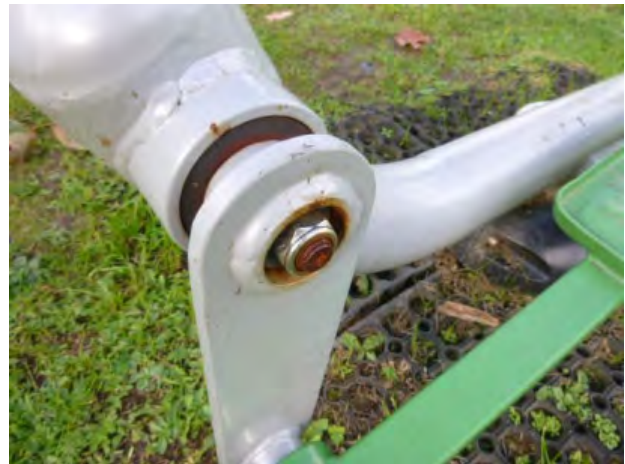
Item: Adult Fitness Equipment - Cross Rider
Manufacturer: Caloo

Finding: Bolt cap covers are missing

Action: Replace missing bolt cap covers

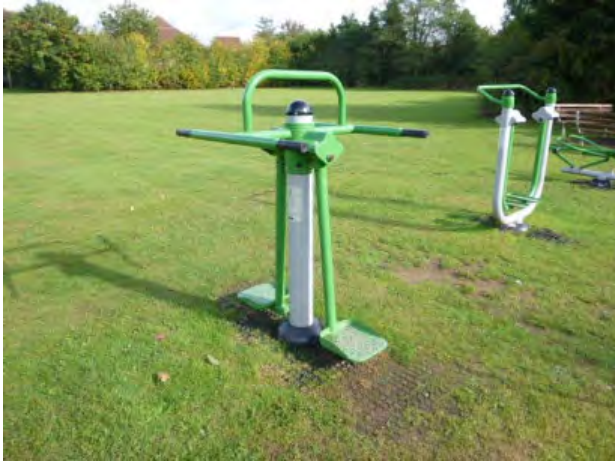
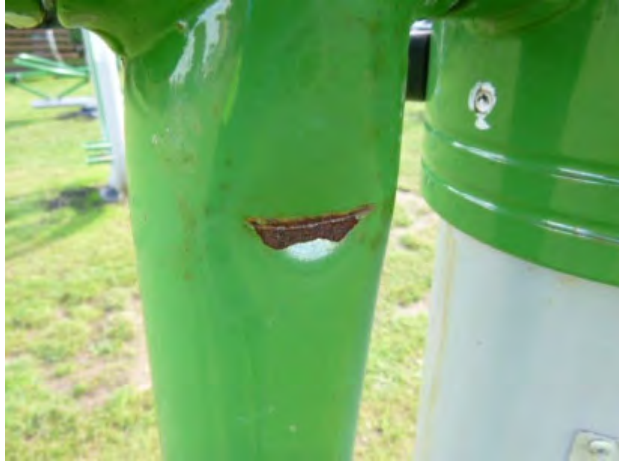
Item: Adult Fitness Equipment - Air Skier
Manufacturer: Caloo

Finding: There is minor damage and the paint is rusty where the bar hits the supporting unit

Action: Repair and repaint

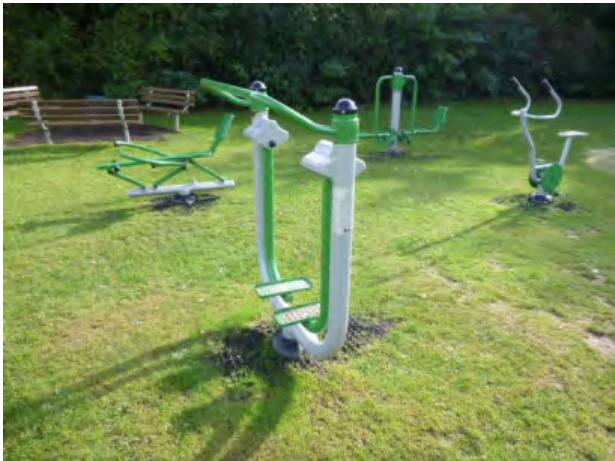
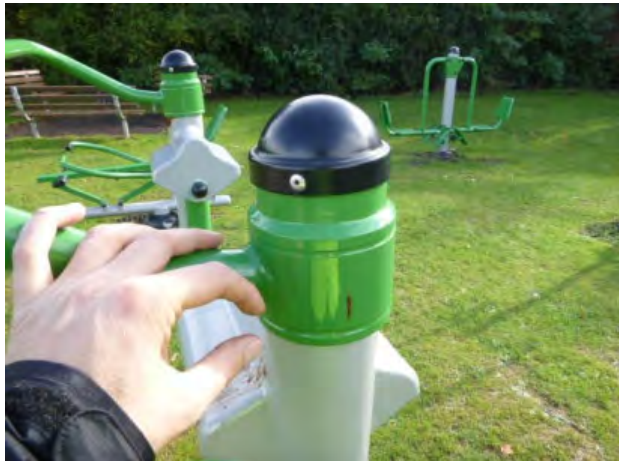
Item: Adult Fitness Equipment - Air Walker
Manufacturer: Caloo

Finding: Fixings have worked loose at the top of the posts

Action: Secure the fixings

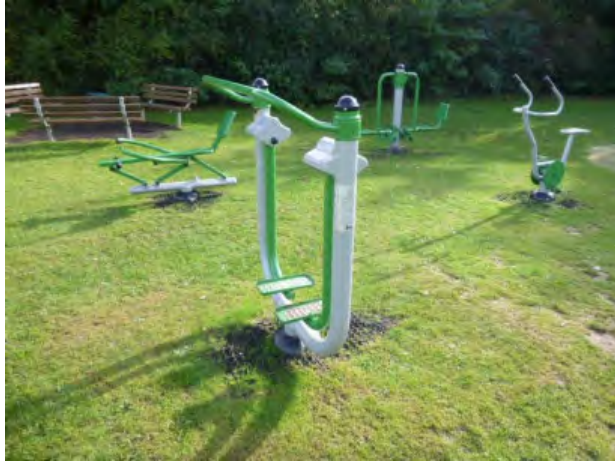
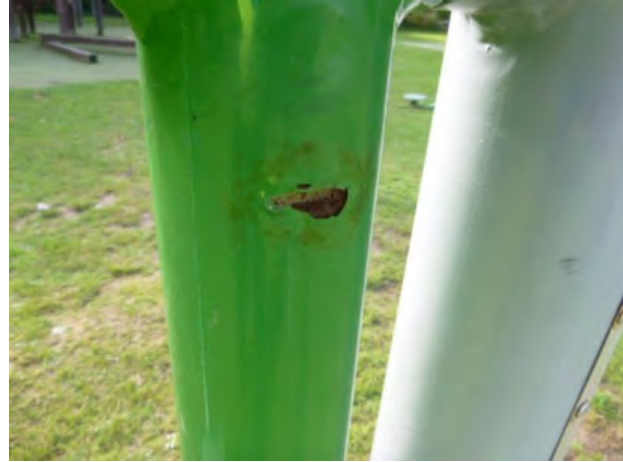
Item: Adult Fitness Equipment - Air Walker
Manufacturer: Caloo

Finding: There is minor damage and the paint is rusty where the bar hits the supporting unit

Action: Repair and repaint

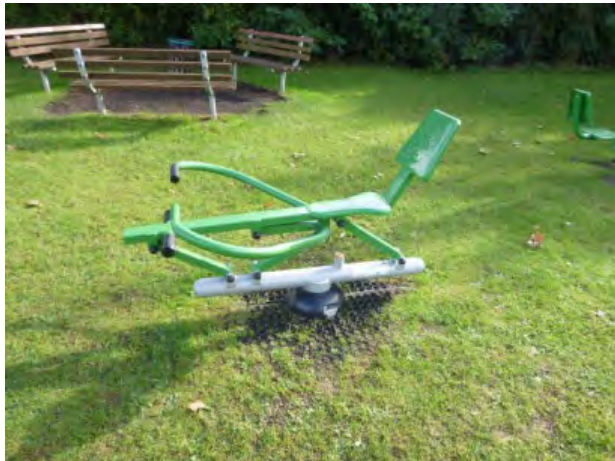
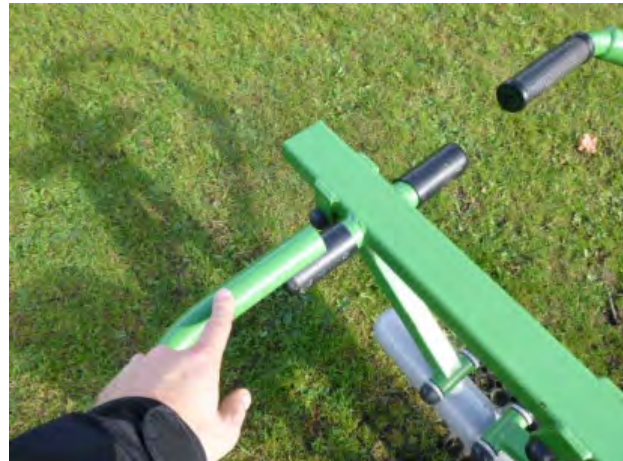
Item: Adult Fitness Equipment - Rower
Manufacturer: Caloo

Finding: A hand grip rubber is missing

Action: Replace the hand grip

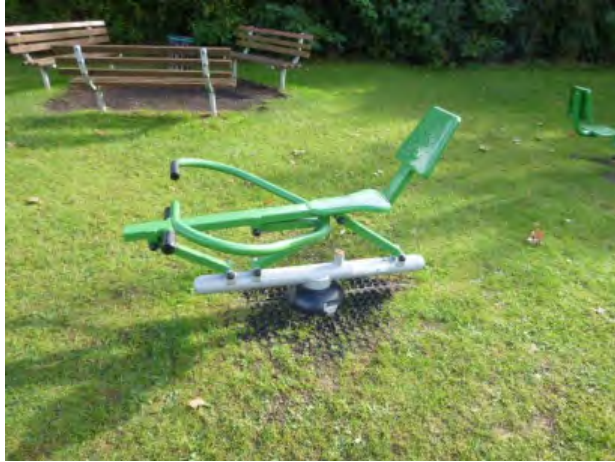
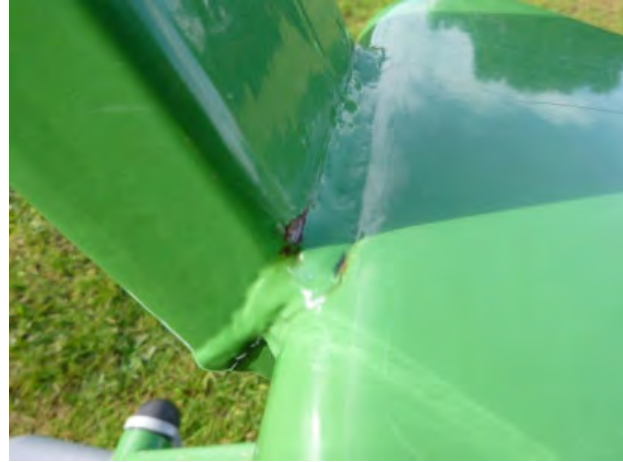
Item: Adult Fitness Equipment - Rower
Manufacturer: Caloo

Finding: There is some evidence of rust around the weld point

Action: Monitor for any further deterioration and repaint as required
