Annual Inspection

Cork Field Skate Park

Normandy Way, Marchwood

Inspection Ref: 122029

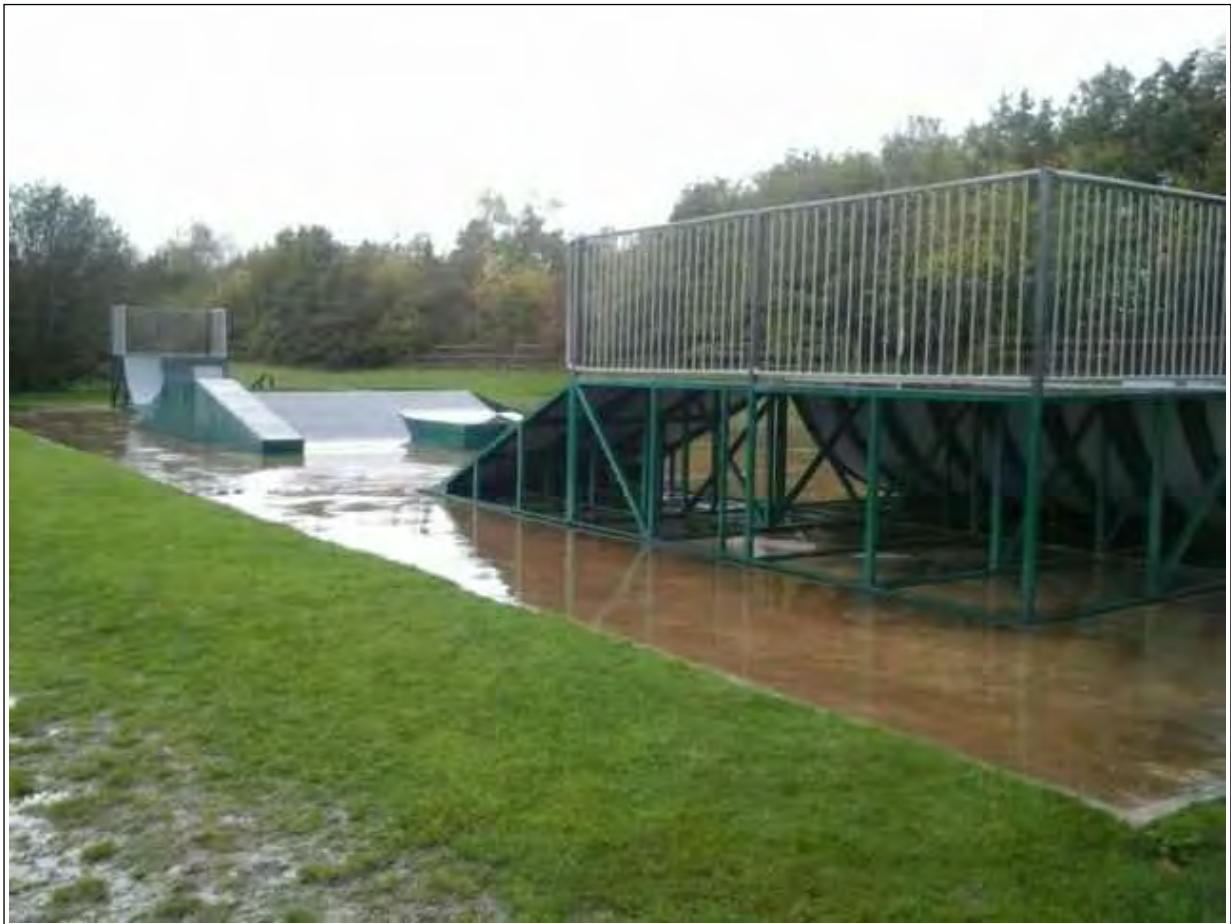
Risk Assessment: **8 - Low Risk**

Location: The site is located in an area of public open space and is not directly overlooked by any properties in the local community.

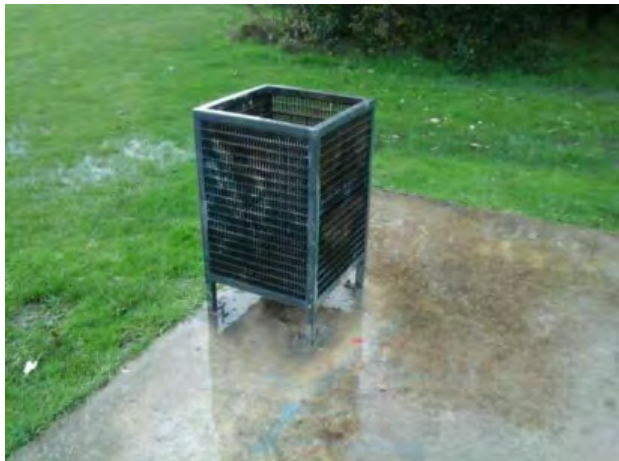
Item: Ancillary Items - Litter Bin
Manufacturer: Owner/Operator
Surface Type: N/A
Equipment Compliance: N/A
Surface Area Compliance: N/A
Ref/Part Number:
Total Findings: 1

Finding 1

This item is satisfactory - no work required
