Annual Inspection Came & Company @ Cork Field Skate Park

Inspection Ref: 79847

Inspected: 14 October 2013 at 1346 Inspector: Didrik Wold RPII Annual Inspector

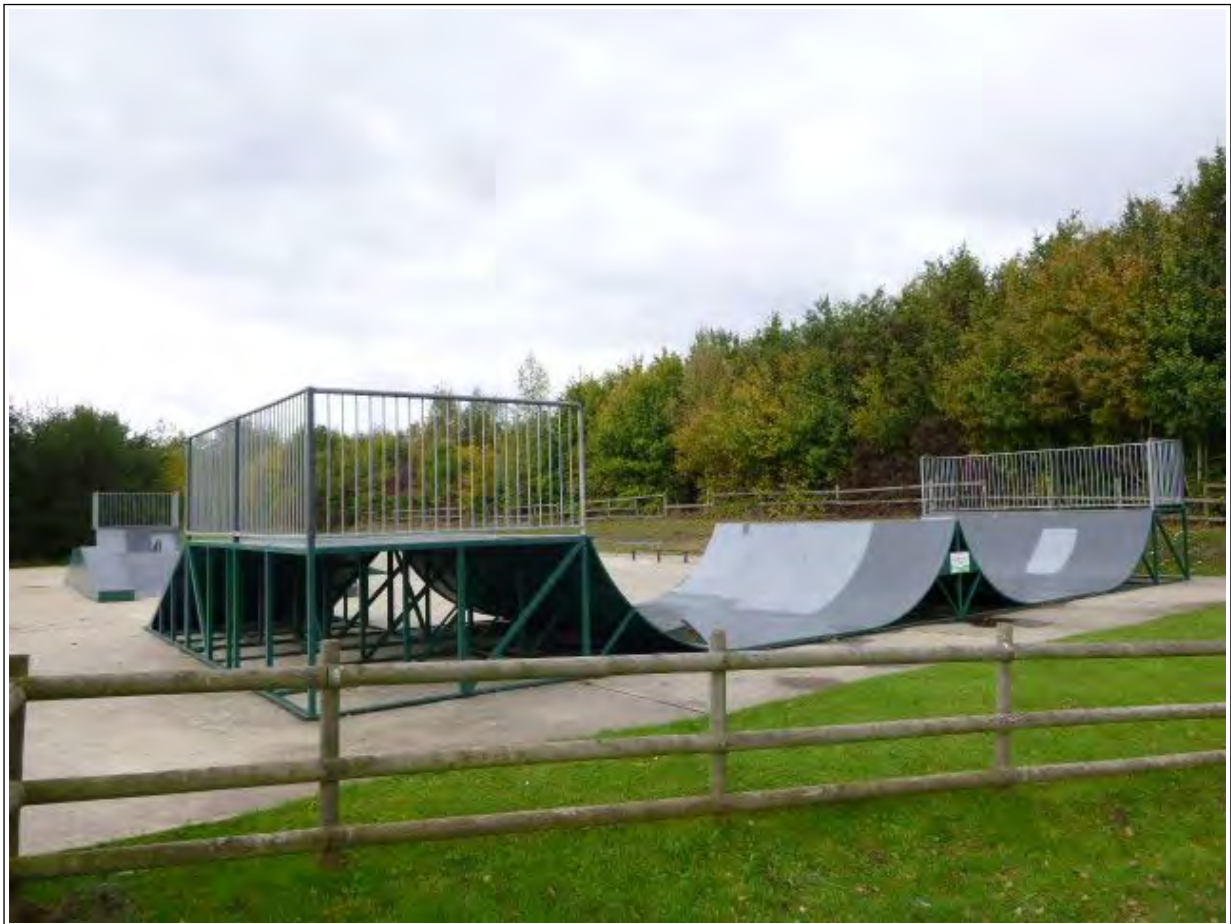
Risk Assessment: **8 - Low Risk**

Location: The site is located in an area of public open space and is not directly overlooked by any properties in the local community.

Disabled Access: Some accessible features – an area that presents difficulties to the majority of people with disabilities but in favourable circumstances and certainly in partnership can be accessed.
