## Annual Inspection

Came & Company

Marchwood over 12's Play Area

Annual Inspection - 03 November 2014 at 10:09 Inspector: Leon Pope RPII Annual Inspector

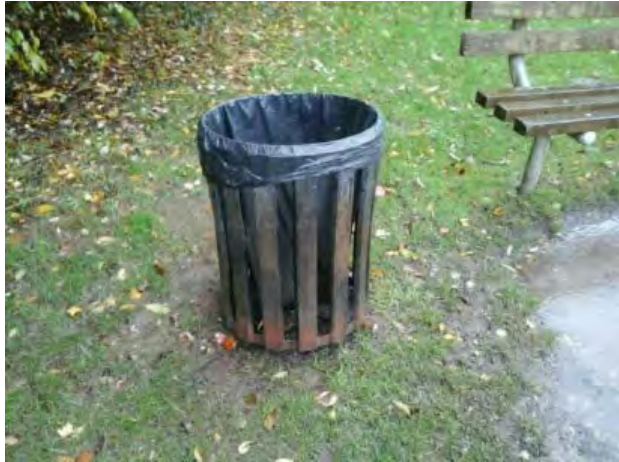
**Item:** Ancillary Items - Litter Bin  
**Manufacturer:** Owner/Operator  
**Surface Type:** N/A  
**Equipment Compliance:** N/A  
**Surface Area Compliance:** N/A  
**Ref/Part Number:**  
**Total Findings:** 1

This item is satisfactory - no work required

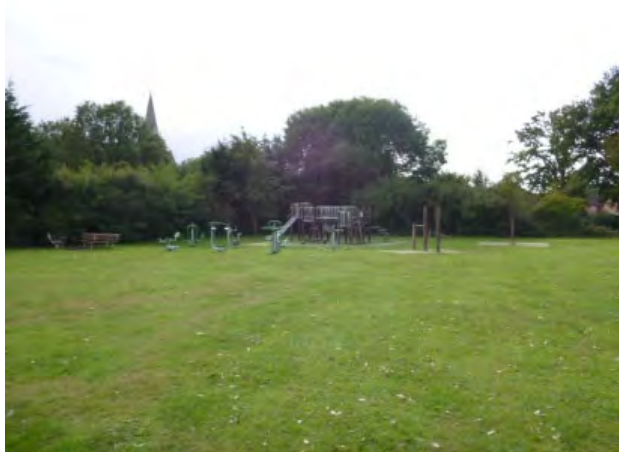
**Item:** Ancillary Items - Site General  
**Manufacturer:** Owner/Operator  
**Surface Type:** N/A  
**Equipment Compliance:** N/A  
**Surface Area Compliance:** N/A  
**Ref/Part Number:**  
**Total Findings:** 2

It is recommended that Adult Outdoor Fitness equipment is installed a minimum of 25m away from a children's playground or separated and screened to discourage access by younger children - Monitor use and consider relocating the equipment

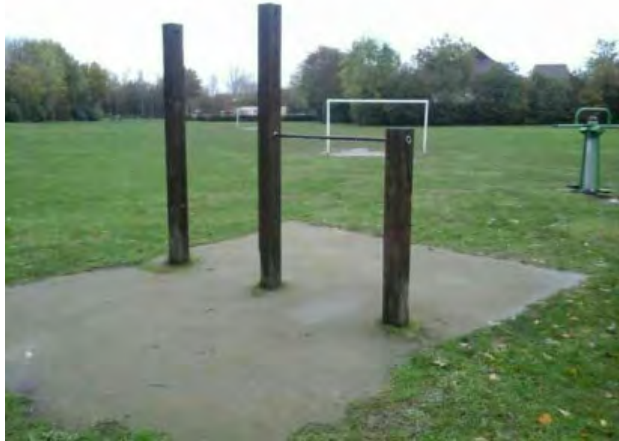
**Item:** Outdoor Fitness Equipment - Pull Up Station  
**Manufacturer:** Not Identified  
**Surface Type:** Carpet System  
**Equipment Compliance:** Yes  
**Surface Area Compliance:** Yes  
**Ref/Part Number:**  
**Total Findings:** 4  
**Life Expectancy:** 1 - 3 Years

There is a missing pole - Consider replacing missing element

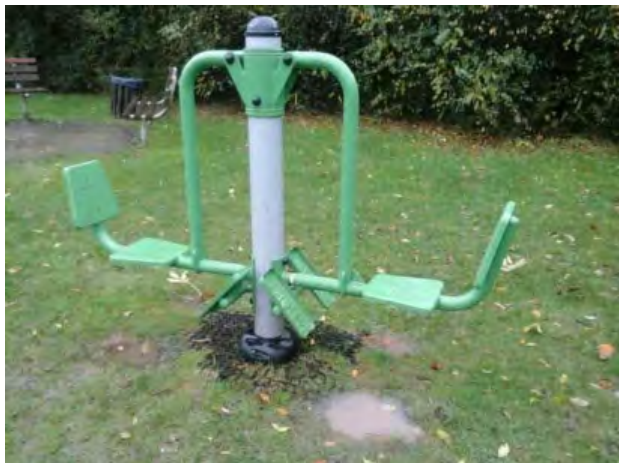
**Item:** Outdoor Fitness Equipment - Leg Press  
**Manufacturer:** Caloo  
**Surface Type:** Grass Matrix Tiles  
**Equipment Compliance:** N/A  
**Surface Area Compliance:** N/A  
**Ref/Part Number:**  
**Total Findings:** 1

This item is satisfactory - no work required

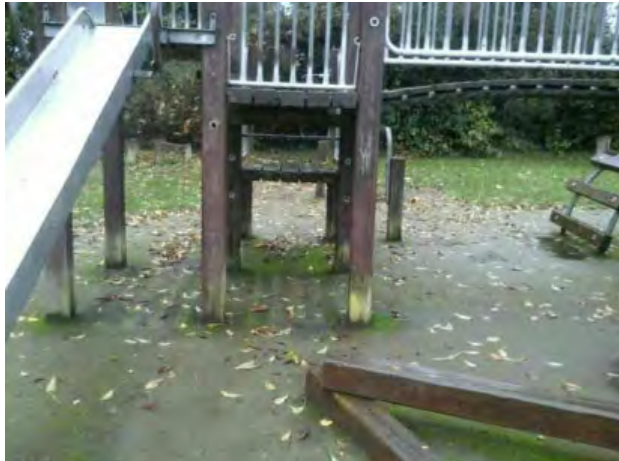
**Item:** Activity Equipment - Multi Play (Junior) **Risk Level:** L - Low Risk  
**Manufacturer:** Not Identified **Surface:** Carpet System

**Finding:** The balance beams form a hard object within the falling space of the equipment in contravention of the requirements of BS EN 1176 Part 1 **Action:** Monitor use

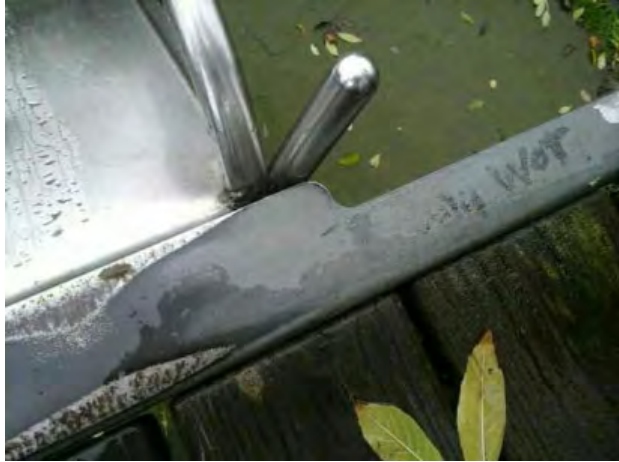
**Item:** Activity Equipment - Multi Play (Junior) **Risk Level:** V - Very Low Risk  
**Manufacturer:** Not Identified **Surface:** Carpet System

**Finding:** There is/are finger entrapment/s at the top of the slide **Action:** Monitor use

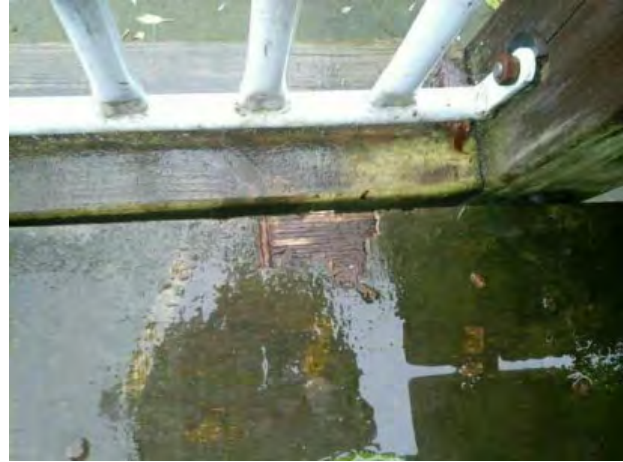
**Item:** Activity Equipment - Multi Play (Junior)  
**Manufacturer:** Not Identified

**Finding:** The plywood has delaminated in some places **Action:** Remove all rough or splintered edges.

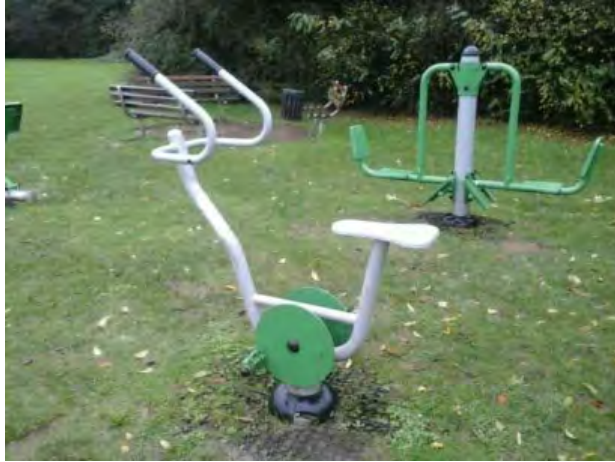
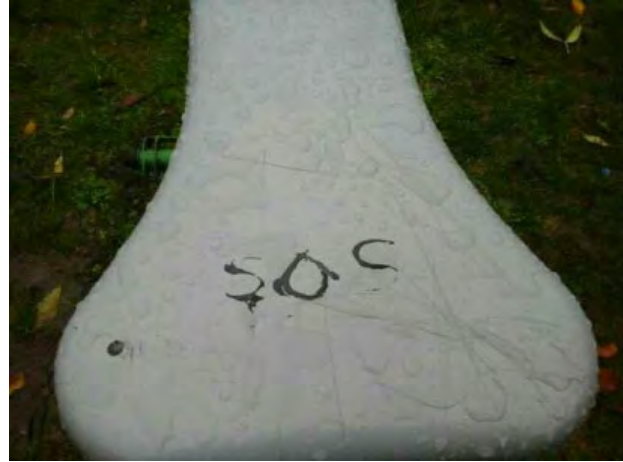
**Item:** Outdoor Fitness Equipment - Cycle  
**Manufacturer:** Caloo

**Finding:** There is some graffiti present on site

**Action:** Remove the graffiti

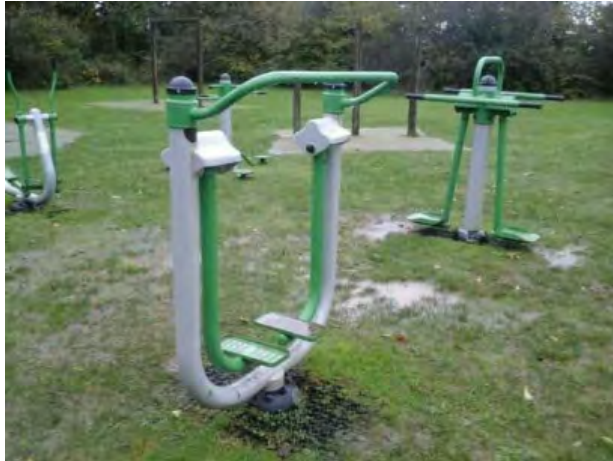
**Finding:** The paintwork on this item has been damaged or worn exposing the metal underneath which is rusting

**Action:** Treat any rusting components and repaint

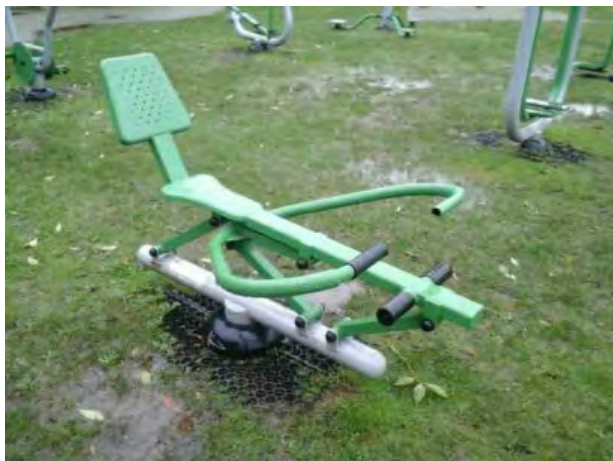
**Finding:** A handgrip(s) is/are missing

**Action:** Replace missing hand grips
