Annual Inspection

Came & Company

Marchwood under 12's Play Area

Marchwood Village Centre

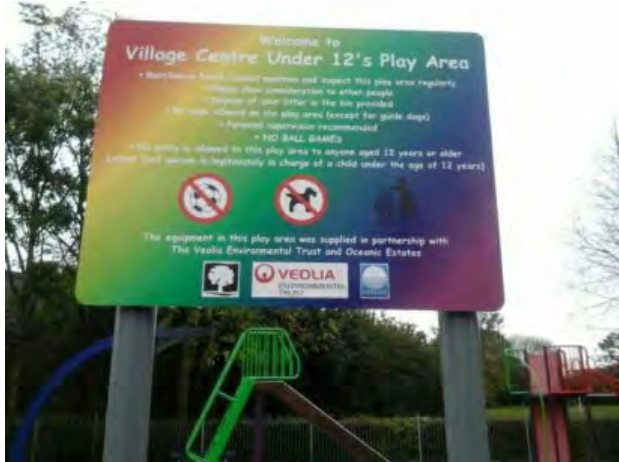
2 - Very Low Risk

Item: Ancillary Items - Sign
Manufacturer: Owner/Operator
Surface Type: N/A
Equipment Compliance: N/A
Surface Area Compliance: N/A
Ref/Part Number:
Total Findings: 1

Finding 1

Finding: It is recommended that information signs with emergency contact details are installed at each entrance/exit point to the playground

It is recommended that information signs with emergency contact details are installed at each entrance/exit point to the playground - Provide in accordance with the recommendations set out in BS EN 1176

Action: Provide in accordance with the recommendations set out in BS EN 1176

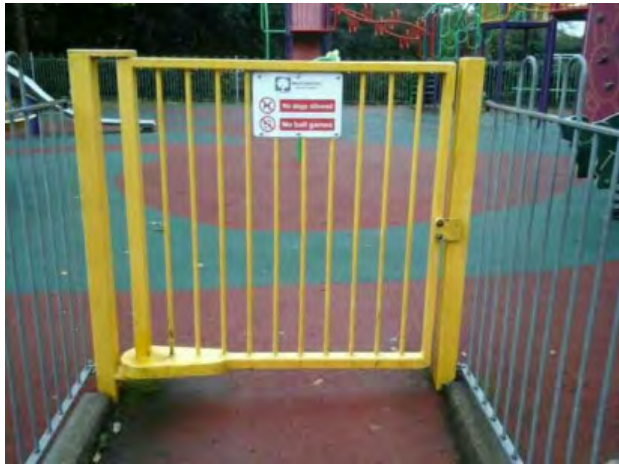
4 - Very Low Risk

Item: Ancillary Items - Gate - Self Closing
Manufacturer: Owner/Operator
Surface Type: N/A
Equipment Compliance: N/A
Surface Area Compliance: N/A
Ref/Part Number:
Total Findings: 1

Finding 1

This item is satisfactory - no work required

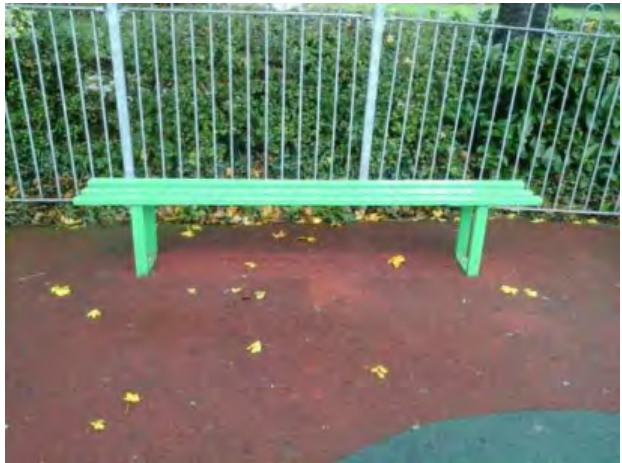
4 - Very Low Risk

Item: Ancillary Items - Bench
Manufacturer: Owner/Operator
Surface Type: N/A
Equipment Compliance: N/A
Surface Area Compliance: N/A
Ref/Part Number:
Total Findings: 1

Finding 1

This item is satisfactory - no work required

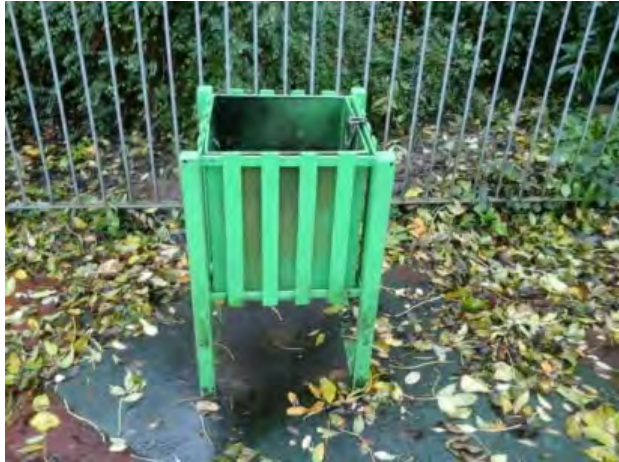
3 - Very Low Risk

Item: Ancillary Items - Litter Bin
Manufacturer: Owner/Operator
Surface Type: N/A
Equipment Compliance: N/A
Surface Area Compliance: N/A
Ref/Part Number:
Total Findings: 1

Finding 1

This item is satisfactory - no work required

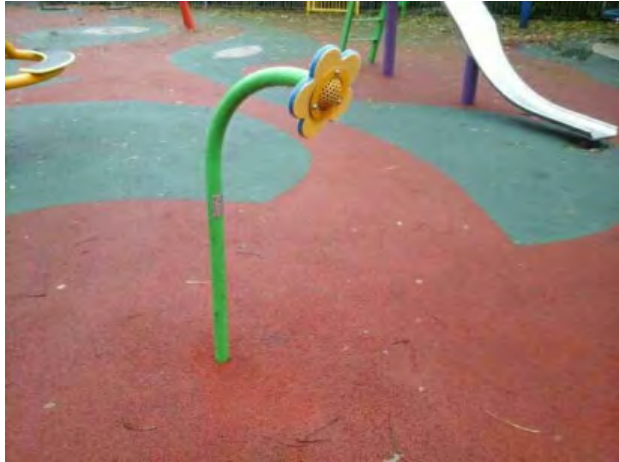
4 - Very Low Risk

Item: Other - Talk Tubes
Manufacturer: Wicksteed Playscapes
Surface Type: Wet Pour
Equipment Compliance: Yes
Surface Area Compliance: Yes
Ref/Part Number:
Total Findings: 1
Life Expectancy: 5 -10 Years

Finding 1

This item is satisfactory - no work required

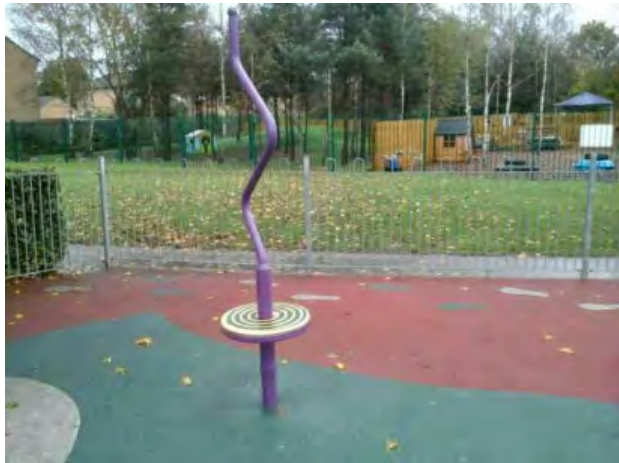
4 - Very Low Risk

Item: Rotor Play - Spinning Pole
Manufacturer: Wicksteed Playscapes
Surface Type: Wet Pour
Equipment Compliance: Yes
Surface Area Compliance: Yes
Ref/Part Number:
Total Findings: 1
Life Expectancy: 5 -10 Years

Finding 1

This item is satisfactory - no work required
