Annual Inspection

Admiralty Quay Play Area

Off Ordnance Way, Admiralty Quay, SO40 4AR

Inspection Ref: 79845

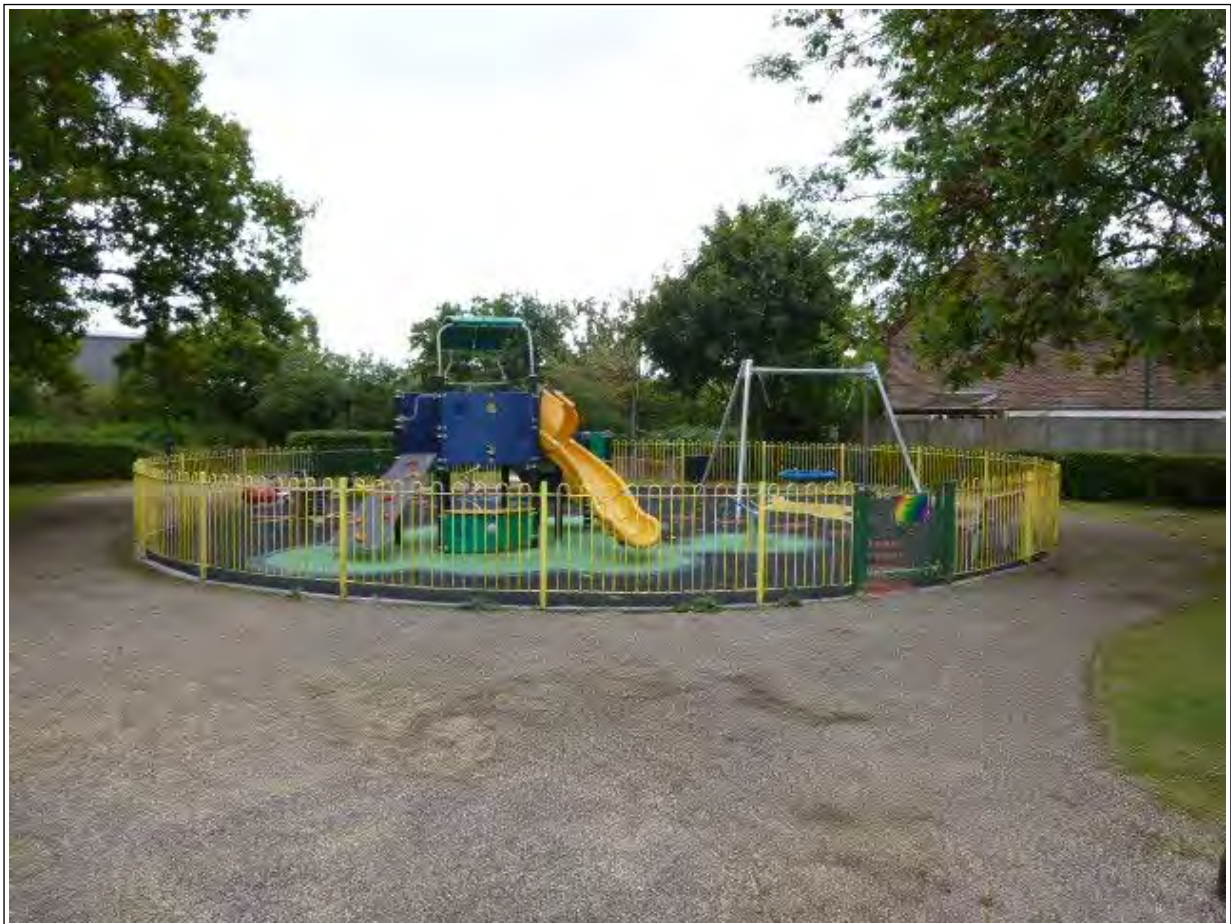
Risk Assessment: **8 - Low Risk**

Location: The site is located in an area of public open space and is overlooked by a number of properties in the local community.

Disabled Access: Generally accessible – an area, accessible to most but not all people even when help is at hand.
