Annual Inspection

Came & Company

Lloyd Play Area

Main Road, Marchwood, SO40 4US

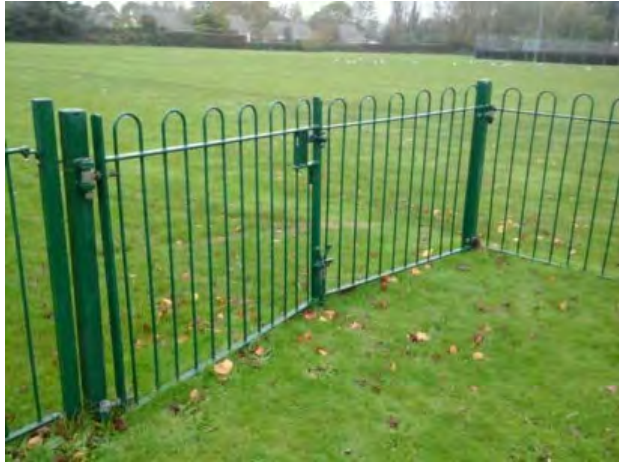
Item: Ancillary Items - Gate - Maintenance
Manufacturer: Owner/Operator
Surface Type: N/A
Equipment Compliance: N/A
Surface Area Compliance: N/A
Ref/Part Number:
Total Findings: 1

Finding 1

This item is satisfactory - no work required

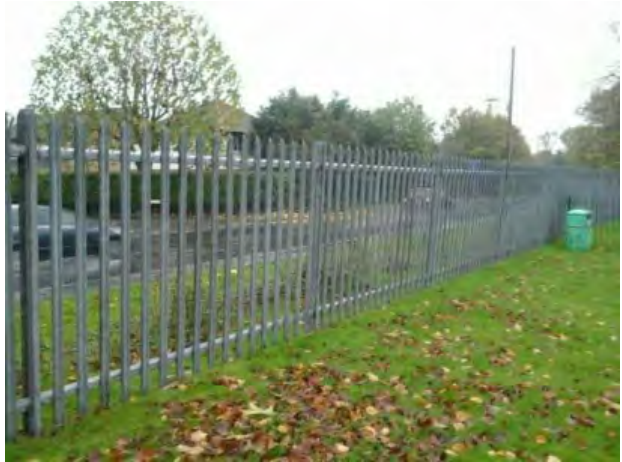
Item: Ancillary Items - Fence
Manufacturer: Owner/Operator
Surface Type: N/A
Equipment Compliance: N/A
Surface Area Compliance: N/A
Ref/Part Number:
Total Findings: 1

Finding 1

This item is satisfactory - no work required

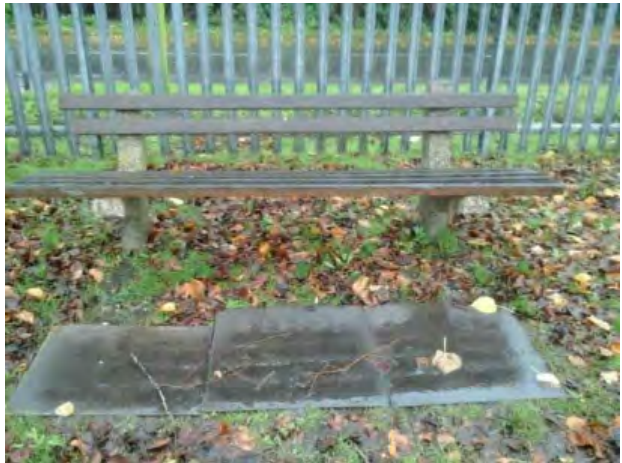
Item: Ancillary Items - Bench
Manufacturer: Owner/Operator
Surface Type: N/A
Equipment Compliance: N/A
Surface Area Compliance: N/A
Ref/Part Number:
Total Findings: 1

Finding 1

This item is satisfactory - no work required

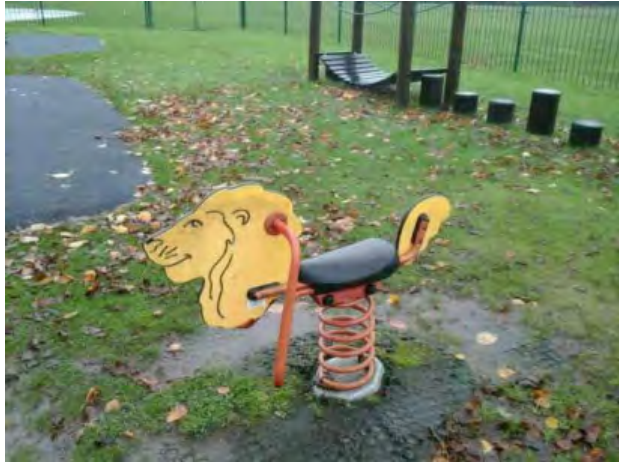
Item: Rocking Equipment - Spring Lion
Manufacturer: Hags SMP
Surface Type: Grass Matrix Tiles
Equipment Compliance: Yes
Surface Area Compliance: Yes
Ref/Part Number:
Total Findings: 1
Life Expectancy: 5 -10 Years

Finding 1

This item is satisfactory - no work required

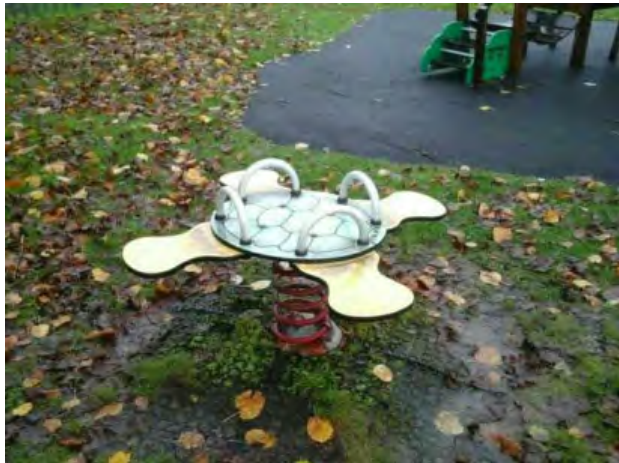
Item: Rocking Equipment - Spring Turtle
Manufacturer: Hags SMP
Surface Type: Grass Matrix Tiles
Equipment Compliance: Yes
Surface Area Compliance: Yes
Ref/Part Number:
Total Findings: 1
Life Expectancy: 3 - 5 Years

Finding 1

This item is satisfactory - no work required

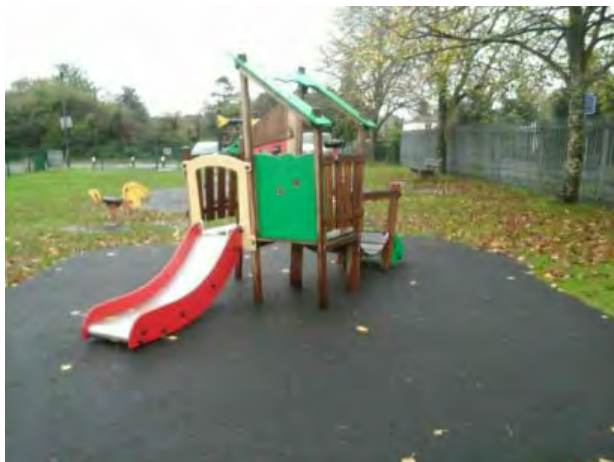
Item: Activity Equipment - Multi Play (Junior)
Manufacturer: Hags SMP
Surface Type: Wet Pour
Equipment Compliance: Yes
Surface Area Compliance: Yes
Ref/Part Number:
Total Findings: 1
Life Expectancy: 3 - 5 Years

Finding 1

This item is satisfactory - no work required

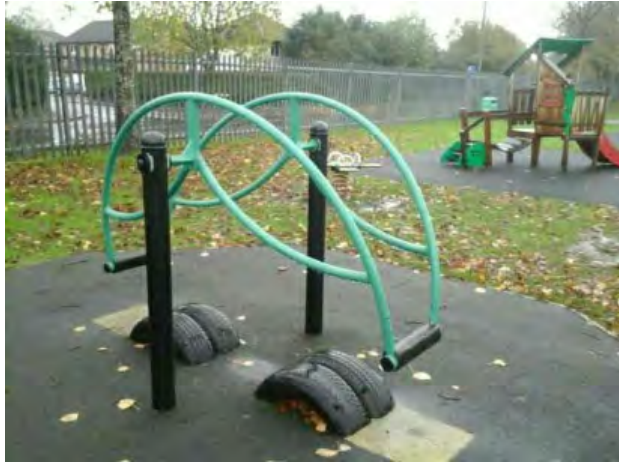
Item: Rocking Equipment - See Saw
Manufacturer: Hags SMP
Surface Type: Wet Pour
Equipment Compliance: Yes
Surface Area Compliance: Yes
Ref/Part Number:
Total Findings: 1
Life Expectancy: 3 - 5 Years

Finding 1

This item is satisfactory - no work required

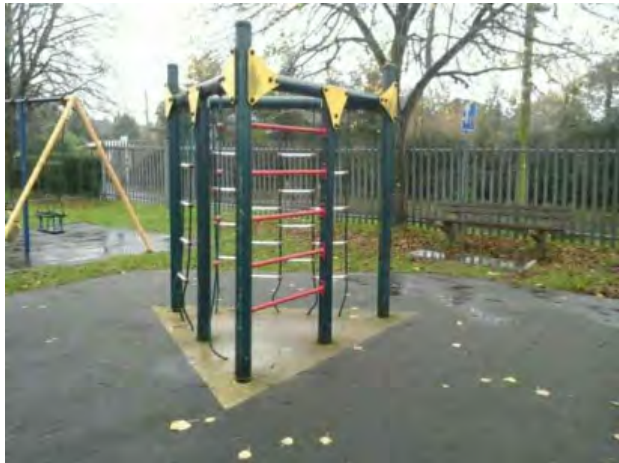
Item: Activity Equipment - Climbing Frame
Manufacturer: Hags SMP
Surface Type: Wet Pour
Equipment Compliance: Yes
Surface Area Compliance: Yes
Ref/Part Number:
Total Findings: 1
Life Expectancy: 3 - 5 Years

Finding 1

This item is satisfactory - no work required
