Annual Inspection Came & Company @ Marchwood over 12's Play Area

Inspection Ref: 79855

Inspected: 14 October 2013 at 1443 Inspector: Didrik Wold RPII Annual Inspector

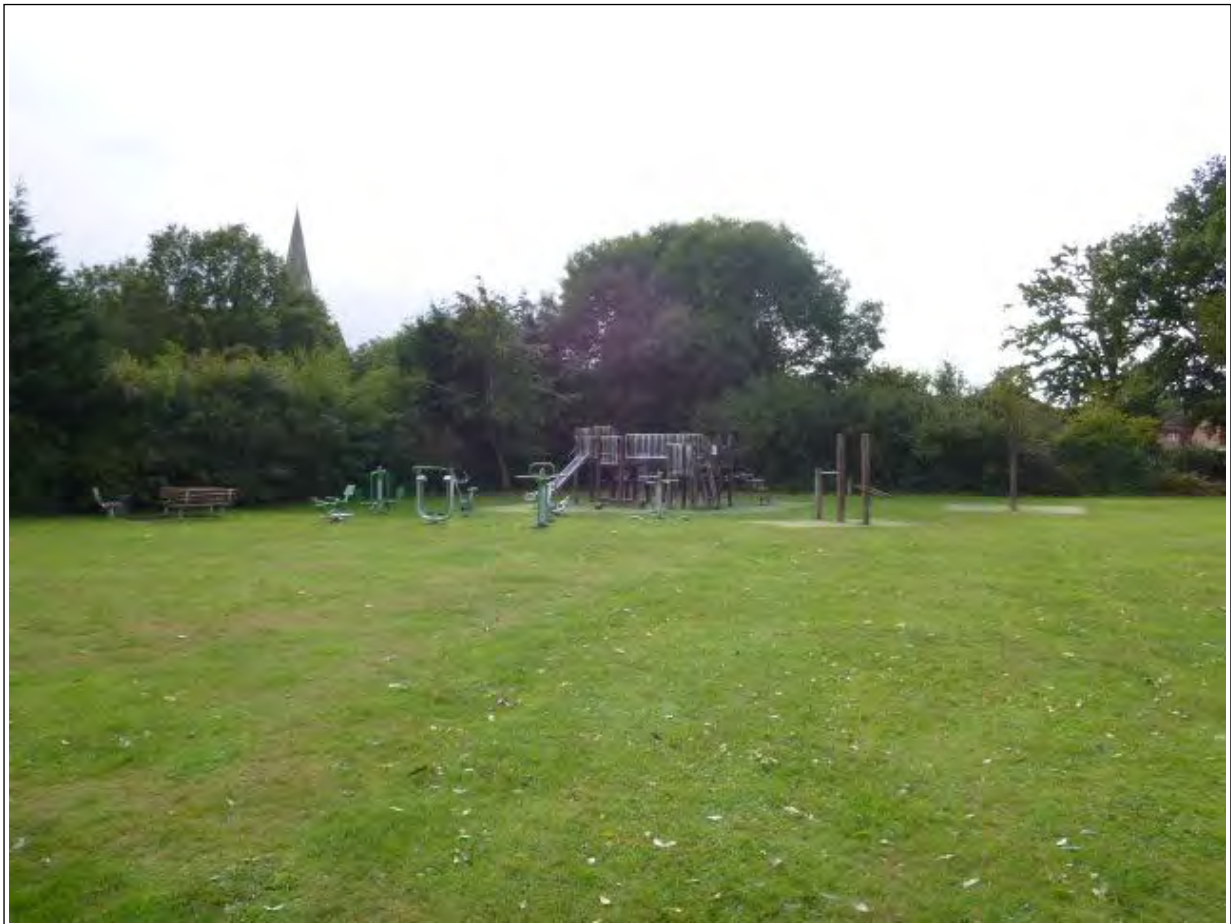
Location: The site is located in an area of public open space and is not directly overlooked by any properties in the local community.

Disabled Access: Severely limited access – an area that presents serious barriers to disabled people, even when skilled help is at hand.
